**UNIVERSITY AT ALBANY
STATE UNIVERSITY OF NEW YORK**

**CAMPUS HERITAGE
PRESERVATION PLAN**

Mesick • Cohen • Wilson • Baker • Architects
388 Broadway Albany, NY 12207

April 2009

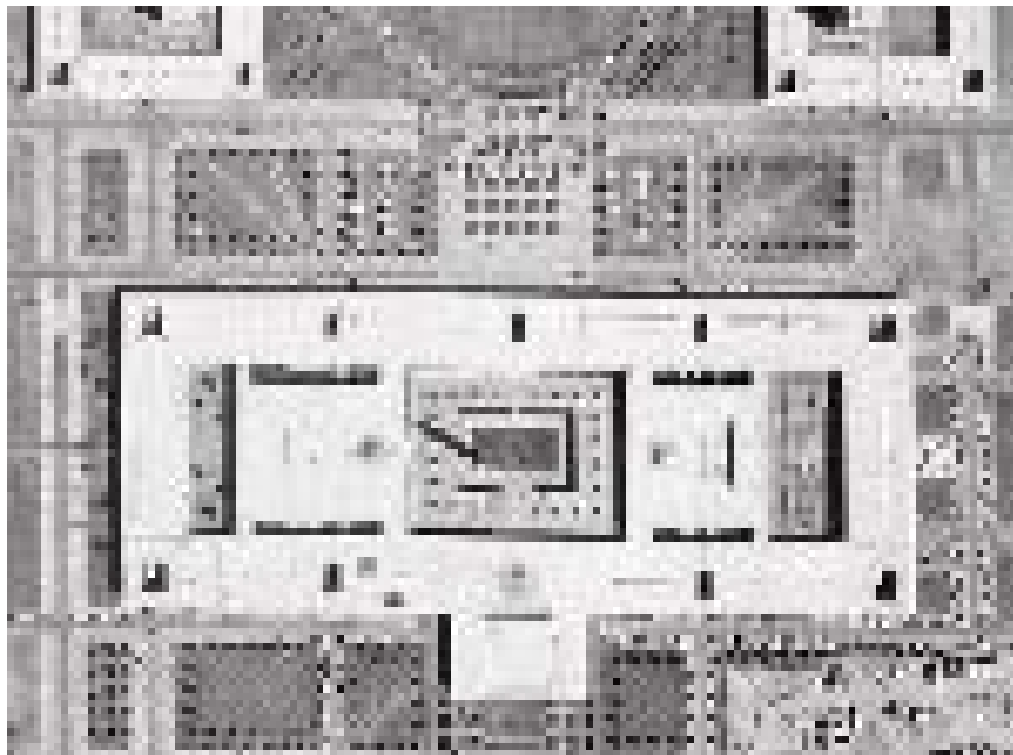
This close-up of the aerial photograph shows vehicles parked around the podium and in the main entry walkway, as well as wear trails created between the Podium and residential quads.

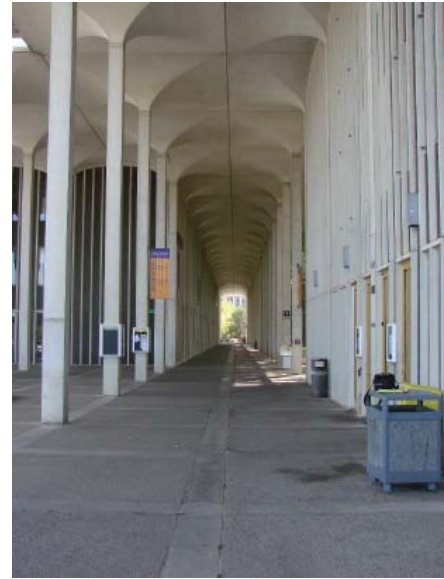
(Image 3)

There are minor hairline cracks in the ribs of the precast concrete panels, which do not appear to be a serious issue. A few of these are larger and have darkened with dirt and moisture. These areas may require patching. There is also some hairline cracking in the poured in place columns, but with few exceptions these do not seem to be a problem. The joints at the intersections of horizontal and vertical ribs above the doors and windows have small vertical or horizontal hairline cracks, which may be from contraction rather than a structural problem, or perhaps from insufficient rebar. This

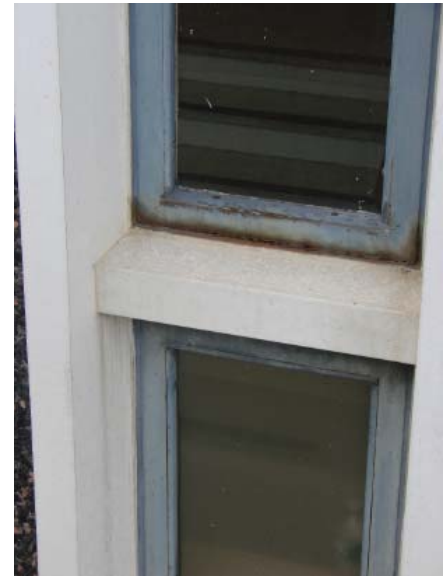
(Image 20)

The windows are steel window sash, both fixed and casement. The sills and lower portions of the frames are rusting and the perimeter caulking has not been maintained. These windows appear to have their original factory finish, and desperately need to be repainted. The windows around the perimeter of the Podium, with only a half bay of roof overhang, all show considerably more rust and deterioration than the elevations with greater roof overhang (Image 20). The University has instituted a program of replacing these original single glazed units with an aluminum frame double glazed window unit, which has similar appearance. The replacement glazing greatly increases energy performance with minimal visual impact of the buildings. For the important public buildings with fixed sashes, interior storm windows could be an alternative to window replacement.

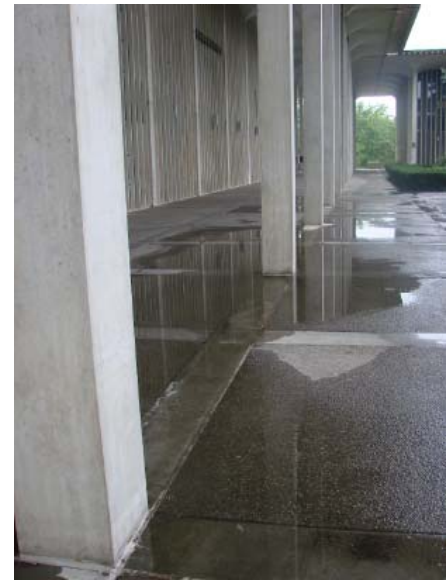
(Image 4)

Across the Podium, large areas have settled unevenly creating areas that do not drain completely (Image 4). This is most prevalent at all the corner courtyards in particular, but it is really a problem across the entire plaza. Additional drains have been added in some of the corner courtyards and across the plaza, but there is still significant puddling in all courtyards and elsewhere. The most dramatically of all is in the southeast and southwest courtyards (Images 5 and 6). These courtyards contain the entry stairs, which have recently been rebuilt. The original construction documents contained an alternate for skylights above the roof opening at these courtyards, which apparently proved too expensive. However skylights in these locations are again being reconsidered and they would be an excellent idea from the point of view of conservation as well as aesthetics. They control water at the roof level, which is easier to deal with, and they minimize snow, ice and water falling on the stairs, which leads to problems of deterioration in the stairs (see “Podium Stairs” pg. 104). These would also affect the planting material in these courtyards and provisions for automatic irrigation would need to be part of any skylight project. Two drains have been added in front of the wings of the Performing Arts Center, however, the paving

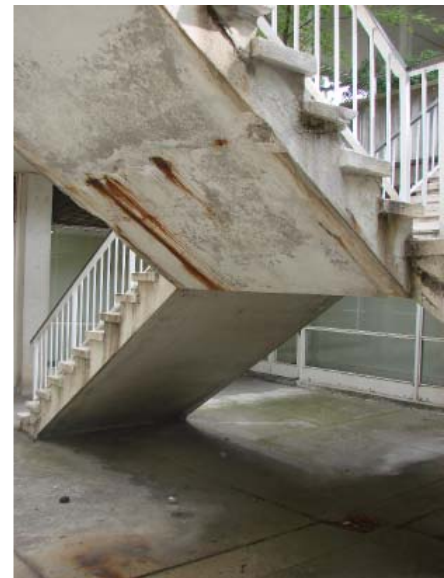
(Image 13)

The northwest and northeast courtyards have original stairs from the Podium to basement level. These use a precast concrete treads and pavers over an exposed concrete structure. The stairs have flights descending to a landing from the north and south, and two flights at ninety degrees descending to the basement level. These stairs are exposed to weather and there is significant deterioration in the precast concrete treads and pavers in addition to significant patches and repairs. Repairs were underway, in some cases, during the time of this survey. The landings have been completely resurfaced. Drainage is such that meaningful deterioration in the concrete substructure due to moisture penetration and possibly the use of salt to melt snow and ice. There are cracks in the concrete structure at the top junction with the podium indicating movement as well as significant accumulation of calcium from leaching water. There is significant rust staining on the structure and some spalling of the concrete caused by the expansive forces of the rusting (Image 13). The locations where the railings have been inserted into the tread have proved vulnerable and most have been patched. These stairs require significant repair. It should be noted that subsequent to this survey that a repair program to rebuild these stairs has been started, which includes replacing the treads and repairing the concrete structure. There are similar stairs in front of the Library and Performing Arts Center, which, are outside the building but have been protected by the skylights above. These stairs are in significantly better condition with only minor repairs required.

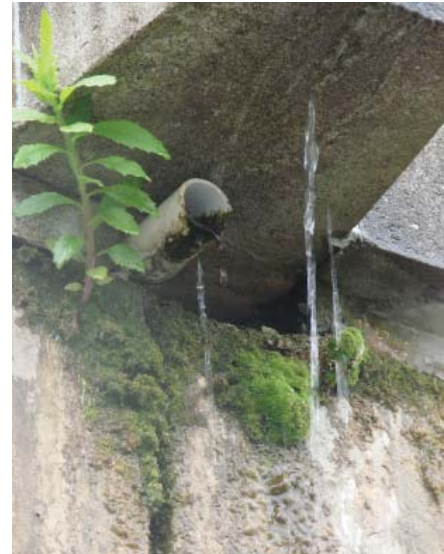
(Image 28)

is sufficient overhang the water tends to splash back against the bottom of the wall, staining it and causing problems. These drains, which are plastic pipe, are not original and have been added relatively recently to help drain the built-up roof beneath the podium paving. Although these drains were required, due to the increased volume of water drained by the roof as the paving above fails, the installation of these drains required removing the scuppers and disturbing the membrane and reglet. It appears that there are leaks around the pipes where the membrane required repair or adjacent to the repair (Image 28).

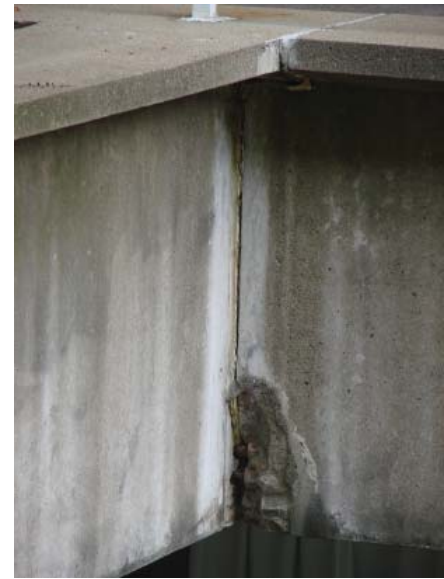
(Image 50)

At the light wells/courtyards, similar benches are used as barriers. The openings are surrounded by a low painted aluminum railing let into the top of the concrete bench. The hole drilled at each post has not always been well maintained and numerous cracks and spalled areas surrounding the now filled holes are a result of freezing water. The upper ledges of the cast-in-place planters are designed and intended to be seating. Some of the cast joints in these benches were meant to be open, however, recent maintenance has resulted in the caulking of all the joints indiscriminately. This type of repair is both unsightly and discourages the use of the benches as seating.

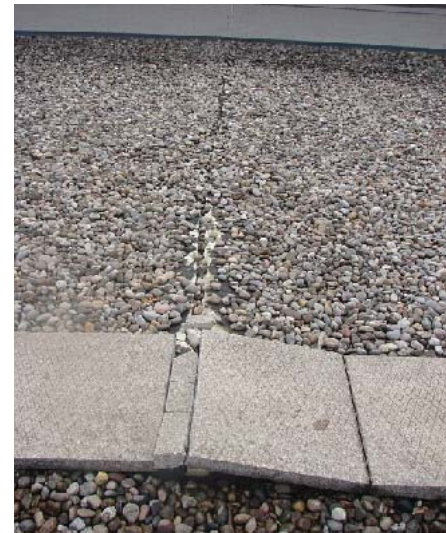
(Image 11)

The insulation and filter fabric has split along line of expansion joints and the ballast has washed into and filled the void (Image 11). There is some visible deterioration of the filter fabric where it is exposed to the sun. The roofing membrane is carried up above the height of the insulation at the roof monitors and concealed by the copper cap flashing.

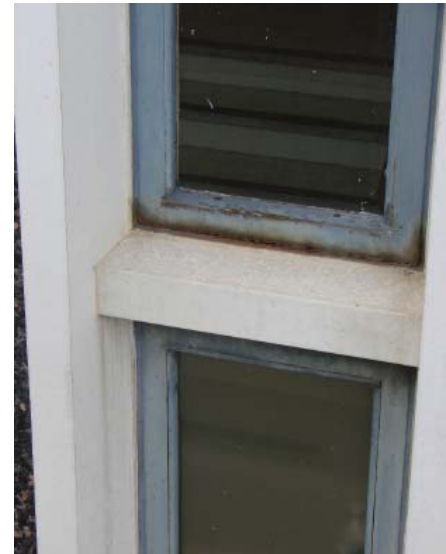
(Image 12)

The windows are all single glazed steel sash with two operable pairs of casement sash flanked by inoperable sash. All operable sashes have flashing at the head, but otherwise are identical to the inoperable sash. The windows on the north elevation show considerably more rust and deterioration than the elevations with greater roof overhang (Image 12).

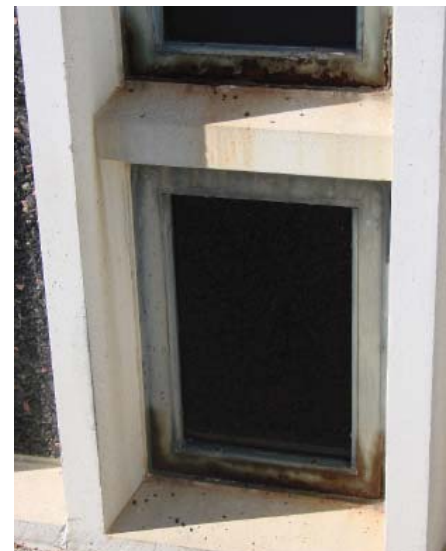
(Image 12)

The windows are all in much worse condition on the north side where the overhang is smaller, with many windows having significant rusting on the sill and lower portion of the jamb (Image 12).

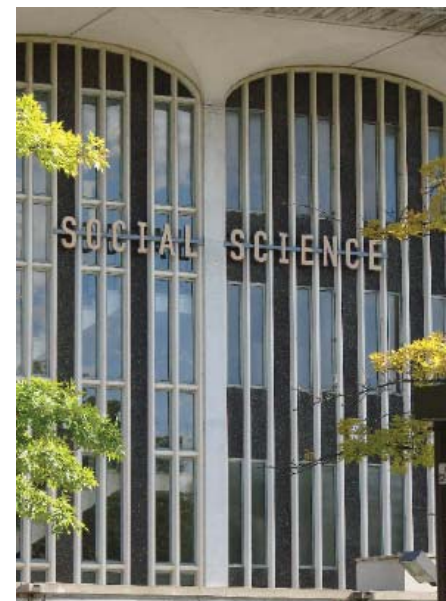
(Image 5)

There is also some hairline cracking on the cast in place columns, as well as spider web pattern cracking. This may simply be in the thick painted

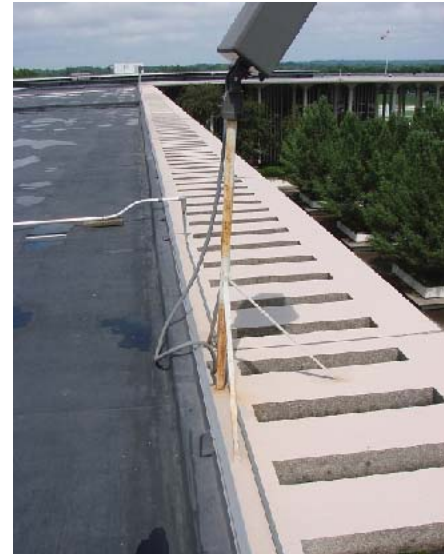
(Image 10)

slab and at the perimeter of the perforation has stained the concrete and minor surface erosion has exposed the fine aggregate. This is a physical concern, but has also created an unintended visual emphasis by outlining each perforation in dark gray. The large exterior spot lights are mounted to the top of the overhang using ferrous connectors (Image 10). Rusting of the connectors and framing member is not simply a visual issue but a conservation issue as rusting connectors will crack the concrete. These lights are an issue on all podium buildings.

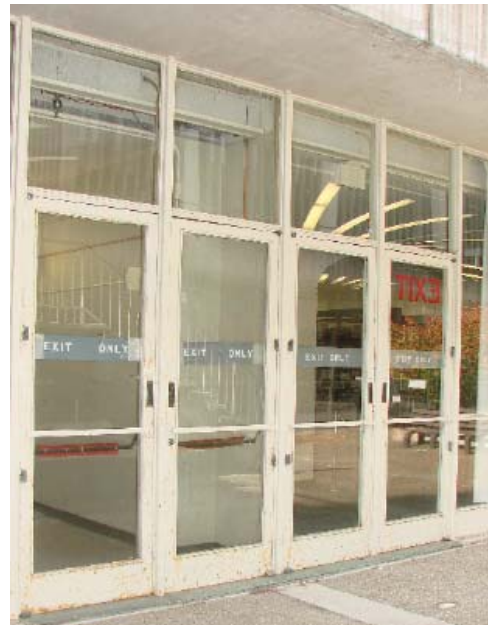
(Image 28)

The lower portion of minimalist glazed walls is exposed to snow and ice accumulating against them and the use of corrosive ice melt. It also appears to receive the drip from the planter box above splashing off the concrete of the planter bed. Exposure to moisture and salt on the steel elements has developed substantial rust and deterioration in the steel tube base and lower bar stock glazing stops (Image 28).
