CAPITAL IMPROVEMENT PLAN

Stormwater, Sanitary
Sewer, Water and
Irrigation Systems

University at Albany
(Uptown Campus)

SUCF Project No. 01834

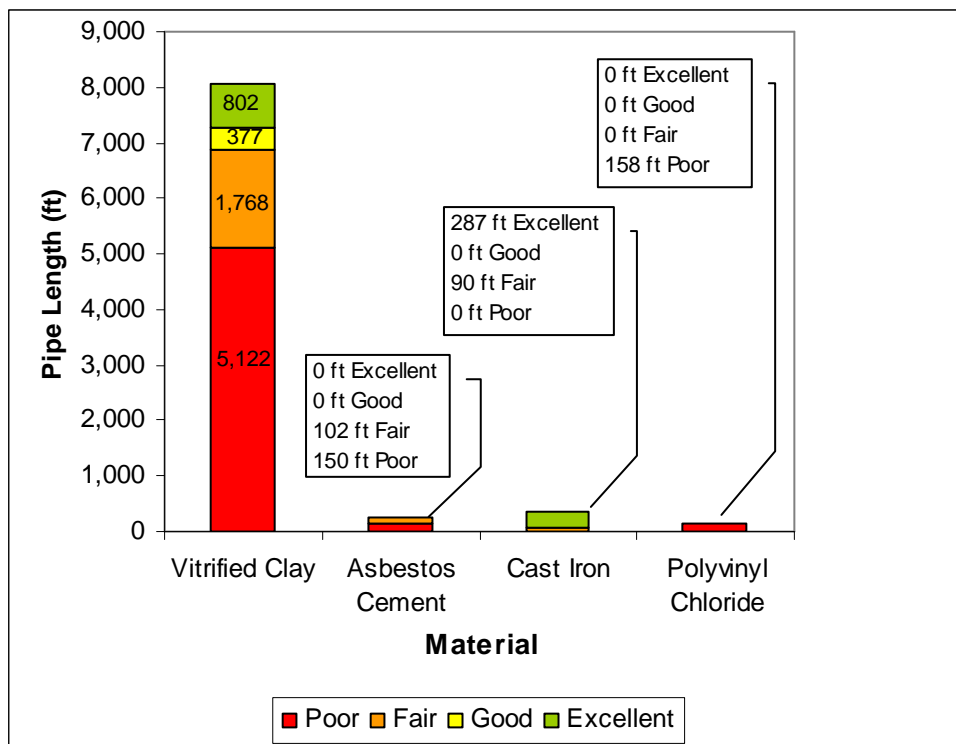
Figure 1-1: Sanitary Sewer Pipe Conditions

The condition of the sanitary sewer system manholes and selected sanitary sewer system pipes was assessed. The sanitary sewer system pipes contained many blockages due to debris, grease, and roots, with several pipe sags and breaks. Much of the sanitary sewer system is composed of vitrified clay pipe, a material not used in modern sanitary sewer construction. Most of the sanitary sewer manholes were in Good to Excellent condition, but a significant number were in Fair condition, and only a few in Poor condition. The inspection results are summarized in Figure 1-1 and Table 1-1.

S1. Sanitary Sewer Pipe Replacement (450pts) – Replacement of sanitary sewer pipes in poor condition or of unsuitable material is scheduled for Years 2, 3, 4, and 5, coinciding with anticipated construction projects. Those areas where breaks, sagging, root intrusion, grease, or debris were found during the sanitary sewer inspections should be cleaned and, where appropriate, slip-lined to prevent exfiltration from the sanitary sewer system (e.g., – breaks and sags) until they are replaced in future years. Additional segments of the sanitary sewer system pipes should be inspected as recommended in the Inspection and Maintenance Plan prepared for the University at Albany by Woodard & Curran.

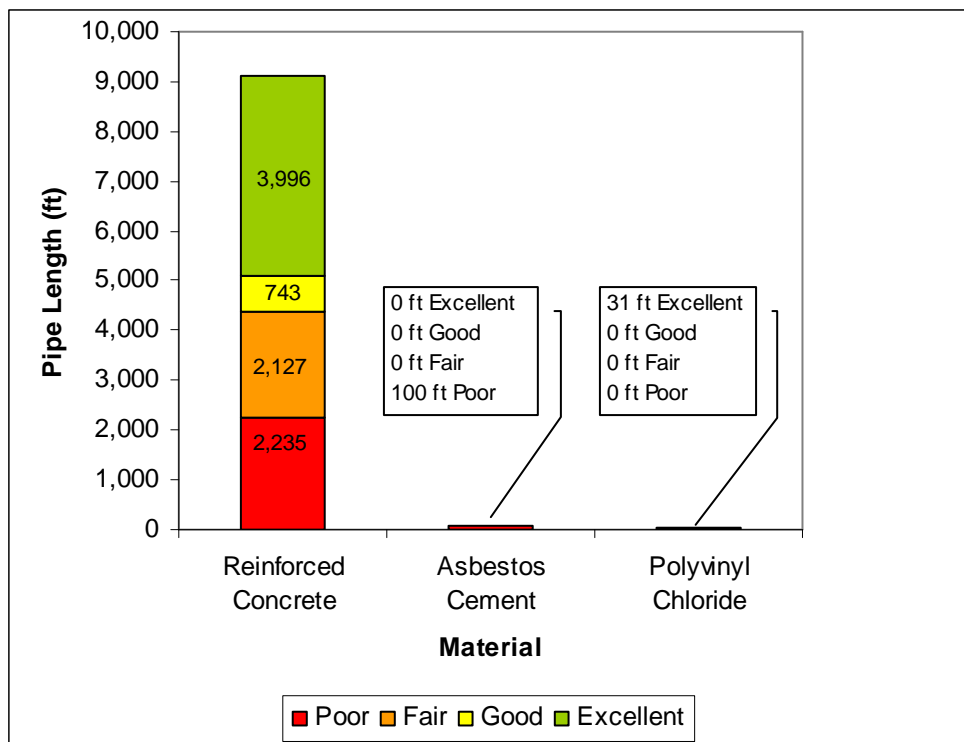
Figure 1-2: Storm Sewer Pipe Conditions

The condition of the storm sewer system features (catch basins, manholes, drain inlets and appurtenances) as well as selected storm sewer system pipes was assessed. The storm sewer system pipes contained many blockages due to debris and roots, with several cracks, breaks, and pipe misalignments. Almost half of the inspected storm sewer pipes were rated Fair to Poor. Most of the storm sewer features were in Good to Excellent condition, but a significant number were in Fair condition, and several in Poor condition. The inspection results are summarized in Figure 1-2 and Tables 1-2 through 1-5 below.

D1. Storm Sewer Pipe Replacement (390pts) – Replacement of storm sewer pipes in poor condition is scheduled for Years 2, 3, 4, and 5, coinciding with anticipated construction projects. Those areas where breaks, sagging, root intrusion, or debris were found during the storm sewer inspections should be cleaned and, where appropriate, slip-lined to prevent infiltration or exfiltration from the storm sewer system (e.g., – breaks and sags) until they are replaced in future years. Additional segments of the storm sewer system pipes should be inspected as recommended in the Inspection and Maintenance Plan prepared for the University at Albany by Woodard & Curran.
