# Condition Assessment Report

**Stormwater, Sanitary  
Sewer, Water and  
Irrigation Systems**

**University at Albany  
(Uptown Campus)**

**SUCF Project No. 01834**

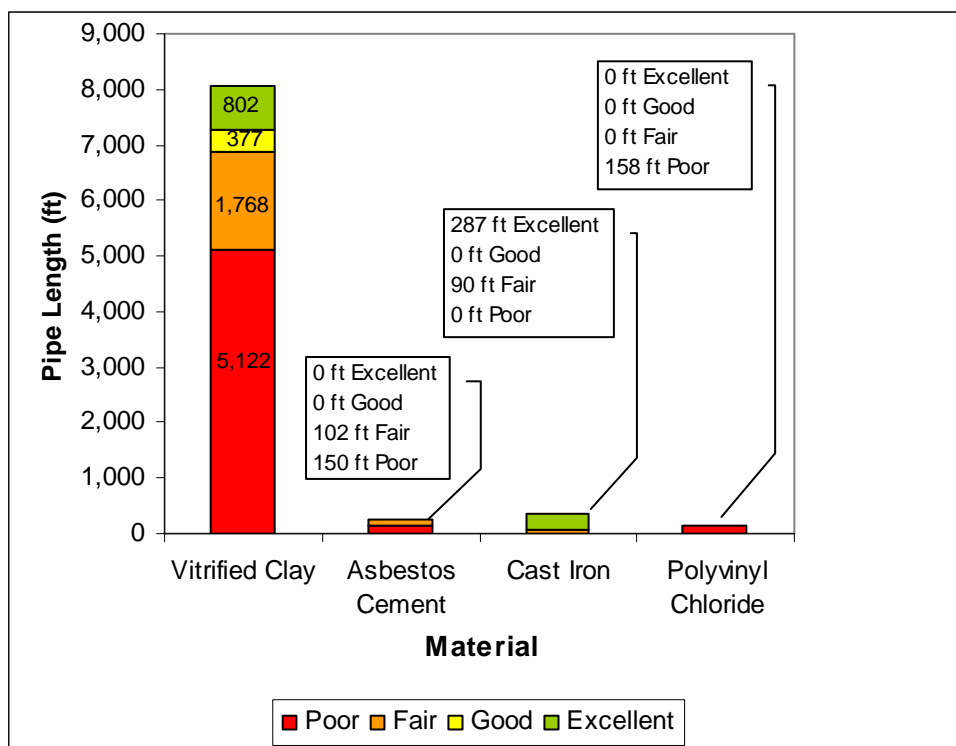
**Figure 1-2: Sanitary Sewer Pipe Material**

Approximately 91.1% of the inspected pipe (8069 ft) was vitrified clay pipe. Of the pipe, approximately 9.9% (802 ft) was in excellent condition, approximately 4.7% (377 ft) was in good condition, approximately 21.9% (1,768 ft) was in fair condition, and approximately 63.5% (5,122 ft) was in poor condition.

Approximately 4.3% of the inspected pipe (377 ft) was cast iron. Of the inspected cast iron pipe, approximately 76.1% (286 ft) was in excellent condition and approximately 23.9% (90 ft) was in fair condition.

Approximately 2.8% of the inspected pipe (252 ft) was asbestos cement. Of the inspected asbestos cement pipe, approximately 40.4% of this pipe (102 ft) was in fair condition, and the remaining 59.6% of the pipe (150 ft) of the pipe was in poor condition.

The remaining 1.8% (158 ft) of inspected pipe was PVC. All of this pipe was in poor condition.

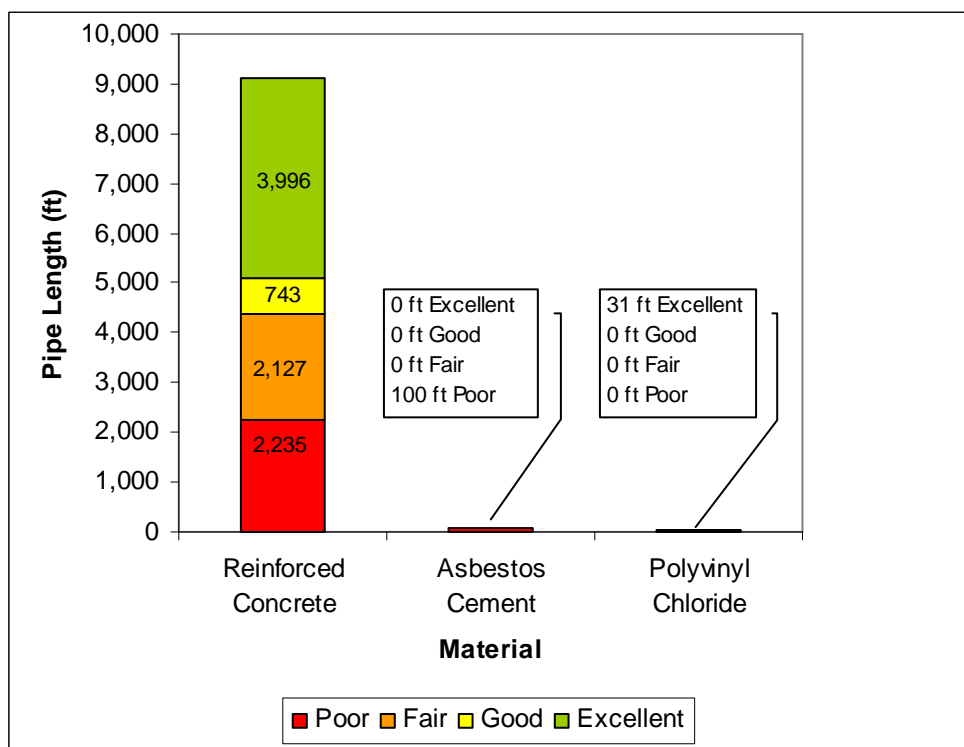
**Figure 2-1: Storm Sewer Pipe Material**

The remaining 0.4% (31 ft) of inspected pipe was PVC. All of this pipe was in excellent condition.
