**UNIVERSITY AT ALBANY
STATE UNIVERSITY OF NEW YORK**

**CAMPUS HERITAGE
PRESERVATION PLAN**

Mesick • Cohen • Wilson • Baker • Architects
388 Broadway Albany, NY 12207

April 2009

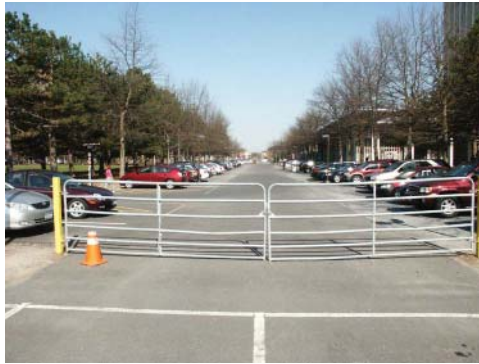
1. Too many vehicles within the campus core resulting in the nearly disappearance of Stone's design of a hierarchy of concentric circles.
2. Many campus core roads are closed off to or restrict vehicular traffic with inexpensive, visually intrusive, and crudely designed gates, concrete blocks, removable bollards, and other such barriers that detract from the visual

Metal gate barrier on Carillon Drive East

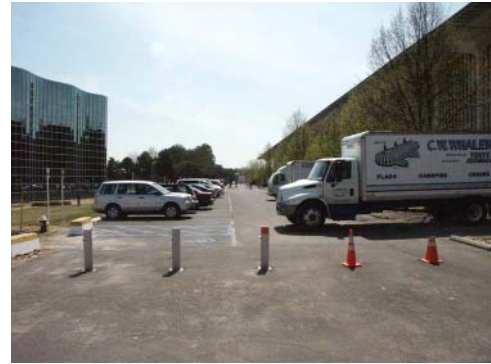
Concrete blocks and removable bollards on Carillon Drive East.

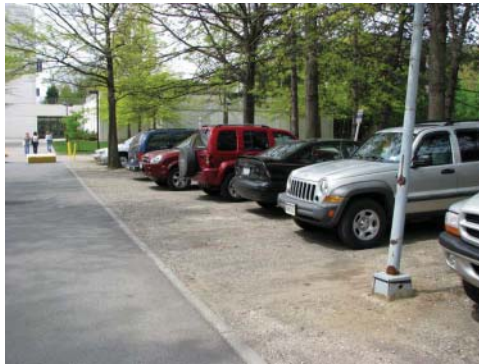
3. Parking under trees within the campus core is and has damaged many original plantings to the extent that most of the double-rows of Pin Oaks no longer exist. The surviving Pin Oaks are in poor condition.
4. Parking under the trees is causing much more stress than the trees can

Ad-hoc parking adjacent to Campus Center Extension.

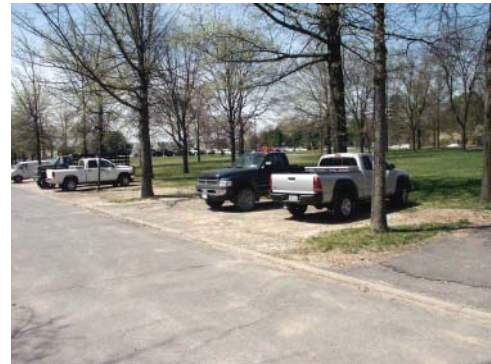
Service vehicles parked at the west end of the podium.

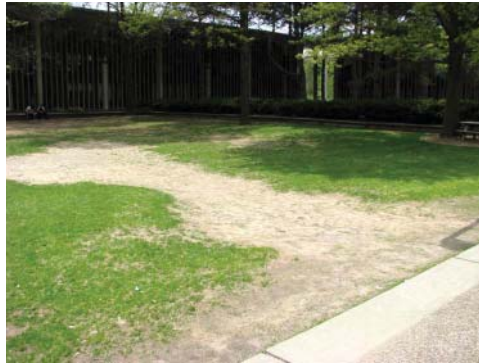
- a. Most students will follow a path a least resistance. If a paved or improved walk does not meet their directional needs they will create their own route. As a result, several diagonal walks have become major pedestrian ways over time. Some of these unintended paths have been paved, but not all. These diagonal paths exist within the courtyards of the residential quads, extend between the parking areas and campus core, and across

Wear trail in residential quad.

3. Evaluate student circulation patterns and desire lines to determine if wear trails should be paved or if barriers, such as hedges or fences, should be installed to control circulation.

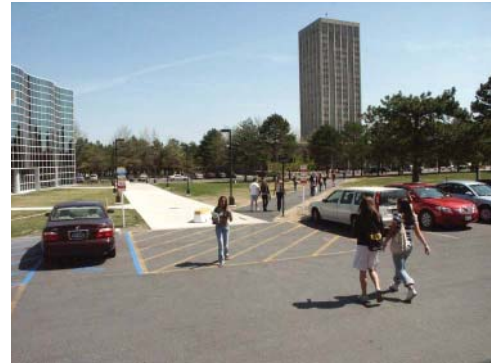
Asphalt paved wear trail from podium to State quad.

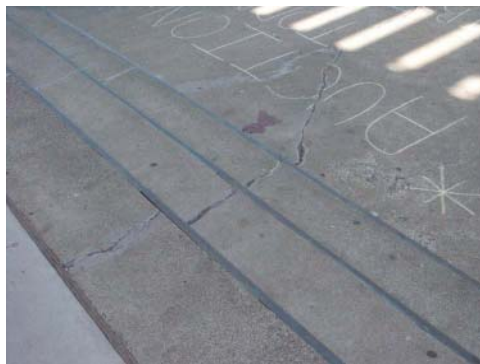
7. Numerous broken, cracked and/or damaged stairs and paved areas exist

Cracked stairs.

6. Properly repair the broken, cracked and damaged stairs and paving after identifying and repairing removing the cause of each failure.

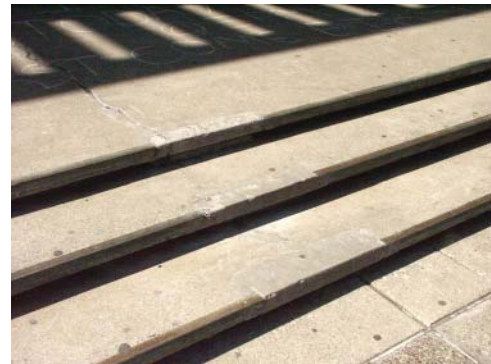
Cracked and repaired stairs.

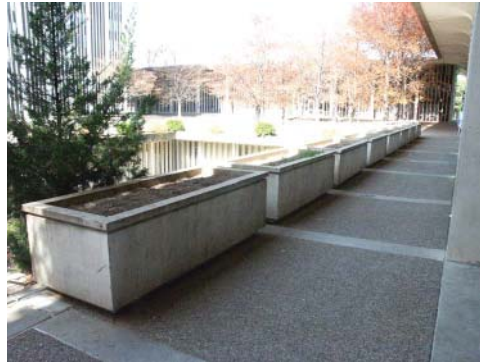
Empty concrete planters in dormitory courtyard.

3. Precast concrete planters provide a harsh environment for plants and are difficult to maintain because of location and quantity.

7. Evaluate the physical design and location of the precast concrete planters and the planters in the courtyards to understanding their existing conditions and to investigate their maintenance issue(s) – drainage, irrigation, soil mix, compaction, wind, solar exposure, insulation, plant selection, etc. Then, modify soil conditions, plant selection, watering practice, and maintenance procedures accordingly.

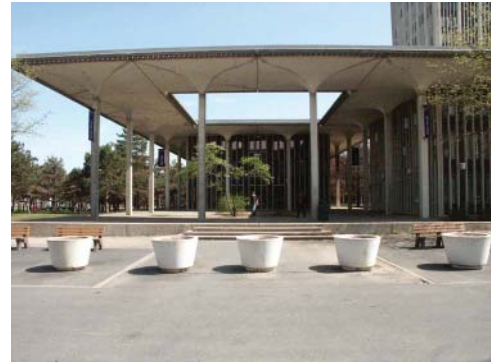
Empty concrete planters near dormitory quad.

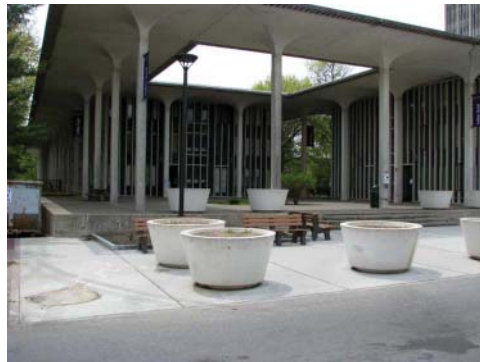
Empty concrete planters at northeast corner of Indian Quad.

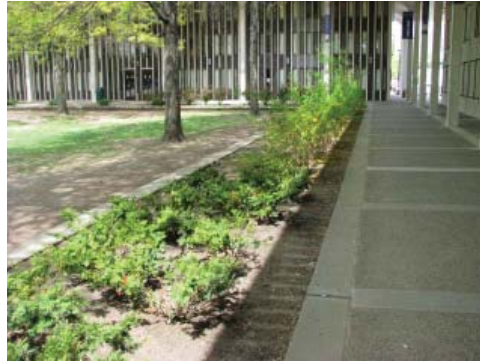
4. Plantings in the courtyard gardens are difficult to maintain because of size, quantity, and locations.

Weak hedges at Indian Quad.

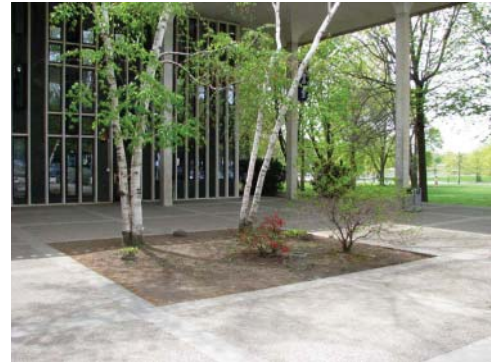
Sparse garden at Indian Quad.

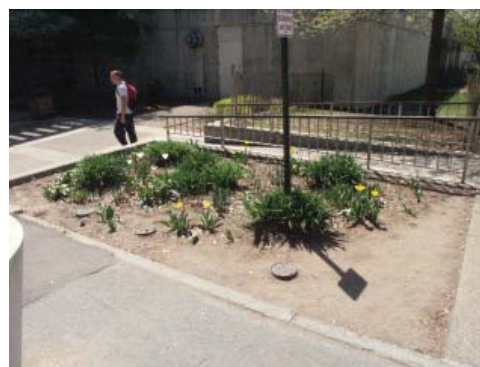
Perennial garden at west entrance of Campus Center.

8. Many of the modern plantings do not follow Stone's original design patterns and intentions resulting in a change in the appearance, character, and sense of place on campus. In fact, some of the plantings are "residential" in scale, design, and layout.

- b. Remove all inappropriate plantings and replace as needed based upon the guidelines and new planting master plan.
 - c. A maintenance plan should accommodate all future plantings so the facilities department will know how to maintain each species.

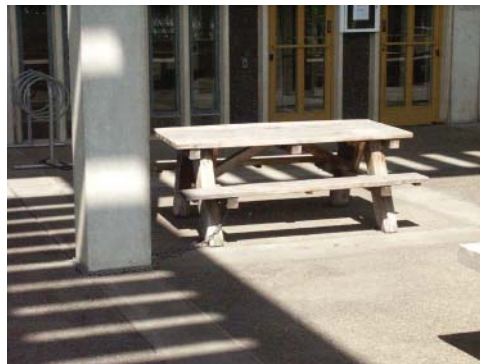
1. These features include trash and cigarette receptacles, recycling bins and containers, bicycle racks, benches and chairs, signs (parking, directional, and informational), emergency phones with lights, planters, road and vehicle barriers, picnic tables, bus shelters, newspaper boxes, mail boxes, parking meters, ramps (temporary and permanent), lights (pedestrian, vehicular, and task lights, such as on buildings), etc.
2. Too many different kinds, styles, colors, and materials of furnishings exist across the campus core landscape resulting in visual clutter.

Wooden picnic table chained to column.

1. Develop guidelines and a master palette for site furnishings. Replace and update existing site furnishes based upon the new guidelines and palette. All future site furnishing should abide by the guidelines and palette to maintain and improve the campus' visual integrity and continuity.
2. Create color options and variations for different areas on campus for orientation and identification purposes, such as specific colors for furnishings for each residential tower.
3. Allow movable, impermanent seating and table options in outdoor gathering areas for seasonal use. Be prepared to replace stolen pieces, repair vandalized pieces, and remove graffiti immediately.
4. Evaluate the quantity and location of the emergency phones, eliminate their strobe lights, and maintain their colored lights for quick identification and use if needed in an emergency situation.

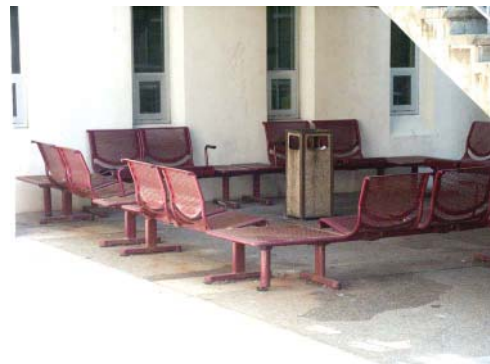
Purple furnishings at west entrance to the Campus Center.

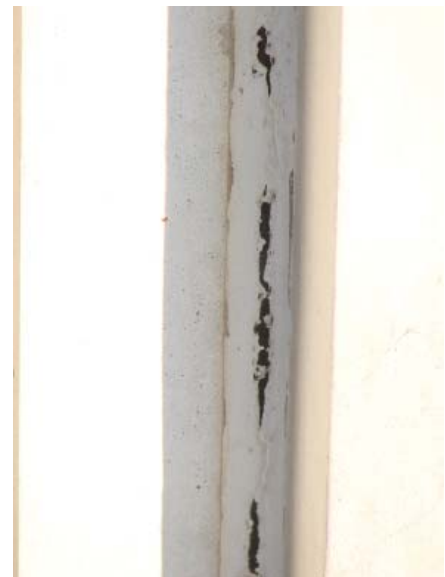
(Image 7)

The caulked joints are numerous and difficult to maintain consistently. Many of the larger vertical caulked joints between columns and precast panels have failed and either one side or the other is not bonded or the caulking is torn (Image 7). The horizontal joint between the precast panels and paving appears to be moving due to settlement in the paving. There are many locations around the façade of all buildings where this joint is open or not bonded on one side (Image 8), and in a few instances the pavement has even settled to below the bottom of the precast panels (see Podium Roof Paving, pg. 100).

- Replace skylights with energy efficient skylights of identical design.
- Investigate steel support for precast tilt-up panels on east and west elevations.
- Clean facades using low pressure wash of water.
- Replace all caulked joints both horizontal and vertical.
- Replace windows for energy conservation with double glazed sash of similar design and color to original steel sash.
- Replace doors with double glazed doors of similar design to original steel doors, maintaining frameless appearance and original width between concrete ribs.
- Patch damaged areas in vaulted colonnade soffits.
- Paint exterior concrete elements except exposed aggregate panels.

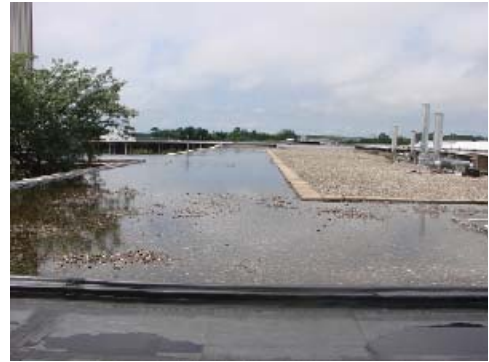
(Image 12)

The older built-up roofs are at the end of their useful lifetime and there are numerous small leaks and stained concrete. The ballasted EPDM roofs, although newer, seem to have more serious problems with drainage and subsequent leaks (Image 12). Below these roofs, especially over the uninsulated walkways and courtyards, there is significant water staining and numerous areas of spalling in the concrete vaults caused by rusting of the embedded rebar (Image 13).

- Replacement aging ballasted roofs over building footprint, walkways, monitor, and courtyards.
- Cover open expansion joints in perforated roof overhang.
- Patch and treat top surface of perforated roof overhang.

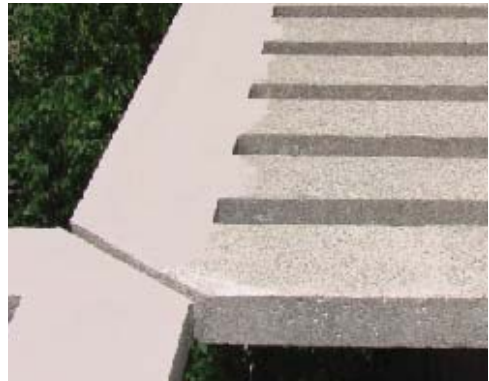
(Image 14)

The top surface in many areas has had a surface coating applied (Image 14), however, on uncoated areas there is considerable surface deterioration and spalling (Image 15). That this portion of the roof slab is still holding together is a testament to the quality of initial construction as most cast in place concrete exposed to the harsh winter climate in the northeast has deteriorated, especially horizontal wash surfaces.

The entire top surface of the overhangs need to be systematically patched and repaired, and should then be treated again with a liquid elastomeric membrane, which will help prevent the absorption of water by the concrete deck. A traditional drip edge at the outside edge would be visually unacceptable so continued slow deterioration of the edge and inner surfaces of the perforations is inevitable, and will someday require repair.

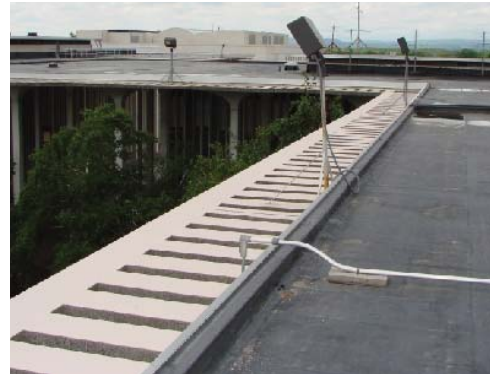
(Image 16)

There are numerous lights anchored to the top surface with ferrous connectors (Image 16), which should be removed or at least properly mounted using lead anchors, stainless steel screws, and rubber isolation washers.

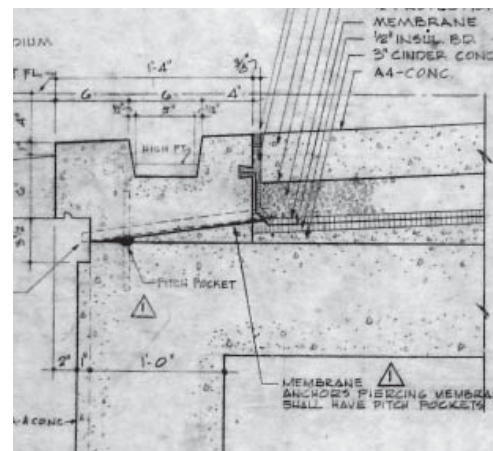
(Image 1)

The roof is not exposed, however, the drawings detail the system used. There is a flat poured roof slab with a 3" cinder concrete (light weight) fill at a 1" pitch above it. On top of this, there is ½" insulation board with built-up felt membrane over it. This was topped with ½" protection board and 3" of gravel fill, and finally the concrete paving was poured into place. The roof experienced drainage problems from the beginning, so shortly after the campus was completed, weeps (¾" in diameter) were installed at ten feet on center to drain any moisture toward the edge of the Podium. The felts are run up the edges of the buildings, planters, and gutter, and are fitted into cast reglets (flashing between the roof and wall, see Image 1). However, this roof is conceived as a secondary roof or fail safe, and the water was supposed to be handled at the paving level by a few internal drains in the paving and by the gutter at the perimeter. Much of the paving is protected by the podium roof above and the paving was designed to shed the surface water that does

Although continued repair and patching will prolong the life of this roof, it is inevitable that the replacement of the roof and paving will have to be addressed. Redoing the paving of the Podium and the built-up roof below is required. Continued patching, although diligently done, is not sufficient to prevent damage. Like the main roof above, this project can be done in large sections starting with the south east corner and proceeding clockwise

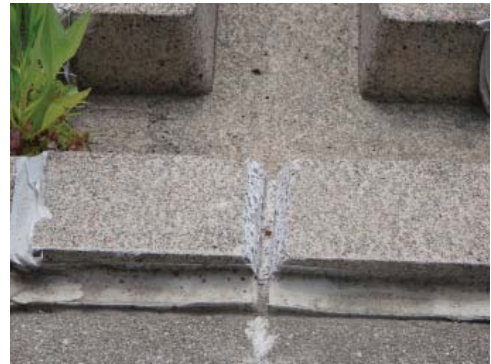
(Image 3)

fall onto it either into the perimeter gutter on the south, east and west elevation and over the edge on the north elevation. A few surface drains were also incorporated into the paving to handle the drainage. Now the paving, which is supported on gravel has settled below the inlet level of the gutter which is supported on the wall almost universally around the perimeter (Image 2). In some areas the gutter has been saw cut to allow for drainage, but in most locations, the water will simple work its way down through the paving to the roof below (Image 3 – note level of paving below inlet of gutter).

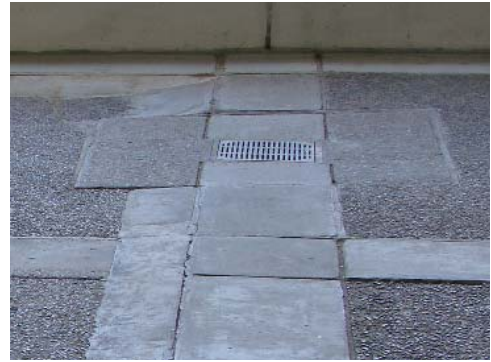
(Image 7)

in both locations has continued to settle below the inlet to these drains (Image 7). Many of the caulked expansion joints are open or not completely bonded on one side, most noticeably in the paving south of the Chemistry Building and west of the Social Science Building where considerable plant life is growing out of these joints (Image 8).

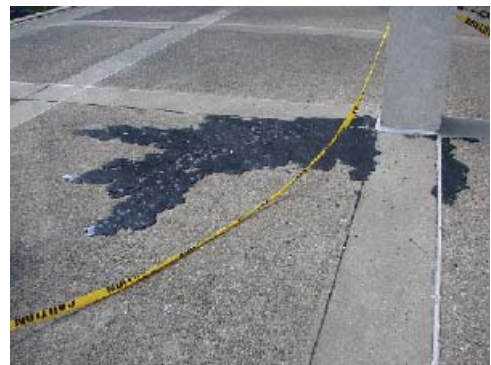
(Image 9)

There are a several locations on the podium where roofing cement has been applied as a last resort. There is a large patch on the southeast corner by the last column (Image 9), drainage here is a problem due to the uneven settlement of podium and paving. There are several patches in front of the Library, and others scattered about. With this application, it is unclear what the intended repair was.

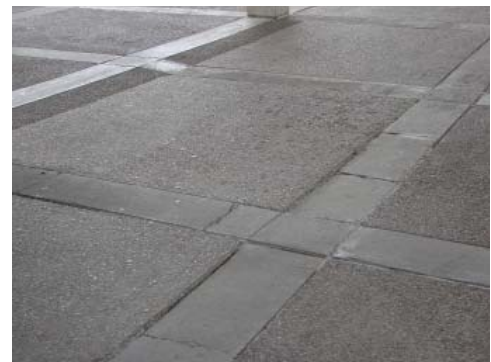
(Image 10)

Several large areas of paving have been replaced in total, presumably to correct settlement problems, which illustrate the difficulty in replicating the appearance of the exposed aggregate finish. One area in particular is the northwest corner of the Biology building. Water continues to pond and the subsequent settlement has cracked and distorted the repaired area (Image 10).

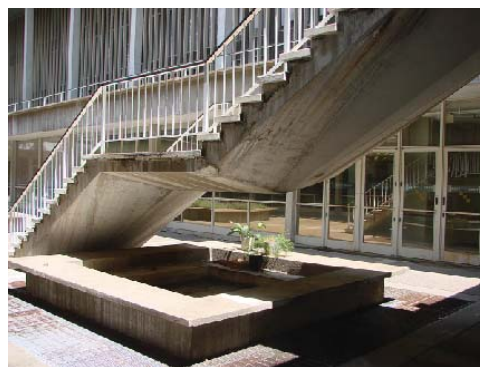
(Image 17)

The two stairs flanking the Library which descend into the light wells/courtyards are original concrete structure and precast concrete treads (Image 17). The design of the concrete uses the same swelling shallow “v” as used on the stairs flanking the Campus Center. Although these stairs have significant deterioration in the treads, they are generally in better condition than the similar stairs in the northeast and northwest courtyards, probably due to less use of ice and snow melts. There is some rust staining and cracking due to water penetration; probably since the deterioration in the treads has advanced. It may be possible to preserve the concrete structure here if the treads

are replaced soon. The courtyard stairs in the small courtyard, between the Earth Science and Mathematics Building and the Fine Arts Building, are in similar condition. A number of treads have already been replaced and some of which, including the originals, are deteriorating. The concrete substructure is relatively free of rust stains, except along the outside edges where there is also some cracking. Run off here is disturbed by deterioration in the treads. All of the original stairs have one piece landings, which even when deteriorated, seem to protect the concrete better than multiple piece landings. This could potentially be attributable to the built-in pitch to shed water.

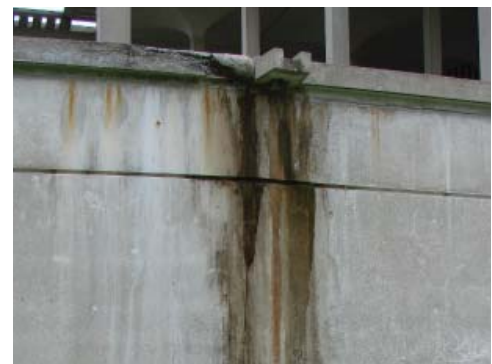
(Image 27)

3. Water from the roof enlarged drains, which has been added beneath each scupper, discharges against the building in many locations. This runoff contains not only a good deal on mineral and salts, but tar or roofing cement and is staining the walls because there is insufficient horizontal overhang (Image 27). Even where there

is sufficient overhang the water tends to splash back against the bottom of the wall, staining it and causing problems. These drains, which are plastic pipe, are not original and have been added relatively recently to help drain the built-up roof beneath the podium paving. Although these drains were required, due to the increased volume of water drained by the roof as the paving above fails, the installation of these drains required removing the scuppers and disturbing the membrane and reglet. It appears that there are leaks around the pipes where the membrane required repair or adjacent to the repair (Image 28).

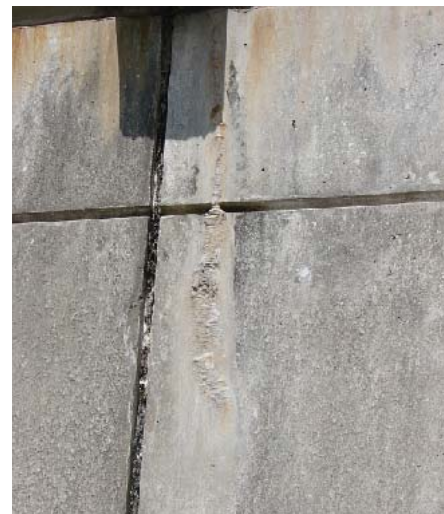
(Image 29)

4. There are indications in the form calcite formation or cracked concrete, presumably by rusting rebar within the wall, that the roof is allowing moisture into the top of the wall at or near the scuppers and added roof drains (Images 29 and 30). This is presumably a problem with the membrane which is cracking or pulling away from the flashing where the horizontal roof turns up the vertical wall and is inserted into a reglet.

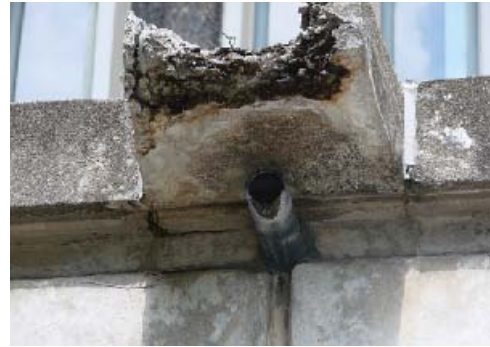
(Image 31)

There are numerous scuppers, mostly replacements, which are deteriorating (Image 31). Some of the replacements require the scupper to be set at an angle to drain properly and because of this the back edge does not meet the paving properly (Image 32). These elements should be factory cast to match the original configurations and dimensions precisely. The use of precast factory scuppers will allow for better quality control, better concrete, and is more likely to match the original color. The flat, underside of the scuppers allows water to flow along side it and fall on or at the base of the wall, causing water to splash back against the wall. This seems to be a problem with both the original and replacement scuppers; although, more damaging to the newer scuppers themselves. A drip edge near the wall was incorporated in the drawing for the original scuppers. Moving this detail forward would be a big help and would not affect the appearance.

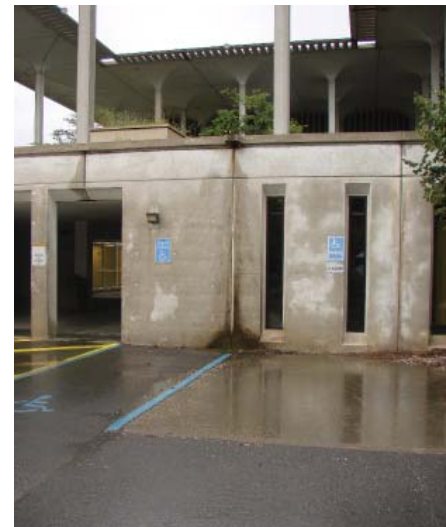
(Image 33)

The use of the scuppers discharges water close to the base of the podium wall and requires positive drainage away for the building and subsurface drainage to prevent rising damp conditions from developing in the concrete walls. The build-up of soil and roads prevents positive drainage along much of the south side of the Podium (Image 33).

The problem continues for a short distance on the southern portion of the west side. During a rain storm a large puddle forms near the base of the wall; the drainage must be improved and controlled. A subsurface drainage system may be required as part of the landscape work if positive runoff away from the base of the Podium cannot be designed as part of the landscaping improvements.

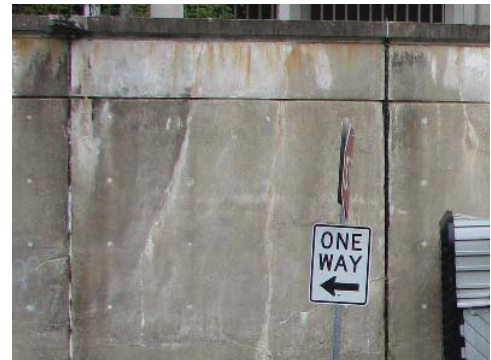
(Image 34)

The southeast corner of the Podium has settled and has small cracks across both the south and east faces of the panel (Image 34). There is also sufficient water within the walls (presumably caused a low spot at the wall which does not drain or from settlement that has damaged the edge of the roof flashing) and leaching out of the cracks to cause calcium build-up on the surface (Image 35).

- Replace aging ballasted roofs over building, walkways, and courtyards.
- Fill open expansion joints in perforated roof overhang.
- Investigate settlement in southeast corner.

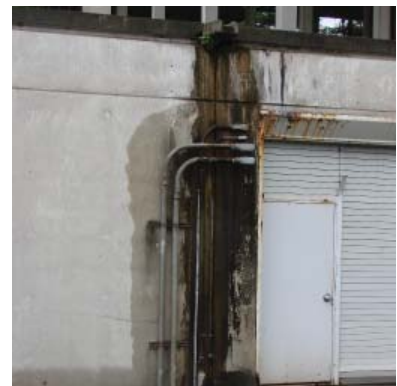
(Image 36)

This moisture problem continues around the corner to the service drive entry where moisture migrating in the wall from the roof caused severe rusting and deterioration in the steel frame of the overhead door (Image 36). The roof leaks are severe enough to keep the wall wet at the adjacent drain below the scupper. During a heavy rain both the scupper and the added drain (plastic pipe) discharge water. although, it appears most of the water running down the upper part of the Podium wall is from the added drain.

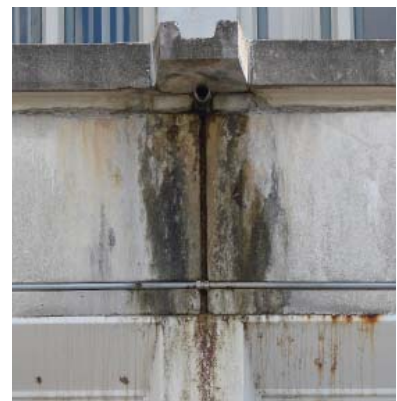
The Social Science loading dock on the west side has similar moisture problems (Image 37) within the wall causing the steel frame of the overhead doors

to rust. In bay 2 of the loading dock, the water is sufficiently calcified to form stalactites on the frame (Image 38).

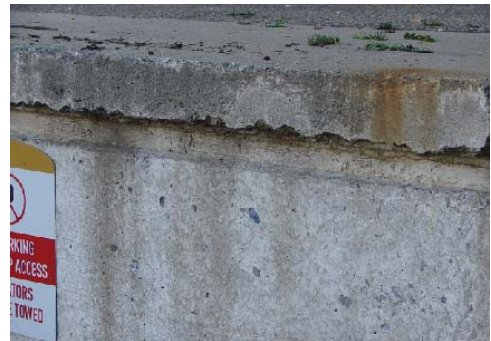
(Image 39)

Along the north wall, where the water runs over and off the cap piece, there are numerous sections with minor deterioration to the surface and/or lower edge (Image 39). The water to be drained is more noticeable at the courtyard than adjacent to buildings where the roof is provides better protected. There are also significant areas where the cap has been replaced. These areas stand out much greater than the original, weathered sections. These replacements appear to be cast-in-place rather than precast, which would allow for greater quality control, color, and finish.

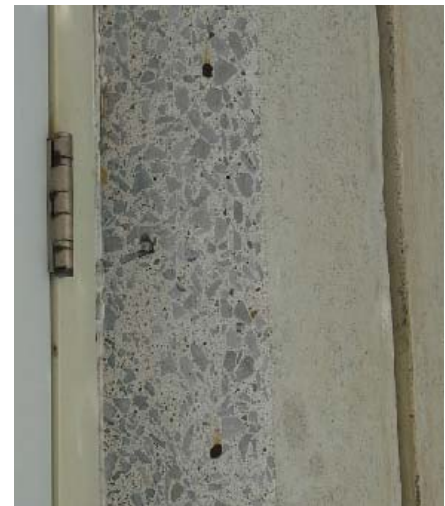
(Image 40)

An additional door opening has been cut into the wall on the eastern side of south elevation, exposing the aggregate and rebar of the concrete panel. The ends of the rebar are now rusting and need to be protected from any more exposure to weather (Image 40).

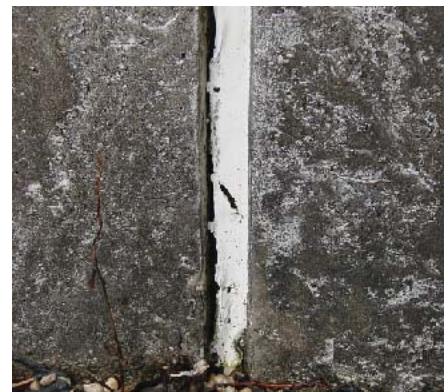
(Image 41)

It is difficult to maintain the caulking at these joints. Some of the caulking has failed and the bond to one side or the other has failed (Image 41). A few of the

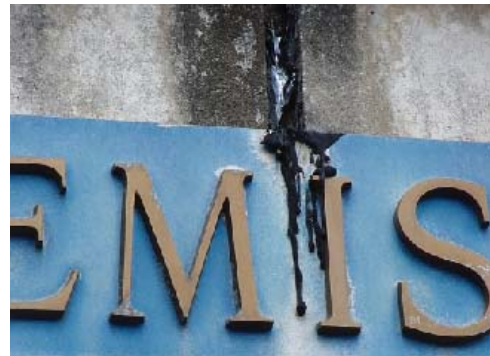
(Image 42)

joints, both types, have been sealed with tar, which is visually unappealing (Image 42).

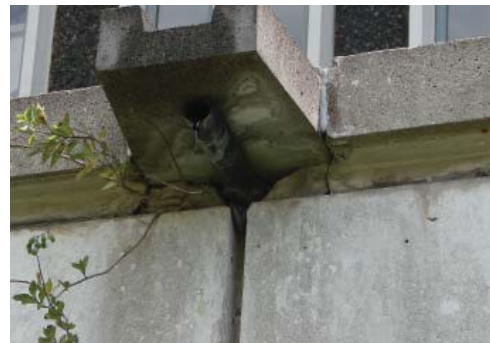
(Image 43)

The entire cast reveal, not just the joint between the wall and gutter, has been caulked, in some cases creating a large unsightly joint at the top of the panels, which is physically too wide for the caulk to span (Image 43).

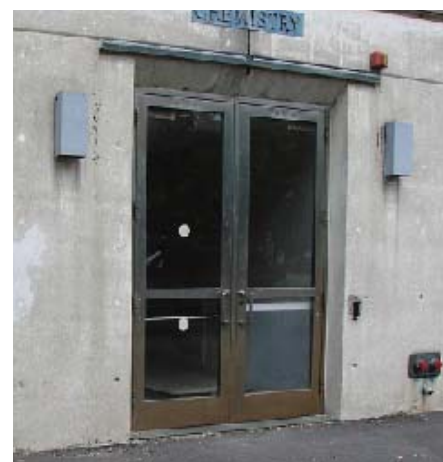
(Image 45)

All entrance doors on the south wall all seem to have been replaced at some point with two, light glazed stainless steel doors (Image 45). Most

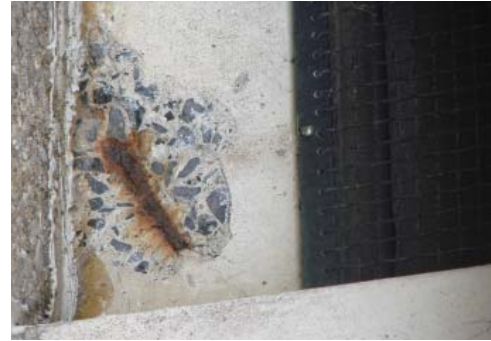
(Image 46)

These elements as a whole seem in good condition. The slab-like benches are precast concrete and are generally in good condition. There are some minor damages, mostly confined to the corners, and overall weathering of the surface. Only one slab in the southeast courtyard appears to be braking up and cleaving in half, presumably at the line of reinforcing. Several other have some minor damage at the bottom edge. The air vent grills below, vary in condition and need to be systematically restored, although, this is not a pressing requirement. A few locations below the slab benches and adjacent to the grills have rusting rebar, which was placed to close to the surface and has caused the exfoliation of concrete (Image 46).

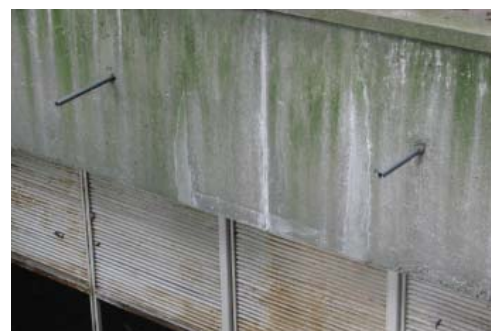
(Image 49)

The planting beds are designed to function as seats and barriers as well as containers for vegetation. The horizontal surfaces of these cast-in-place elements have some weathering. There is some minor damage to the edges, at the exposed mitered corners, and edges flanking the expansion joints. In a few locations there is rebar too close to the surface that has rusted and exfoliated the surface of the concrete (Image 47), or where minor differential settlement has caused vertical displacement (Image 48) or a crack in the bench. The sloped drip, used on the inside of the light and stairwells, allows water to run back against the vertical spandrels streaking the surface. In a few instances, this has lead to deterioration in the surface and spalling at the bottom edge (Image 49). The same condition

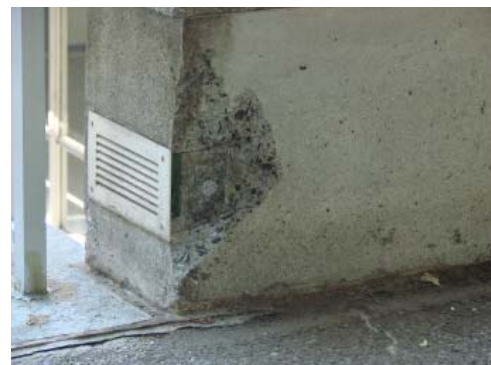
(Image 51)

At the top of the stairs, recessed lights were provided in the end of the wall. Although these are designed to be recessed wall mounted fixtures, this application resulted in the embedded box to be close to the surface and it has rusted causing spalling on the edge of the wall in several locations (Image 51). Most of these lights are covered over, not working, or have been removed, although, they are a big contributor to the safe use of the stairs at night. They should be replaced with fixtures containing nonferrous embedded elements.

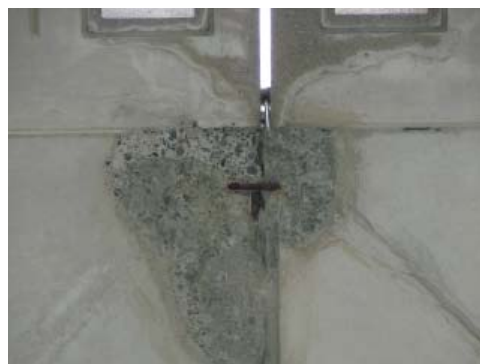
(Image 52)

as were the perforations. The open joint allows water to run along the ribs of the vaulting. This has caused unsightly dirty staining across the vaults, around the entire Podium perimeter, and around all the courtyards and walkways. In a few cases, most noticeably on the southwest courtyard, there is a sufficient volume of water causing the rusting of the rebar and subsequent spalling of the concrete surface (Image 52).

- Replace Podium roof and under paving drainage system. This requires replacing concrete paving and perimeter gutter system.
- Provide perimeter drainage system at grade.
- Patch deteriorated concrete vaulting of courtyard.
- Patch deteriorated concrete column and mullions.
- Patch podium walls where deteriorated.
- Replace all caulked joints in Podium walls.
- Replace windows for energy conservation with double glazed sash of similar design and color to original steel sash.

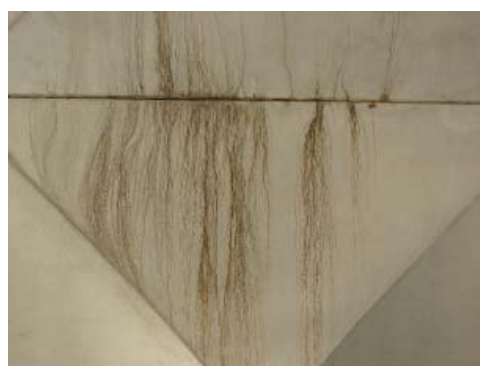
(Image 53)

At the roof level, there are also expansion joints between buildings which originally received metal caps. The individual expansion joints between pours in the slab are simply filled and roofed over. It appears that when the older felt roof became brittle, the movement at these small joints caused local failure along these lines (Image 53 - Chemistry building). It is also possibly that moisture from a leak elsewhere is finding its way out. In several locations below the replacement roofs, there are dirty, stained areas which follow the fillets from what are now inactive leaks, but others are still active.

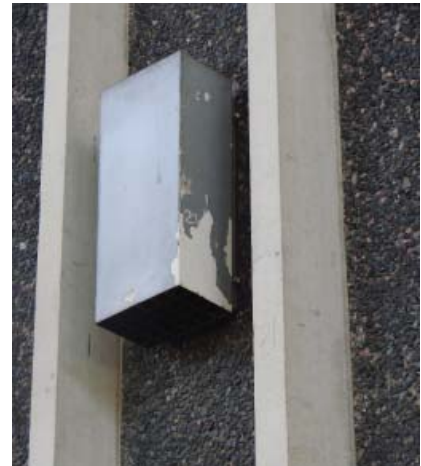
(Image 56)

Each building on the Podium has a series of wall sconces flanking the entrances and lining the walkways. These rectangular boxes are painted an aluminum color, however, many retain bits of their original white finish (Image 56). These geometrically simple, minimalist fixtures are part of the original appearance of the building, and replacement fixtures on the main facades of the Campus Center and the Performing Arts Center are unfortunately conspicuous.

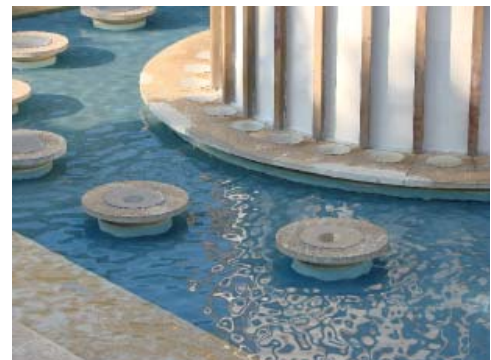
(Image 57)

The up lights in the fountain, which surrounded the water tower/carillon, have been covered over (Image 57), as have the ones on the little islands surrounding it. The numerous fountains in the sunken courtyards were all fitted with lights (Image 58), which no longer function now that these fountains are planter beds. Recessed lights were cast into the stairs and fitted for many of the planters, most of which are now inoperative.

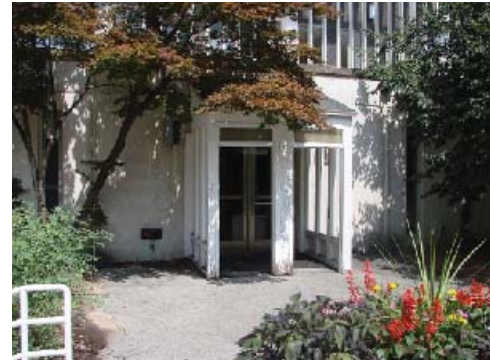
(Image 59)

There are two wood “doghouse” type vestibules on one of the exterior entries of the Education and Physics Buildings (Image 59). The vestibules are anchored to the stainless steel channels above the entry doors, leading to the classrooms and laboratories at the south of the Podium. It would seem that these were originally conceived as seasonal, but these two existing vestibules have clearly been in place for several years. There is some deterioration in the lower frame where the wood is in contact with the paving, however, these structures are truly incompatible with the design aesthetics of the campus. There is an interior vestibule at each entry so the exterior vestibules seem redundant. If an additional wind break is required at these entries, a more appropriate enclosure should be designed using steel and glass, similar to the one at the Arts and Science Building.

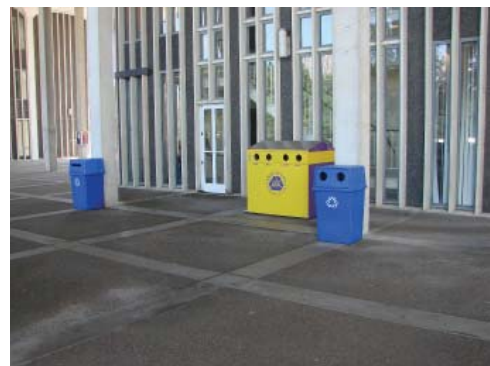
(Image 60)

There is a general clutter of extraneous site furniture at the entrances to the Campus Center and Library (Images 60 and 61). Bright yellow and blue plastic and metal containers are inappropriate at the entrances to the buildings, as are the generic exposed aggregate fiberglass waste baskets. These elements should be appropriately designed for areas where they are required. The colors palette and graphics should be appropriate for the architectural character, and should be consistent throughout the campus. The concrete columns across the campus are now used to support sign boards and information announcements in aluminum framed bulletin boards, and in many locations,

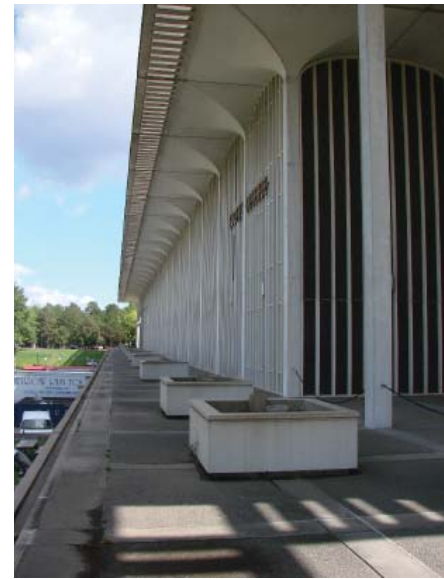
(Image 65)

Landscaping and planters are integral to the conception of the campus. The internal raised bed and planters are largely intact, although, planting species have been modified over the years for this raised planting bed in particular. The large concrete pots at the perimeter have not fared as well and are now left unattended (Image 65). Each of the large concrete pots had two spot lights recessed in a cement pipe (Image 66). These up lights, which are no longer operative, would have dramatically lit the underside of the flared capitals filtered through the branches of the pine trees originally planted in them

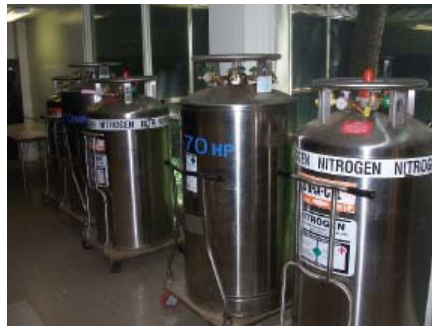
Tanks in the basement corridor of the Physics Building

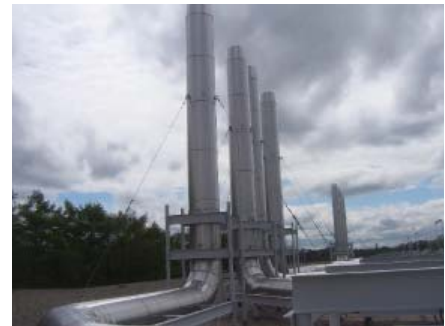
Fume hood exhaust ducts above the Chemistry Building

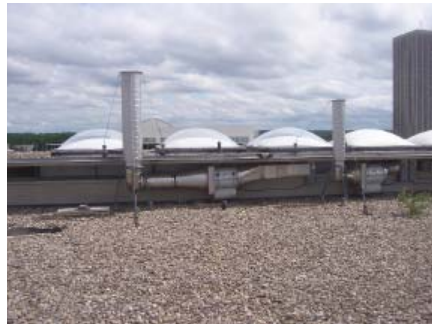
Fume hood exhaust ducts above the Earth Science Building

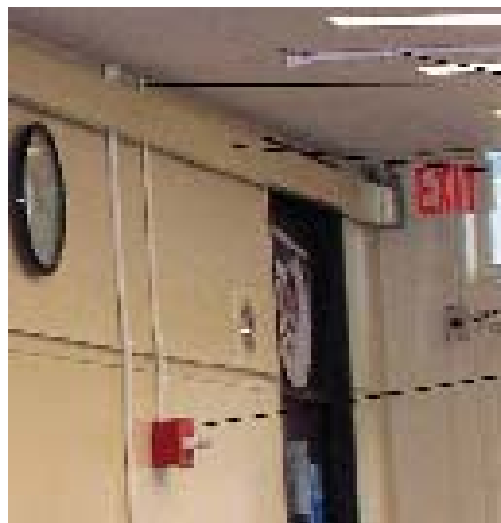
Surface mounted wiremold

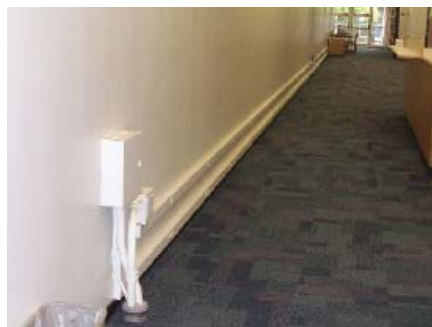
- d. Life Safety Security and Telecommunication Upgrades: The addition of strobe notification devices has created a need for running new wiring which, in a campus built of hard interior surfaces, resulted in the application of surface mounted wiremold. Likewise is true for security and telecommunications cabling that were not anticipated when the campus was designed.

Surface mounted wiring in the Library, basement reading room

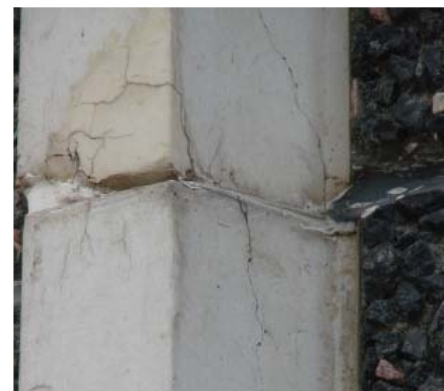
(Image 6)

There is one upper rib on the north side of the west façade damaged from what may be movement of the panel, and the support system for this upper panel should be investigated (Image 6). The columns of the courtyard are more exposed than the engaged columns of the building, and all show greater deterioration of the surface especially on the north, west and east elevation. The corner column shows deterioration on all faces as it is in the most exposed situation. On the east façade, the ribs have been damaged by the installation of a sign and now require repair. There are also

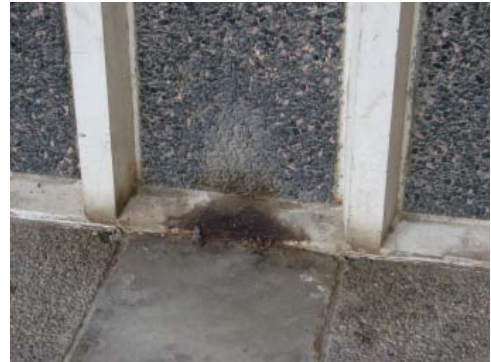
(Image 7)

several spots of spilled oil on the sill members on both the south and west facades (Image 7). The ribs adjacent to the recessed door closer are often stained with lubricant.

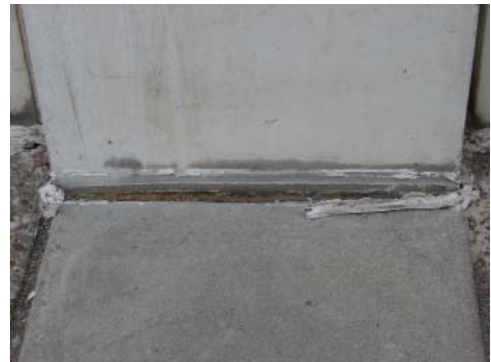
(Image 8)

The horizontal joint between precast panel and paving appears to be moving due to settlement in the paving and instead of cutting out the old failed caulk recent repairs appear simply to be layering another bead of caulk over the old. There are many locations around the façade where this joint is open or not bonded on one side; particularly on the north side (Image 8). The image also shows that the paving has continued to settle and that the top backer is now above the paving.

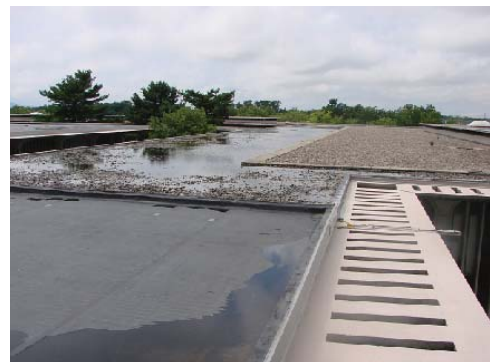
(Image 9)

There was several inches of standing water covering the entire area of the podium walkways (Images 9) on the roof outside the insulation on the day inspection (it had rain that morning). This is a significant amount of water as the walkway here

- Roof replacement over building footprint, walkways, monitor, and courtyards.

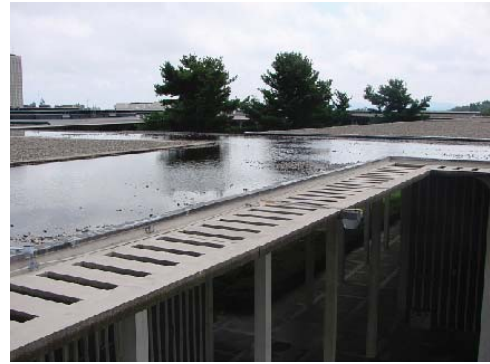
(Image 10)

covers the northwest courtyard (Image 10). Any standing water will eventually find its way through the membrane, and indeed there is staining from rusting rebar, and some deterioration and spalling of the concrete vaults in the northwest courtyard.

- Replace skylights with energy efficient skylights of identical design.
- Patch concrete vaulting of northwest courtyard.
- Clean facades using low pressure wash of water.
- Replace all caulked joints.
- Replace windows for energy conservation with double glazed sash of similar design and color to original steel sash.
- Replace doors with double glazed sash of similar design to original steel doors, maintaining frameless appearance and original width between concrete ribs.
- Paint exterior concrete elements except exposed aggregate panels.

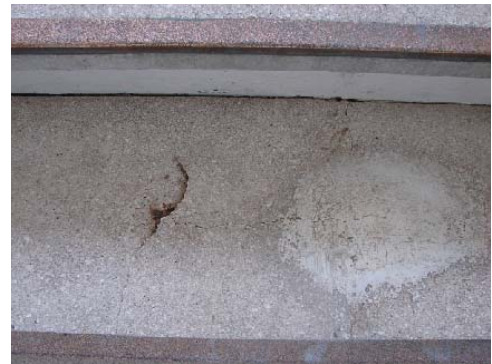
(Image 21)

There are a number of treads that have either been patched or need to be (Image 21). There is significant hairline cracking and loss of surface.

Stairwell is largely intact. Precast stair treads show considerable deterioration of surface and there are several where surface is spalling. These may have been cleaned with an inappropriate cleaning compound at some point, however, all precast treads on Phase II buildings generally seem to be inferior to Phase I treads.

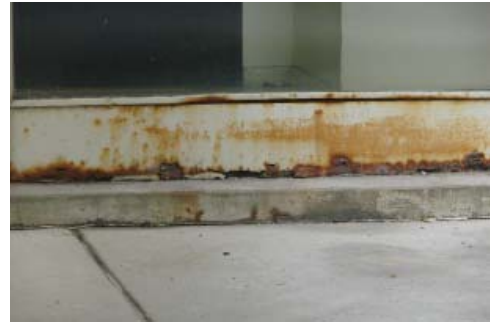
(Image 26)

The lower portion of the minimalist glazed walls is exposed to snow and ice accumulating against them and the use of corrosive ice melt. The north and south walls also appears to receive the drip from

the planter box above splashing off the concrete of the planter bed. Deterioration is more advanced on these walls. Exposure to moisture and salt on the steel elements has developed substantial rust and deterioration in the steel tube base and lower bar stock glazing stops (Image 26).

Preservation of these walls is certainly desirable and after basic repairs, the walls could be fitted with interior or exterior storm sash rather than being replaced.

The current program of replacement of the stairs treads on the exterior stairs may include painting of the steel elements of the glazed walls.

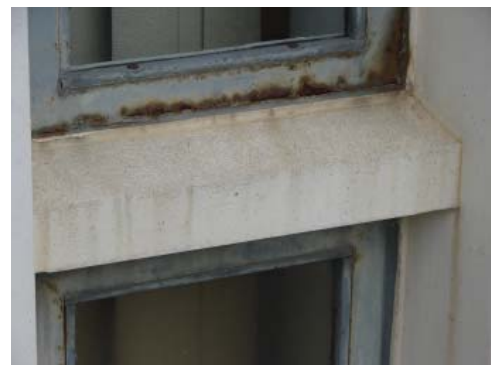
(Image 7)

There is considerable rusting in the sills of the steel sash windows especially on the north side, which has stained the horizontal ribs (Image 7). The sill is generally dirtier than other elements and there are a few spots of tar on some panels. Both types of staining could be remedied with general cleaning, however, will return unless the windows are replaced or painted, and some bird proofing or control is instituted.

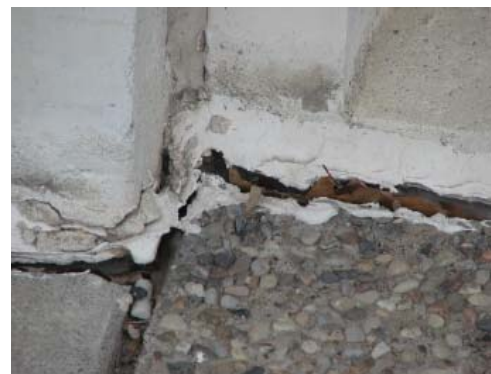
(Image 8)

The horizontal joint between precast panel and paving appears to be moving due to settlement in the paving. On the north side in particular there seems to be movement in the paving and this joint is open (Images 8). There are many locations around the façade where this joint is open or not bonded on one side.

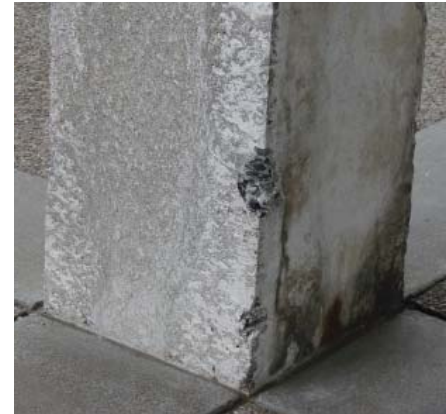
(Image 9)

The courtyard columns are open to the weather on four sides and all show surface deterioration a little more advanced than columns at the building line. Deterioration, although still modest, is clearly more advanced on the north and west surfaces (Image 9). There is also some impact damage from motorized carts used for construction project.

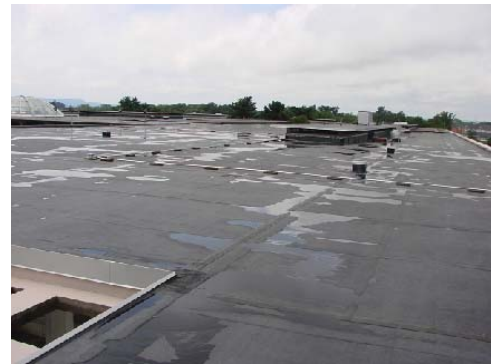
(Image 10)

The roof has recent EPDM roofing over tapered insulation (Image 10). It appears to be sound and better than acceptable by industry standards. There is minor ponding across the surface of the roof (it had rained on day the of inspection). Vertical flashing at monitor, vents and skylights appears to be acceptable. At the monitor roofing membrane is carried up about 24" inches to a binder bar under the projecting sill.

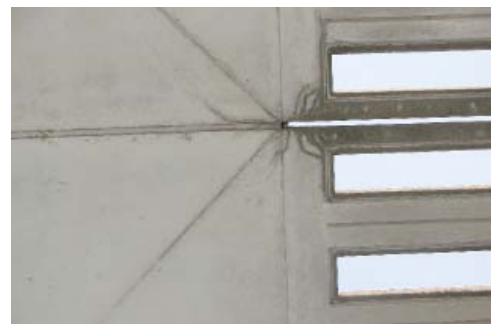
(Image 11)

At the center of each structure bay is an expansion joint between two concrete pours. This joint is filled and covered with the roofing membrane until the perforated roof overhang. These joints are all open, and water running through these joints follows the ribs of the flared capitals back to the building façade or column in the walkways (Image 11). Water on these concrete surfaces causes problems of deterioration of the surface of the concrete or can rust rebar embedded close to the surface causing spalling of the concrete. This condition is most noticeable at the north elevation along the edge of the Podium.

- Clean facades using low pressure wash of water.
- Replace all caulked joints.
- Cover expansion joint in roof overhang.
- Replace windows for energy conservation with double glazed sash of similar design and color to original steel sash.
- Paint exterior concrete elements except exposed aggregate panels.

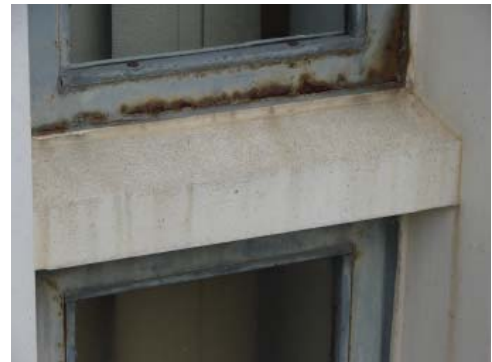
(Image 12)

Steel window sash, both fixed and casement sash. The sill and lower portions of frame are rusting and the perimeter caulking has not been maintained. These windows appear to have their original factory finish, and desperately need to be repainted. The windows on the west elevation show considerably more rust and deterioration than the elevations with greater roof overhang (Image 12).

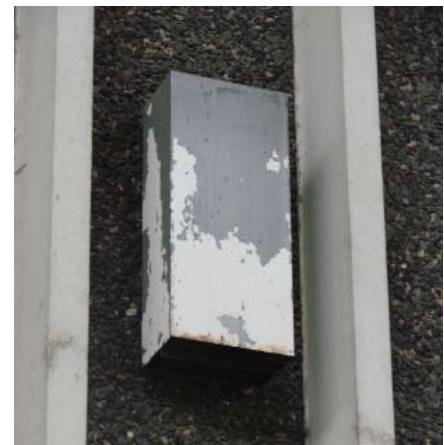
(Image 13)

Mounted on the central exposed aggregate pier of each bay is a typical rectangular box wall sconce. These rectangular boxes are now painted an aluminum color, however, many bits of their original white finish can be seen (Image 13).

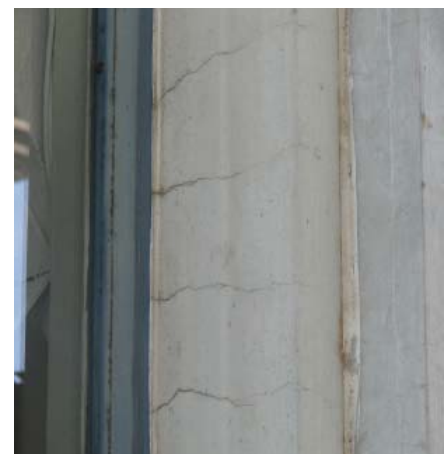
(Image 3)

There are minor hairline cracks in the ribs of the precast concrete panel, which do not appear to be an issue (Image 3). A few of these cracks on the

west façade slightly larger and dirty, but if protected from moisture (leaks in expansion joints at edge of roof overhang above – Image 4), they should not be a problem. A limited number of ribs are cracked as if the upper panels are settling slightly, which may indicate fatigue in the steel supports and should be investigated. There is also some minor cracking in the cast in place columns, which again does not appear to be an issue. There is also some impact damage to the lower portion of the northwest column. There is minor surface deterioration to the exterior column on the north where the overhang is smaller and to the north and west faces of the courtyard columns (Image 5). A few joints at the intersection of horizontal and vertical mullions above the doors and windows have small vertical hairline cracks, which may be a contraction crack rather than structural problem, but should be monitored. There is considerable rusting in the sills of the steel sash windows, which has stained the horizontal mullions (Image 6), as well as staining and dirt from birds roosting under the overhanging roof on the south elevation and southern bay of the west elevation (Image 7). Both types of staining will be addressed in a general cleaning, however, will return unless the windows are replaced or painted and some of bird proofing or control is instituted.
