**UNIVERSITY AT ALBANY
STATE UNIVERSITY OF NEW YORK**

**CAMPUS HERITAGE
PRESERVATION PLAN**

Mesick • Cohen • Wilson • Baker • Architects
388 Broadway Albany, NY 12207

April 2009

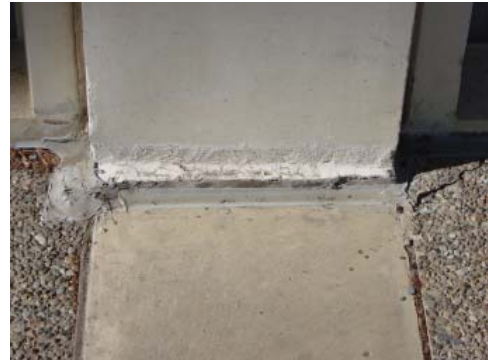
(Image 8)

The horizontal joint between precast panel and paving appears to be moving due to settlement in the paving. On the north side in particular, the

settlement is noticeable and repairs appear simply to be layering new caulk over the old (Image 8). There are signs of movement and failure of the bond even in these recent horizontal joints.

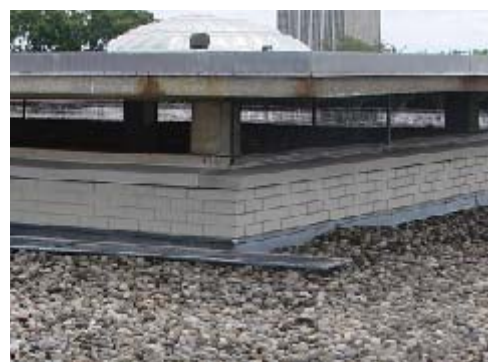
(Image 11)

There is some visible deterioration of the filter fabric where it is exposed to the sun. The roofing membrane is carried up above the height of the insulation at the roof monitors and concealed by the copper cap flashing (Image 11).

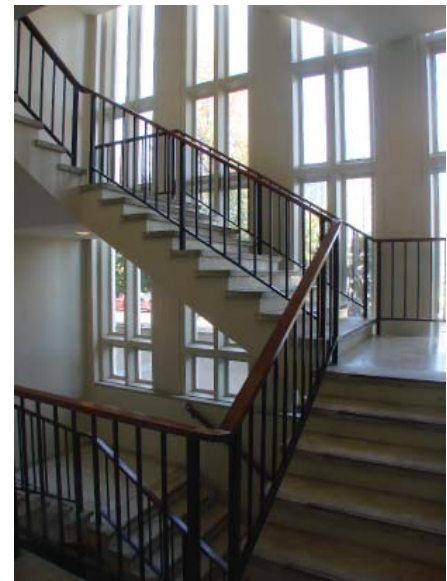
(Image 26)

Typical of the public exiting stairs in all the classroom buildings this stair is virtually identical with those used throughout the campus, and is largely original (Image 26).

The floor is white terrazzo within a grid of bronze bars. At the edge of the open well there is a pre-cast concrete paver matching the pre-cast stair treads. The treads show considerable surface deterioration, which may be from the use of an inappropriate cleaning solution. There is also some cracking in the treads and a few spots of exfoliation.

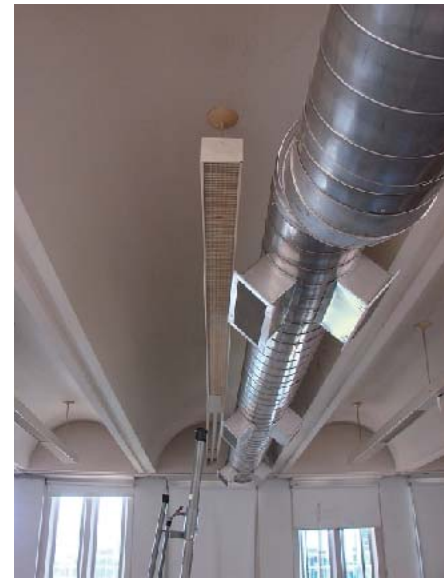
(Image 33)

A new HVAC system has been added within the studio to help better ventilate the space, as mentioned above. Full height Celotex tack boards have been installed on some of the walls. There is a temporary podium for the use of 'posing' models. There are also mobile painting stations, exposed conduits for fire detection and wall mounted track lighting (Image 33).

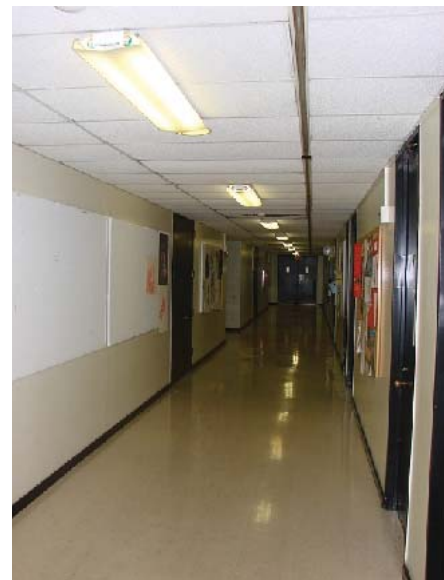
(Image 34)

Typical of the public corridors in all the classroom buildings, this corridor was virtually identical with those used throughout the campus, and is largely original (Image 34). The south wall is articulated with the classroom doors set into recesses, which provide a rhythm of movement within the space, and give some relief to the long corridor space.

is provided by surface mounted strip fluorescent fixtures that have plastic lenses, which replaced the original recessed down lights originally used in the corridors. The plastic end panels are mostly broken or removed. The integral east vestibule has the same acoustic tile ceiling, although slightly higher.

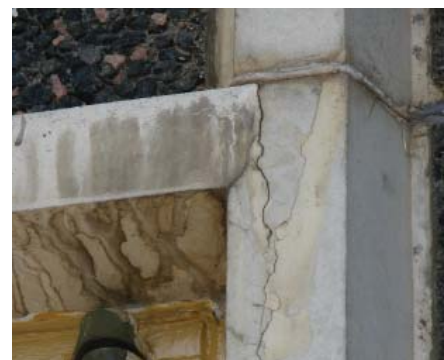
(Image 5)

The lower edge of one of the ribs on the upper panel on the south side of the east façade is damaged from what appears to be movement of the panel (Image 5), and the support system for this upper panel should be investigated. The ribs flanking the doors are badly stained from lubricant used in the floor closers. Additionally, there is another grease

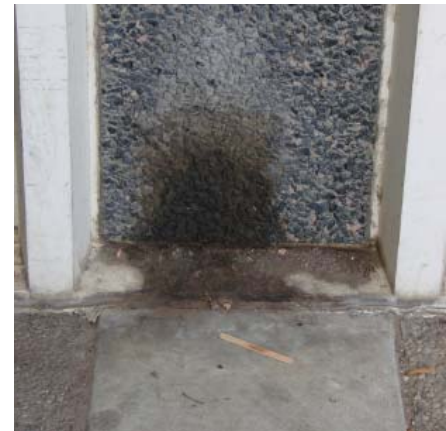
(Image 6)

spot on the exposed aggregate and precast panel south of the doors (Image 6). There are several spots of overspray of paint on the exposed aggregate panel, which need to be removed.

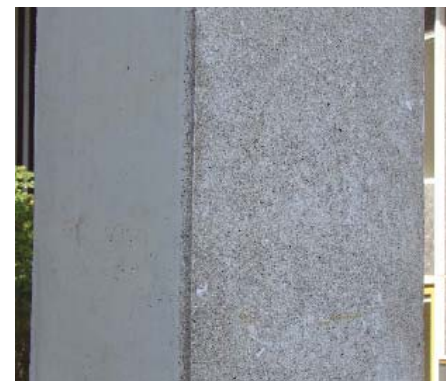
(Image 8)

The courtyard columns are open to the weather on four sides and all show surface deterioration a little more advanced than columns at the building line. The deterioration, although still modest, is clearly more advanced on the north and west surfaces (Image 8).

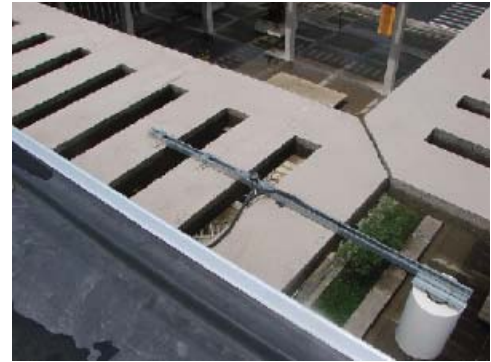
(Image 10)

the north east courtyard supported by galvanized channels and anchored with galvanized bolts set in expansion shields (Image 10). These lights are wired with surfaced mounted conduit from a box on roof monitor (Image 11). Water draining off the edge of the slab and at the perimeter of the perforation has stained the concrete and minor surface erosion has exposed the fine aggregate. This is a physical concern, but has also created an unintended visual emphasis by outlining each perforation in dark gray.

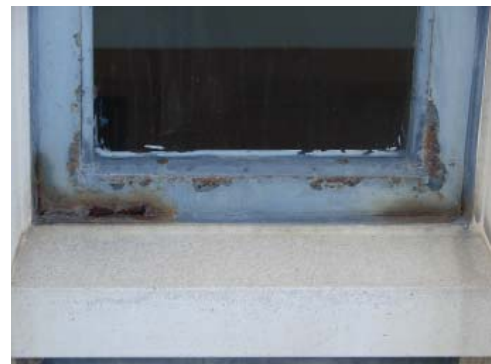
(Image 14)

Steel window sash, both fixed and casement sash. The sill and lower portions of frame are rusting and the perimeter caulking has not been maintained. These windows appear to have their original factory finish, and desperately need to be repainted. They are all in much worst condition on the north side where the overhang is less with significant rusting in the sills and lower portion of the jambs on many windows (Image 14).

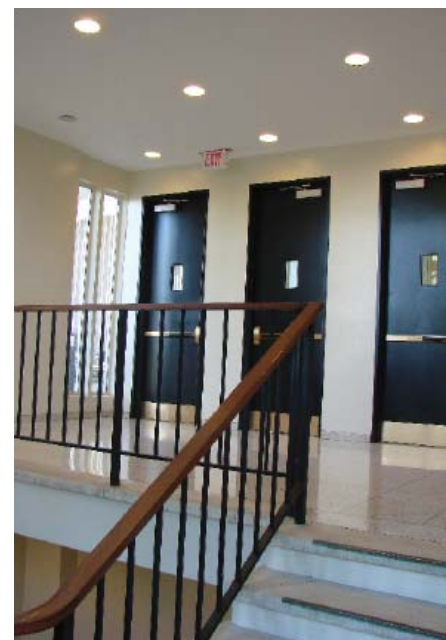
(Image 20)

These stairs are typical of the fire stairs in all the Phase II Podium buildings, and are the main public circulation stairs off the lobbies and central corridor (Image 20). These stairs were not affected by the recent first corridor floor was renovated.

The stairs have a concrete structure with precast white concrete treads. The treads have a textured bronze nosing strip. As with all Phase II building these treads are generally not in as good condition as the Phase I stair treads. There is some loss of the surface and fairly extensive hairline cracking. The stair treads used in Phase II seem be inferior to those used in Phase I.

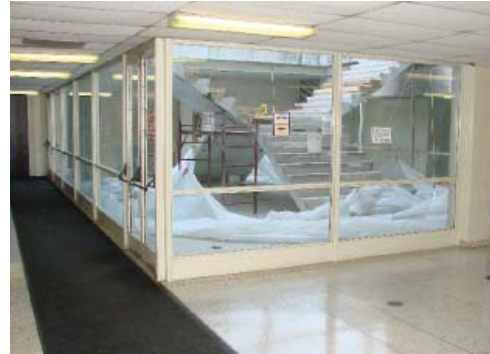
(Image 21)

The courtyard light well at the northeast corner of the Podium punctuates the end of the east –west basement corridor which originally ran from corner courtyard to corner courtyard. It also serves as the change in direction from the corridor in the Earth Science Building to the north-south corridor in the Biology Building, although the service tunnel must be crossed at this point. The light well contains a stair (see Podium Survey pg. 99), but primarily functions to introduce natural light into an otherwise long, windowless, basement level corridors (Image 21).

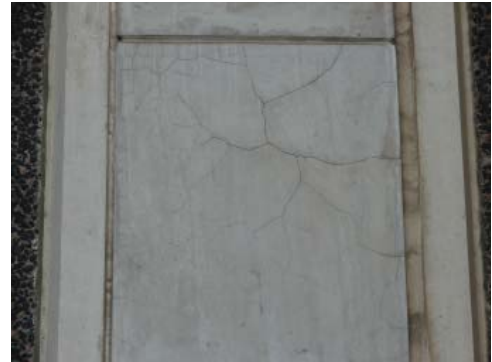
(Image 6)

There is also some hairline cracking on the cast in place columns, as well as spider web pattern cracking. This may simply be in the thick painted

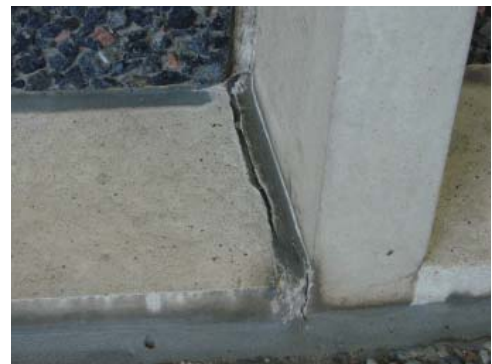
(Image 8)

There are many locations around the façade where the horizontal joint between the precast panel and paving is open or not bonded on one side. This same joint was repaired on the west facade using a very viscous caulk, which was poured over the top of the paving (Image 7) as well as into the joint. There are signs of movement and failure of the bond even in these recent horizontal joints. Several of the joints have been caulked using a black caulk on top of the top the original white, which is unsightly (Image 8).

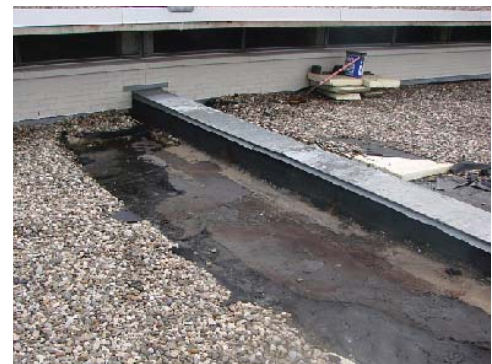
(Image 9)

This roofing membrane is visible in a small area where ballast and insulation was removed, and appears to be a mopped felt, traditional built-up roof (Image 9). The rigid insulation is laid over the top with stone ballast above. The membrane and insulation is separated from ballast by filter fabric. In this instance, the insulation and the ballast is carried over the walkways and terminates at the end with a sheet metal drip edge. This system depends on drainage below the insulation, and seems to be vulnerable to dirt and debris clogging the drains or drainage path. Although there was no standing water visible on the day of inspection, there were a few areas where the insulation was floating above a pond of water. Any standing water will eventually find it way through the membrane. The insulation and filter fabric has split along line

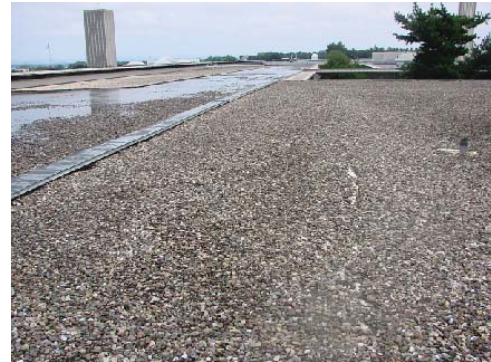
(Image 10)

of expansion joints and the ballast has washed into and filled the void (Image 10). Although there was no standing water on the day of inspection, it is the same roofing system as the adjacent Business and Humanities Buildings where there was significant standing water. There are a few visible leaks on the interior. This roof is basically at the end of its useful lifetime.

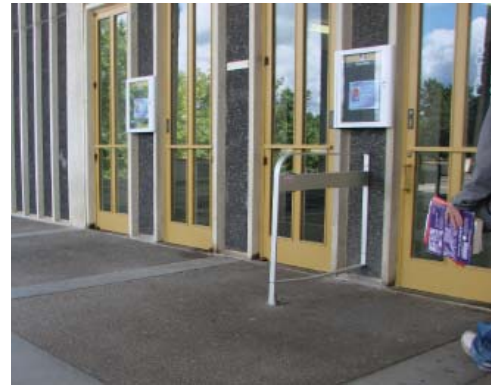
(Image 11)

The hardware is all original brass with US10B finish, with the exception of where handicap accessible hardware has been installed. The three part thresholds are original. Where the doors have been modified for handicap accessibility, the interior panic bar has been replaced with a brass panic bar and a motorized opening device is fitted at the top of the door. At the north, entry the automated door uses a continuous aluminum hinge surface mounted to door and frame. At the south entry, the automated door retains the intermediate and upper pivots. On both handicapped doors the closer is removed, however, the steel bar pull on the exterior is retained. There is an exterior and interior aluminum railing at all handicapped modified doors (Image 11).

There is some rust on the lower rail of some doors and overall the doors could be repainted.

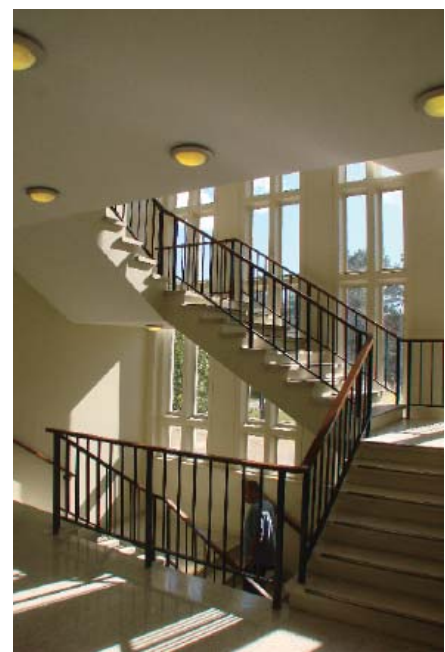
(Image 23)

These stairs are typical of the fire stairs in all the original podium buildings, and are the main public circulation stairs off the lobbies and central corridor. These have been gently renovated when the corridors were renovated (c.2000). The only obvious visual element for this work is the semi-recessed down lights which replaced the original fully recessed down lights (Image 23). These lights

represent a significant improvement in energy efficiency and represent a reasonable compromise which maintains the grid of many individual spots of light that was an important component of the original design.

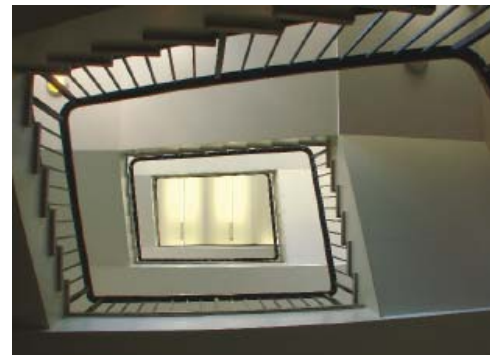
(Image 24)

The stairs have a concrete structure with precast white concrete treads. They rise from basement to third floor without interruption (Image 24). The treads have a textured bronze nosing strip. As with all Phase I building these treads are in good condition with only minor surface loss and some hairline cracking (Phase II stair treads seem to have been inferior).

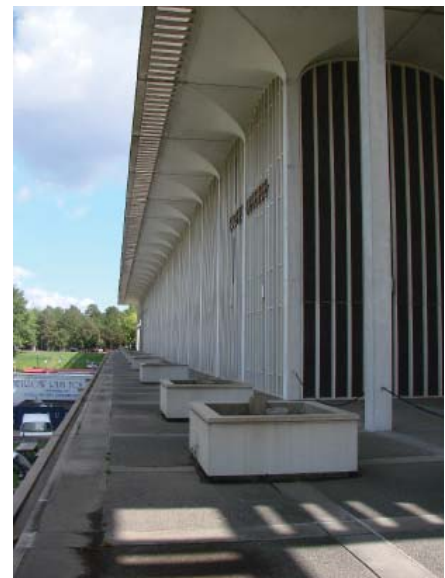
(Image 25)

The precast concrete planters along the north edge of the Podium are no longer maintained as landscaped elements. These were conceived as design elements of the Podium buildings to both soften the rigid physical appearance and to use for dramatic night lighting of the campus (Image 25).

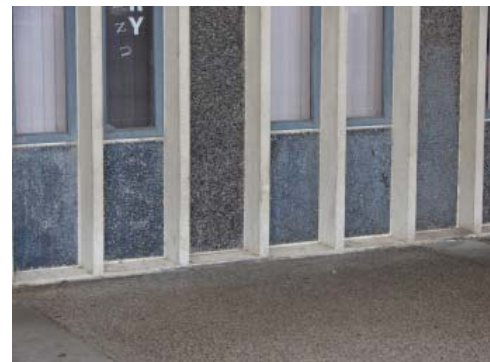
(Image 8)

The columns of the walkways are exposed and have some surface deterioration, which is less advanced than on the face protected by the building. The columns with a western or northern exposure show slightly greater surface deterioration. The sill members of the precast panels are generally dirty and there are several spots of oil or grease, and bird droppings under the large signs. Overspray from a project has discolored several panels on the west elevation of the north pavilion (Image 8).

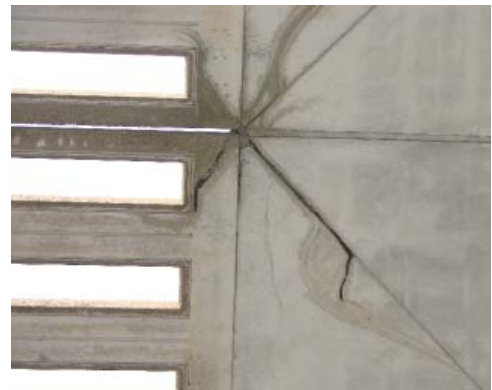
(Image 11)

At the center of each structure bay there is an expansion joint between two concrete pours. This joint is filled and covered with the roofing membrane ending at the perforated roof overhang. Here the joints are all open, water running through these joints follows the ribs of the flared capitals back to the columns in the walkways (Image 11). Water on these concrete surfaces causes problems of deterioration of the surface of the concrete or can rust rebar embedded close to the surface causing spalling of the concrete. The joint needs to be sealed, perhaps, with a flexible rubber gasket.

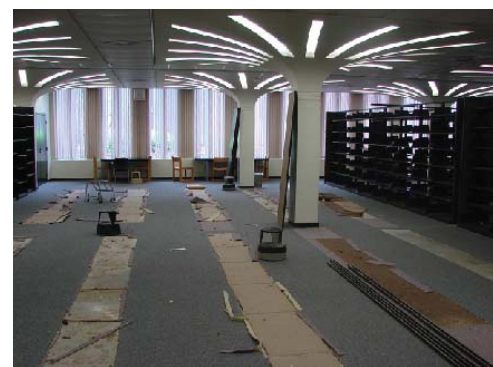
(Image 13)

There is carpet over a concrete floor slab. The existing bluish carpet is new, however, the original looped pile buff colored carpet was found under some recently removed bookcases (Image 13).

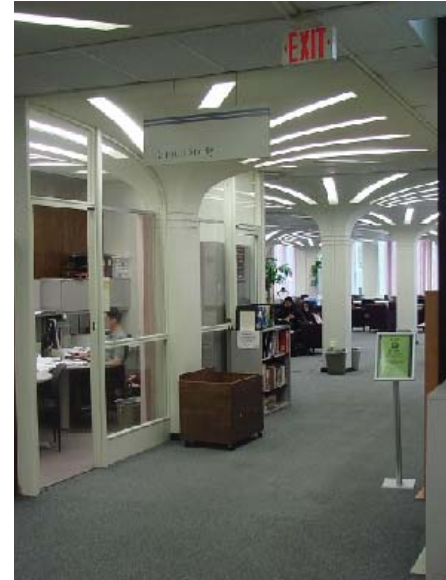
(Image 14)

There are glass walled offices and sound rooms flanking the exit stairs (Image 14). The glazed walls are the typical minimalist wall of glass and steel. These walls use narrow steel tubes for mullions and steel bar stock for muntin bars and stops. Most of these rooms have sound absorbing, open wood-slatted walls used in the Lecture Center.

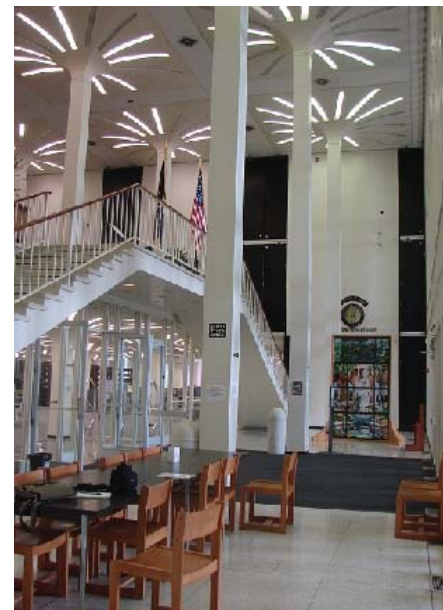
This lobby (Image 15) is a three-story linear space flowing into the second floor atrium above and beyond. There is a single row of three story columns down the center. The columns rise to large individual capitals with recessed strip lights forming tree branch formations around the tops. This ceiling is a continuation of the second story atrium ceiling, and like the reading room, these capitals

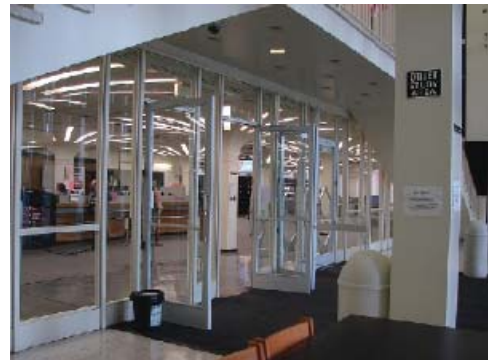
(Image 17)

Entry into the building is through the glazed east wall by means of four original glazed steel frame doors. The two flights of stairs rise to a common landing at the second floor mezzanine lobby (atrium) with the glazed entry doors into the Library space are under the landing (Image 17). There are original recessed down lights on the underside of the landing, as well as a security camera. This stair cannot be accessed directly from the main entrance lobby. The stair passes through the glass wall from the library side and makes a quarter turn then continues parallel to the east window wall. The floor is white terrazzo with strip grilles along the east window wall. There is a removable carpet running from the exterior entrance doors to the Library entrance.

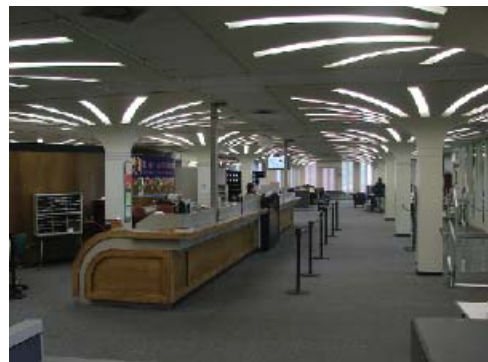
(Image 18)

Once through the glazed interior doors the ceiling seems low and enclosing (Image 18). The structural grid of columns defines the space, and the flared capitals of the columns supports balcony floor of the atrium/lobby above. These capitals do not meet like vaulting but are divided by a flat band of acoustical tiles in a drop-in metal grid. These appear to be original acoustical tiles. The air conditioning ducts are above the acoustic tile and the sheet metal supply grilles used at the diffusers, which occur on the structural grid and are rotated 45 degree to the structural grid.

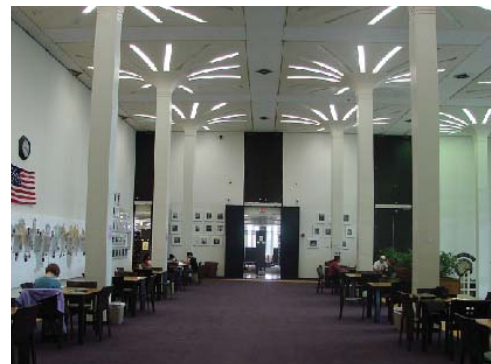
This is a two story lobby space (Image 19) feels balcony-like and overlooks the main entrance lobby. The structural grid of columns provides order and definition to the room. Each column rises two stories to form their own individual capitals. These capitals have recessed strip lights that form a tree branch formation around the top of the column. Between these large square capitals is a strip of drop-in acoustical tiles in a metal grid that unites the entire ceiling. The air conditioning ducts are above the acoustic tile and the sheet metal supply grilles used at the diffusers, which occur on the structural grid and are rotated 45 degrees to the structural grid. The ceiling appears to be completely original.

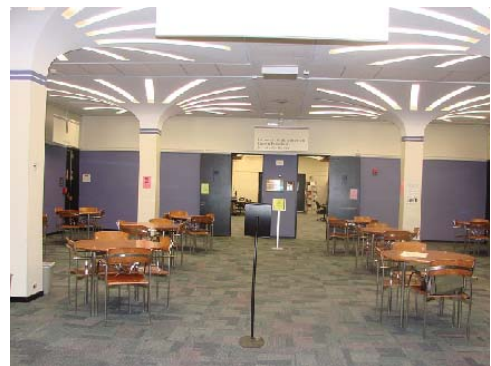
(Image 21)

The north and south stairs lead directly onto this square mid-size space. The four, single story columns, each with the typical large individual capitals, provide order to the room (Image 21). The capitals have strip fluorescent lighting that radiates around the top of the column to form a tree branch like formation. The acoustic tiles strips between the four capitals are original and lay level with the top of

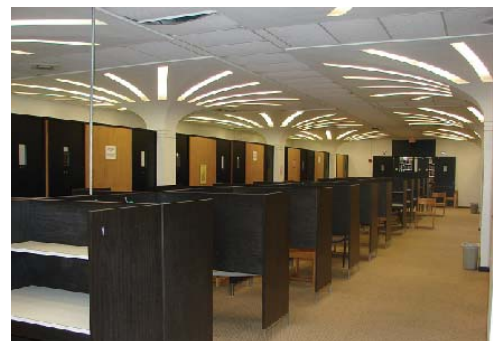
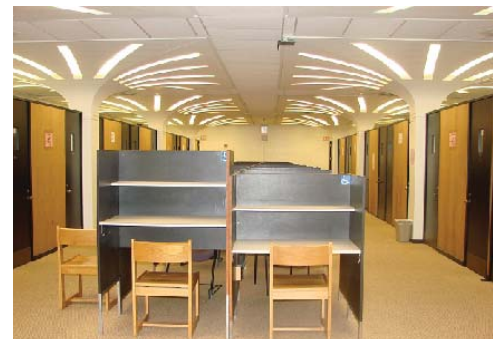
This interior room is a linear space with eight columns forming a colonnade (Images 22 and 23). The typical flaring capitals form vault like ceiling giving this space an almost grotto like feeling. Between each column, running the length of the room, is a three quarters height metal framed wall, used to partition the individual study spaces on the outside of the columns. These walls have a series of painted brown, solid wood doors with vision panels and a veneered panel. Each carrel is divided by painted gypsum board walls. There are two rows of private plastic laminate study desks down the center of the space, within the colonnade.

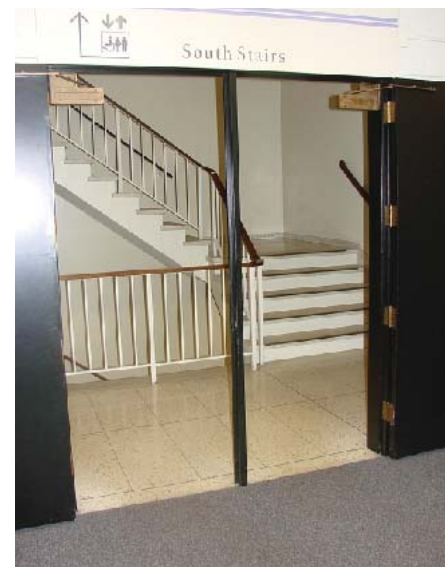
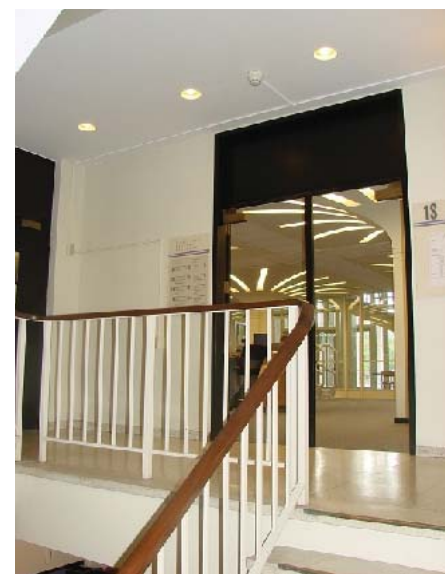
The two existing and circulation stairs are located at the northwest and southwest corners of the Lobby. These stairs are typical of the stairs in the classroom buildings (Image 24 and 25). The floors are white terrazzo laid out as a rectangular grid. Walls are all painted plaster over concrete masonry units. Light is provided by recessed down lights in the ceiling and under the landings. The stair structure is concrete with precast concrete treads. The landings are white terrazzo. The base is white terrazzo, which is carried up the wall as a wall stringer. Doors are

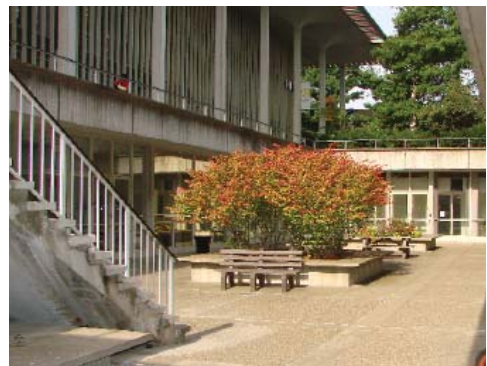
(Image 27)

The raised planting beds in the courtyards were originally fountains equipped with lights to illuminate them at night (Image 27).

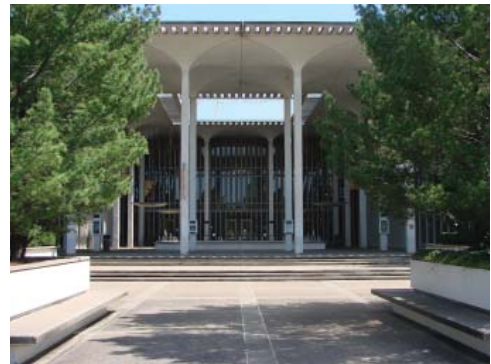
The Performing Arts Center (Image 1) was part of the Phase II Podium construction. It sits on the central east-west axis of the Podium at the symbolic heart of the campus. Its main entrance faces the central plaza and fountain, and is reflected by the Library on the west side. The building like the symmetrical Library is a stubby “U” with the entrance enclosed by the projecting pavilions. It is approximately 260 ft. by 200 ft. in plan; the longer east-west dimension encompasses the wings.

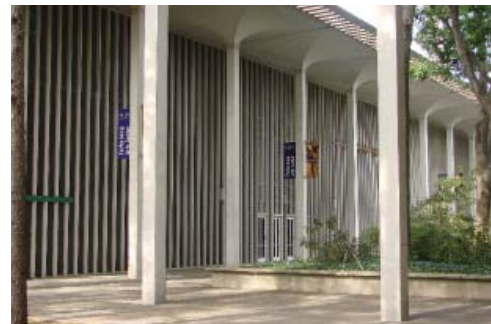
(Image 3)

The north and south facades are mirror images of each other (Image 3). The western three and a half bays continue the panels of the main west façade. The next three bays are completely windowless with continuous panels between the ribs, followed by another bay including doors on the first floor and windows above. Then one bay of windowless wall, and finally at the east end one bay of windowless wall with a vent grill at the third floor level.

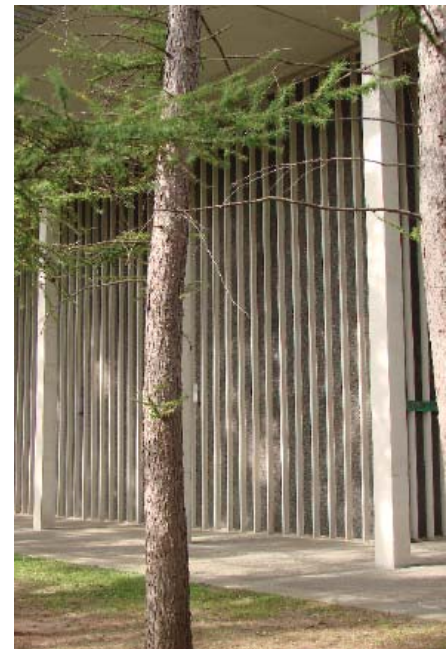
(Image 4)

The ten bay east façade is all windowless wall panels (Image 4), but does include two with the horizontal slat vent. These occur a half bay in from the corners.

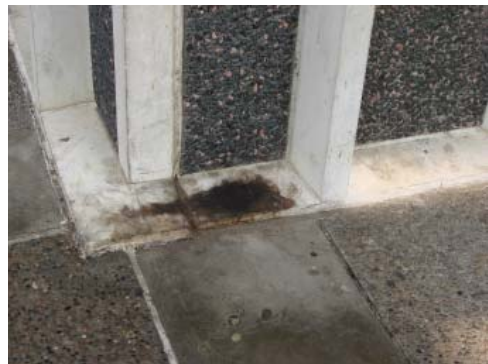
(Image 7)

The columns of the walkways are exposed and have some surface deterioration, which is less advanced than on the face protected by the building. There are also several spots of spilled oil on the sill member (Image 7). Along the east façade there are spots where the paving is now lower than the bottom edge of the precast panel (Image 8).

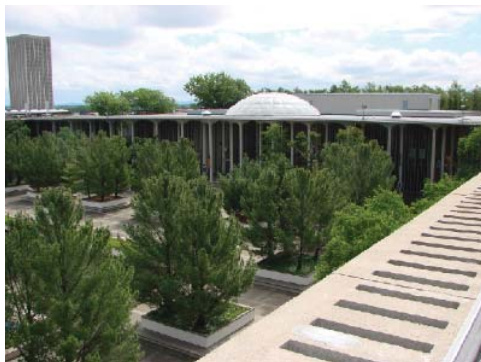
(Image 9)

The roof is a recent Carlisle .060 EPDM roof over tapered insulation. The roof encompasses several levels above the theatres and finally the fly loft of the main theatre (Image 9). All of these individual roofs appear to be sound and better than accepted industry standards with only minor ponding mostly around the edges of the roof. At the vertical brick wall the membrane is brought up the wall and sheet metal cap flashing protects the top edge. The flashing on the curb of the skylight flashing is protected by the overhanging skirt of the skylight

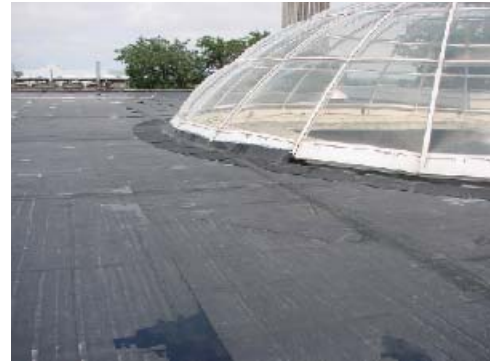
(Image 10)

frame. On the west side of the skylight, apparently in response to a leak, additional flashing membrane has been adhered to the outside of the skylight skirt (Image 10).

The skylight needs considerable work, a major program to remove Plexiglas glazing, repaint steel frame and caps and re-glaze. A proper access panel should replace the current one cut into Plexiglas. The internal system of incandescent lights has not worked in years, however, reintroducing light here would be highly desirable.

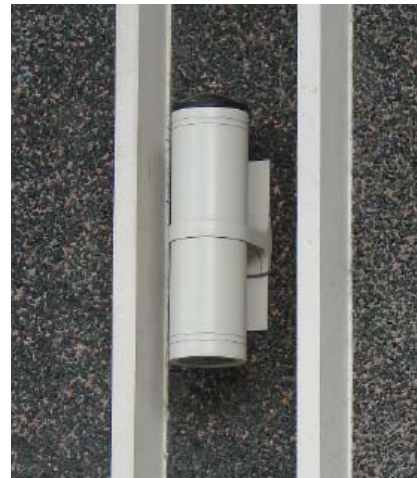
(Image 11)

simple minimalist fixtures are part of the original appearance of the building, and where they have been replaced the new fixtures are unfortunately conspicuous. On the west façade where these fixtures have been replaced the new cylindrical fixtures are visually intrusive (Image 11).

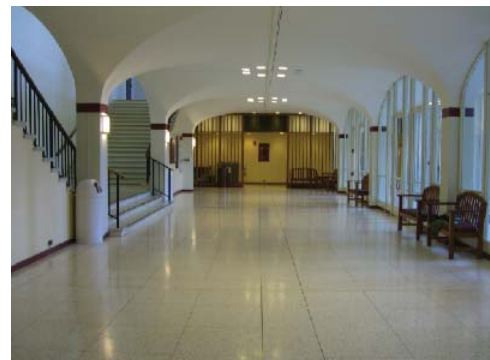
(Image 12)

Immediately upon entering the building, there is a glass walled vestibule from which one enters the Lobby (Image 12). The long, linear Lobby is bordered by eight engaged columns. The flared column capitals form a vaulted ceiling, which feels low and enclosing. The clusters of eight recessed down-lights emphasizing the junction of the groins light the space. At the north and south ends of space there are vertical wood slat walls that were

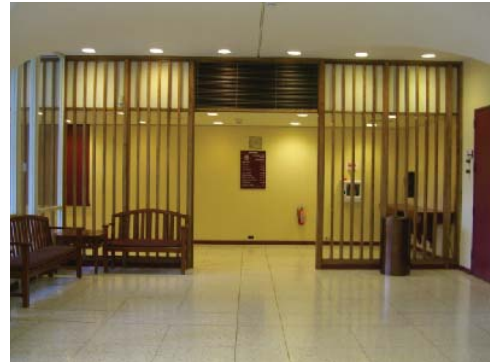
(Image 13)

originally stained dark brown, but have recently been refinished (Image 13). The floors are white terrazzo divided into bays following the structural grid.

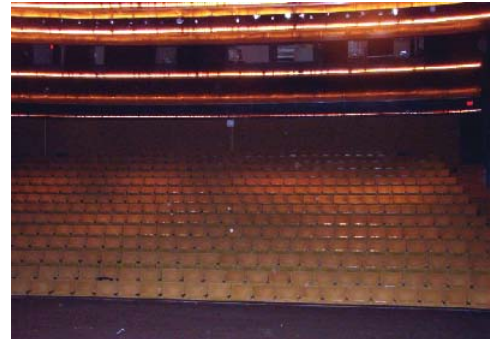
(Image 18)

This is the largest theatre space on campus (Image 18). It is substantially intact including the stepped ceiling of curved gold anodized stamped aluminum sheets, mini lights, door hardware, exit signs, seats, stage area and fly space. The side walls are a dark brown edge banded plywood, the stained flush wood doors fit seamlessly into this paneling system. The stepped, or tiered, ceiling has curved panels of stamped aluminum sheets, which have strips of small lights at each step (Image 19). The original dull brass hardware still remains in excellent condition as do the exit signs. The floor is painted concrete and the side aisles are carpeted to match the recent upholstery (Image 20). The rear wall is carpeted. The stage area is painted black. The original stage curtain has been removed.

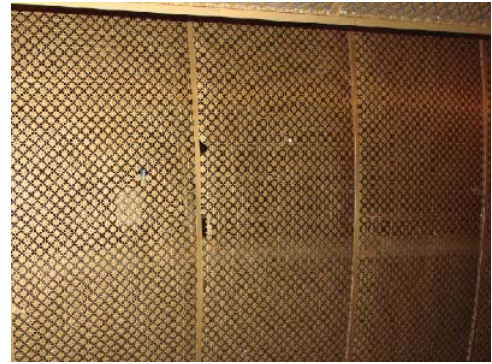
(Image 21)

Original upholstery, carpet and curtain are missing. The ceiling is very dirty and in poor condition with numerous dents and holes (Image 21). There are some minor scuffs and scratching on the wood walls. Additional modern theatrical lights are not a problem. This is a full theatre with fly space and dressing rooms.

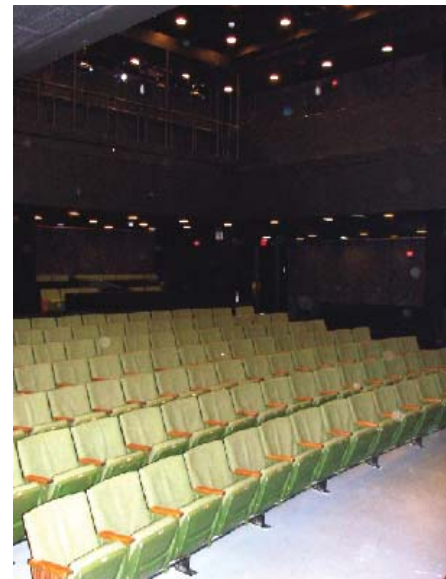
(Image 24)

This small theatre is a very intimate space (Image 24). It is composed of a central area seating area with a walkway on three sides. Behind the main seating area there is a raised platform with additional seating along the back wall (Image 25). The two seating areas are separated by the walkway. The ceiling rises to two stories above the central group of seats while remaining low in the circulation and gathering spaces of the walkways. Light is provided by recessed down lights in the ceilings. The original seats retain their original green upholstery; however the fibrous wall panels, ceiling and stage are now painted black.

The all black paint scheme seem unfortunate and deprives the theatre of its individual character. The black ceiling is particularly disturbing here.

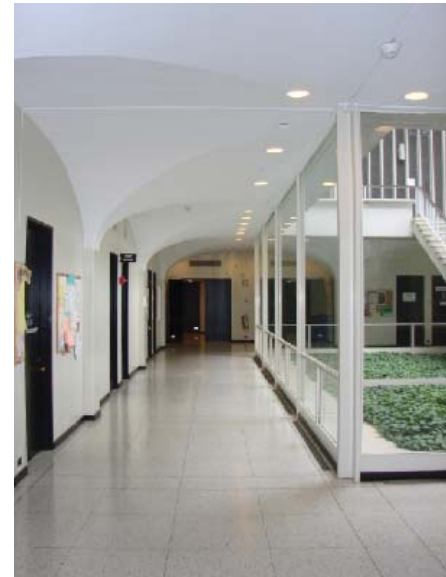
(Image 26)

These light and airy basement areas are used for general circulation and lobbies for the studios and smaller rehearsal theatres in the basement (Image 26). They are enclosed with elegantly detailed minimalist plate glass walls and look out onto a green courtyard. The interior walls are painted plaster on concrete masonry units. The exterior window walls have a minimalist frame composed of steel tubes and bar stock, which barely intrudes on the view of the green ground cover of the courtyard. The steel tube base continues the horizontal line of the bottom rail of the door (Image 27). The steel frame doors are those typically used at the building entrances; however, the two lights are divided horizontally by a muntin continuing the horizontal line of the window wall.

The terrazzo floor in the interior extends to the exterior as the border around the raised green space planting bed. The single glazed glass wall will need to be upgraded for energy conservation. Great care should be given to replacement glazing ideally using an additional layer of storm windows either inside or on the exterior.

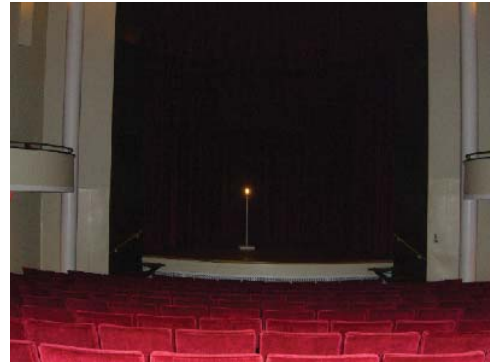
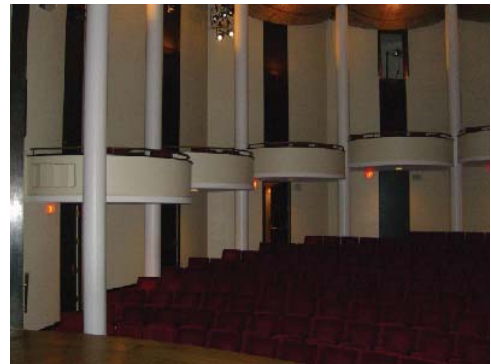
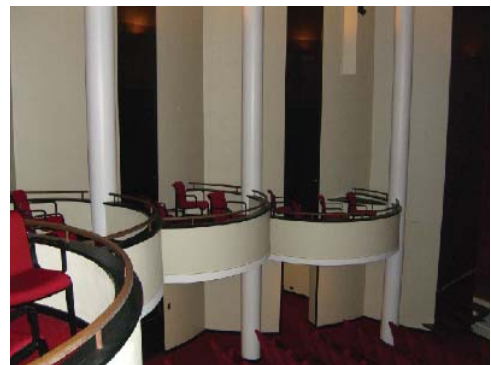
This is a circular space (Image 28) with ten round columns framing it, and nine individual balconies cantilevered between them stepping up toward the rear (Images 29 and 30). The stage is about two bays wide with seating that slopes down and in toward it and a string of staggered red velvet curtains. The ceiling is a series of twelve curved, stamped gold, anodized aluminum panels with the original crystal chandelier hanging from the center (Image 31). The seats are re-upholstered with red velvet. Red carpet is installed on the floor and the walls are painted plaster. Each individual balcony is bordered by a brass railing. On the main seating level, there are exit doors between each column. Surrounding the theatre space is a small corridor leading to each exit door and a stair. The stair leads to a second level which gives access to the balconies. The stair is carpeted and has brass balusters and newels along with a brass wall mounted handrail. The exterior wall of the corridor is carpeted for acoustical purposes and the second level corridor is similar. The corridors have a series of original recessed down lights, and the same fixtures are used under each balcony.

Seats have been re-upholstered on both levels and theatrical lighting has been added. There are exposed conduits for fire detection, strobes, electrical outlets and power boxes. Many of the original lights have burnt out and there is no easy access to replace the ones that are beyond the perforated ceiling.

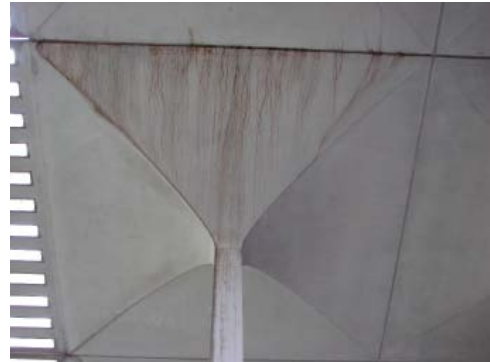
(Image 4)

Extensive stains and dirty streaking in the walkways and courtyards indicate that this roof was not performing well (Image 4). There is extensive staining and streaking on the east side of the wall, running down the vault ribs and columns (Image 5). However, this is active and emulating from the open joints in the roof overhang, not a failed roof membrane. The water seems to be contributing to the deterioration in the ribs of the northern most bay, and to a lesser extent the rusting of the window sash and subsequent staining.

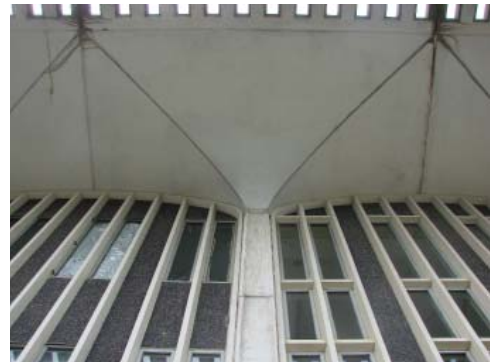
(Image 5)

The expansion joints are all open and water running through these joints follows the ribs of the flared capitals back to the building façade or column in the walkways (see Image 5). Water on these concrete surfaces causes problems of deterioration of the surface of the concrete or can rust rebar embedded close to the surface causing spalling of the concrete. This condition is most noticeable at the east elevation along the edge of the Podium. These joints should be covered with a flexible gasket of some kind.

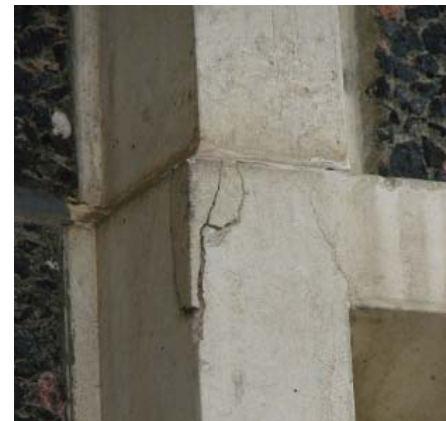
(Image 6)

There is a rib on the south façade that is cracked which appears to be caused by movement of the panel above (Image 6). The ribs adjacent to the closer side of the doors are often stained from spilled lubricant. There are several spots of overspray of paint on the exposed aggregate panel, which need to be removed. There is a 's nest above the east entry, behind the added third generation plastic sign, and a considerable mess below.

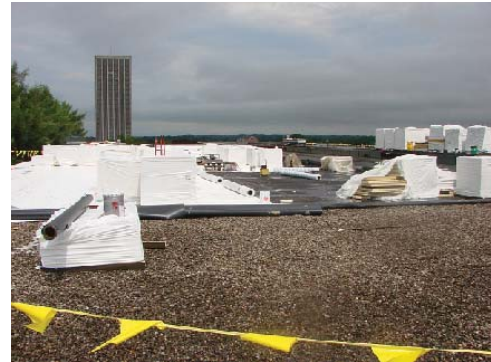
(Image 8)

This roof is being replaced with a new TPO

membrane (Image 8). The northeast courtyard roof is continuous with the roof on the Earth Science Building and is a recent EPDM roof. The northeast courtyard roof is continuous with the roof on the Chemistry Building and is a membrane roof with stone ballast, which is not functioning well and needs to be replaced. Storing materials on and the traffic generated from accessing the current roofing work on this roof will only aggravate the situation.

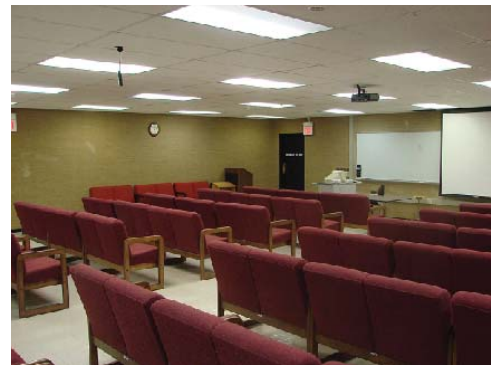
This room was originally a student commons and periodical room (Image 11) and originally encompassed three structural bays, two full bays in the middle and half bay to the north and south. It is now divided into two spaces; the north half structural bay being a seminar room, with the remainder being a seminar room. A “temporary” folding metal partition with a wood door separates these spaces. This aluminum and paneled partition forms the north wall of the conference room. The room originally had a small entrance space frame by the coat closet and kitchen on the south and north. The walls for the kitchen and storage attached room survive but the coat closet has been removed.

Although the room is listed as compromised above, much of the original material still survives, such as the concrete ceiling above the existing dropped ceiling. However, the original intent of the space has been compromised.

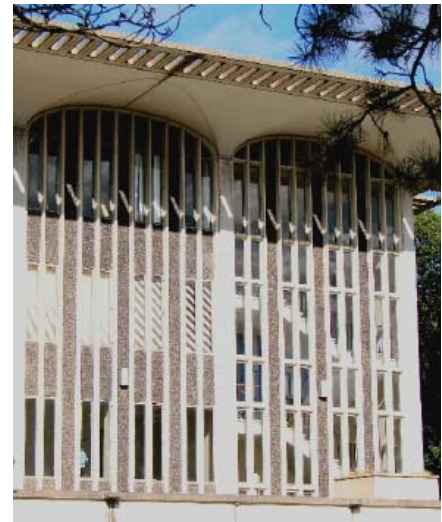
(Image 4)

The broad thirteen bay north and south façades run the long direction of the Podium, from corner courtyard to interior courtyard shared with the Education Building. The bays on the north façade are all identical. The south façade is similar to the north; except the east and west end bays are fully glazed bays for the stairwells (Image 4).

The columns at the southwest courtyard are less protected and all have some surface deterioration, which is more advanced on the west and north faces.

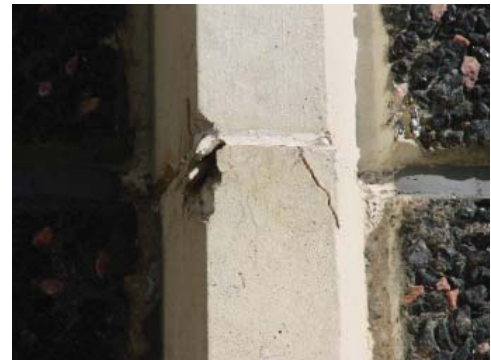
(Image 5)

There are two ribs on the south side of the west façade damaged from what appears to be movement of the panel above, and the support system for this upper panel should be investigated (Image 5). There are two spots of deteriorated concrete on the base member one of which has been patch, however, the patch did not bond properly and has now cracked at the edge (Image 6).

- Replace skylights with energy efficient skylights of identical design.
- Patch deteriorated concrete vaulting of courtyard.
- Patch deteriorated concrete column and ribs.
- Clean facades using low pressure wash of water.
- Replace all caulked joints.
- Replace windows for energy conservation with double glazed sash of similar design and color to original steel sash.
- Replace doors with double glazed sash of similar design to original steel doors, maintaining frameless appearance and original width between concrete ribs.
- Paint exterior concrete elements except exposed aggregate panels.

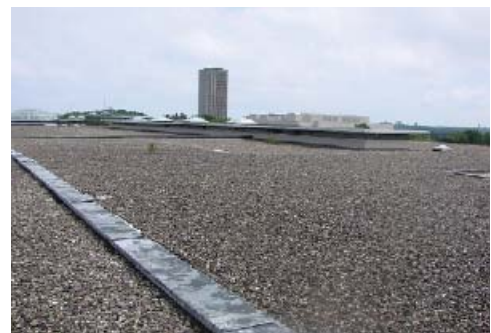
Although this roofing membrane was not visible (Image 7) it appears to be a mopped felt, traditional, built-up roof of the same period as the roof on the Social Science Building. The rigid insulation is laid over the top with stone ballast above (the membrane is separated from ballast by filter fabric). In this instance the insulation and the ballast is carried over the walkways and terminates at the edge with a sheet metal drip edge. Although there was no standing water visible on the day of inspection (it had rain that morning), there were a few areas where the insulation was floating above a pond of water. The insulation and filter fabric has split

- Replacement roof over building footprint, walkways, monitor, and courtyards.
- Fill open expansion joints in perforated roof overhang.
- Treat top surface of perforated roof overhang with liquid membrane.

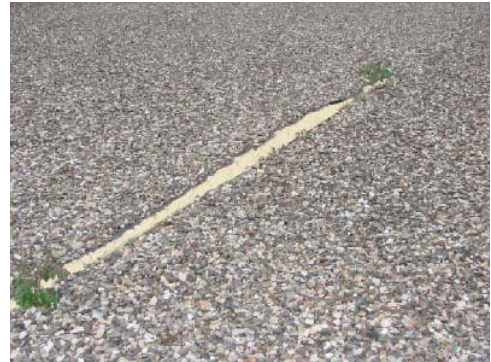
(Image 8)

along line of expansion joints and the ballast has washed into and filled the void (Image 8). There are also some small plant life growing in the cracks of the insulation indicating enough water and soil to support growth in these areas.

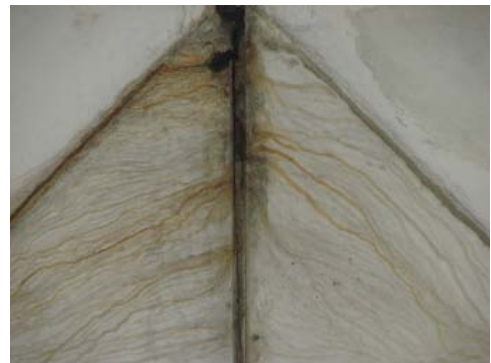
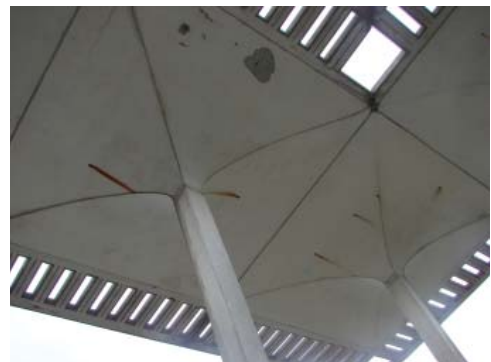
This roof encompasses the southwest courtyard and there is considerable staining and deterioration due to active roof leaks (Images 9 and 10). There are numerous rust spots, staining and areas of concrete which have spalled off due to rusting rebar. There are some expansion joints (between sections of the roof slab) where water is draining through and running down the ribs of the column capitals onto the building facades. There is also typical staining from water running through the open joint between sections of slabs in the roof overhang (see below).

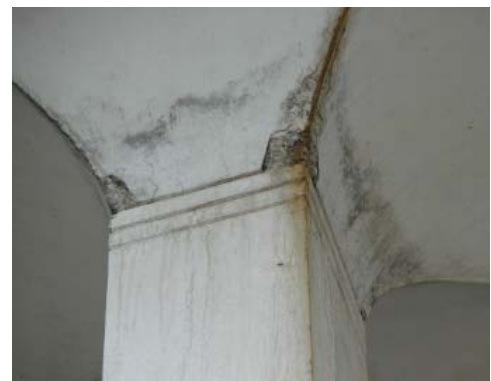
There is some erosion of the top surface of the perforated slab on this building which is exposing the aggregate, and the top surface has been coated around the full perimeter of the building. There are lights cantilevered off the edge of the roof slab on the interior courtyards wired with exposed conduit. These replaced four original saucer light fixtures in the southwest courtyard and two in the smaller courtyard with the Education building. The expansion joints between the individual slabs are open to the weather in the overhang and water coming through these joints runs down the ribs of the vaulting to a column. There is now some spalling and deterioration due to rusting rebar (Image 11) in the columns and precast ribs. This open joint

should be sealed in a manor that allows for movement, perhaps with a compressible rubber gasket.

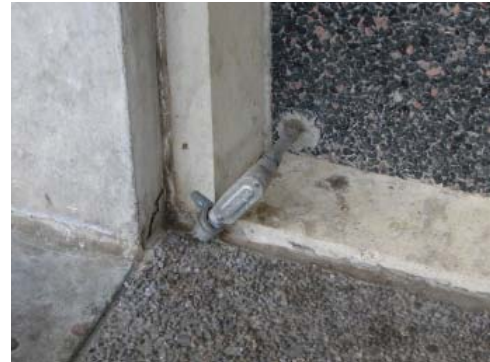
(Image 7)

There is an exposed electrical conduit at the northeast corner (Image 7), the purpose of which is unknown.

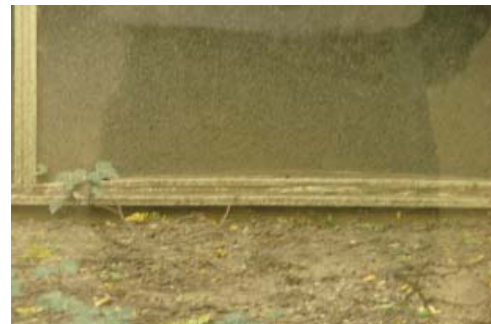
(Image 18)

The lower portion of minimalist glazed walls is very dirty from the drip splashing off the dirt of the planter bed. This may be partly a result of the sparseness of the ivy, but also the ineffectiveness of the drip on the planters above. Moisture on the steel elements has developed substantial rust and deterioration in the steel plate and the lower bar stock glazing stops (Image 18). Preservation of these walls is certainly desirable and after basic repairs the walls could be fitted with interior or exterior storm sash rather than being replaced.

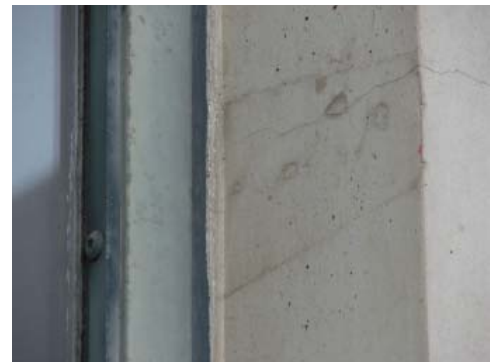
(Image 5)

The repetitive nature of the precast panel forms can be seen where horizontal ribs have been removed. Ghosting can be seen on many vertical ribs (Image 5). This same ghosts can be found occasionally on the classroom building façades as well.

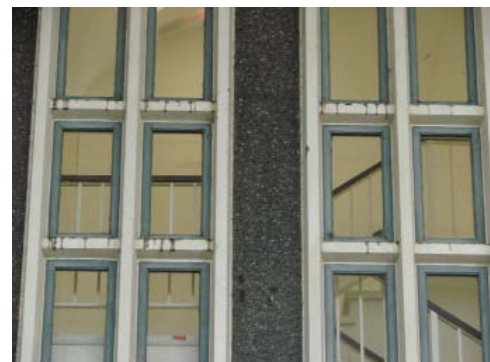
(Image 6)

There is an extensive bird problem on the upper horizontal ribs of the stairwell bays (Image 6), particularly the bays flanking the entrance.

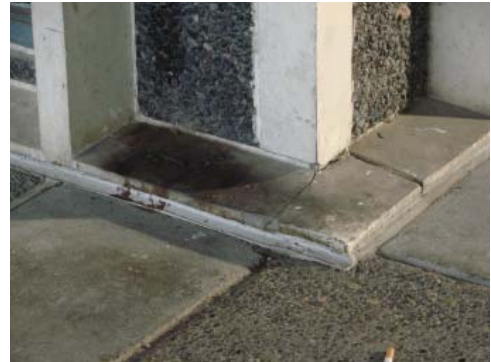
(Image 7)

than some of the interior courtyard columns. The corner column shows deterioration on all faces as they are in the most vulnerable situation, but all columns show less advanced surface deterioration on the face protected by the building. There are also several spots of spilled oil on the sill member (Image 7).
