**UNIVERSITY AT ALBANY
STATE UNIVERSITY OF NEW YORK**

**CAMPUS HERITAGE
PRESERVATION PLAN**

Mesick • Cohen • Wilson • Baker • Architects
388 Broadway Albany, NY 12207

April 2009

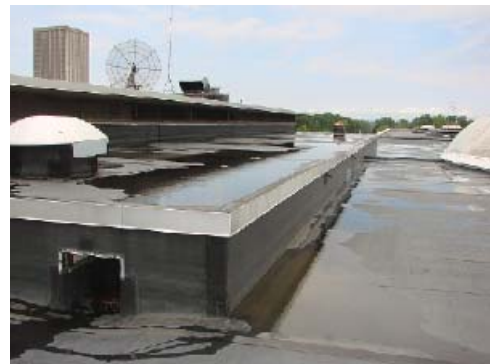
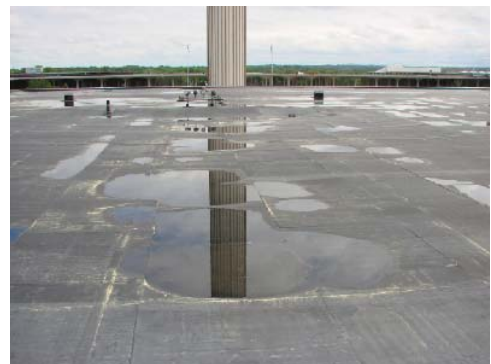
This building has recent EPDM roofing (Firestone) over tapered insulation (Images 8 and 9). There is extensive ponding of water across the roof, but particularly at the edges. Some of the ponding on the lower roof of the monitor and at vertical penetration is at least 1" deep after heavy rain. The vertical flashing at the monitor, vents and skylights appears to be acceptable. The original wire broken lovers are missing or have been covered over.

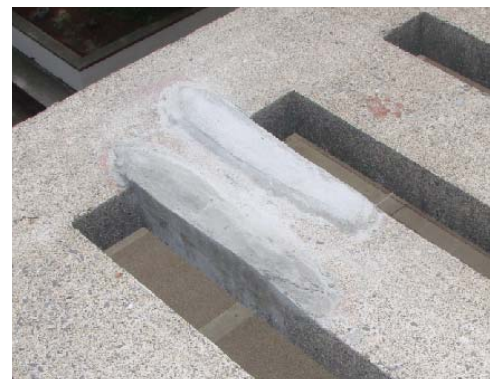
(Image 10)

There is some erosion of the top surface of the slab on this building exposing the aggregate and in some cases spalling and patching (Image 10). The top surface has been coated around much, but not all, of the building. Water draining off the edge of the slab and at the perimeter of the perforation has stained the concrete and minor surface erosion has exposed the fine aggregate. This is a physical concern, but has also created an unintended visual emphasis by outlining each perforation in dark gray. The large exterior spot lights are mounted to

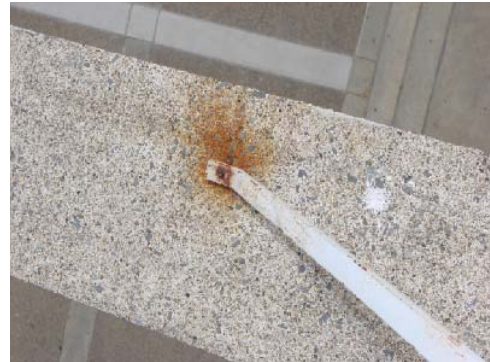
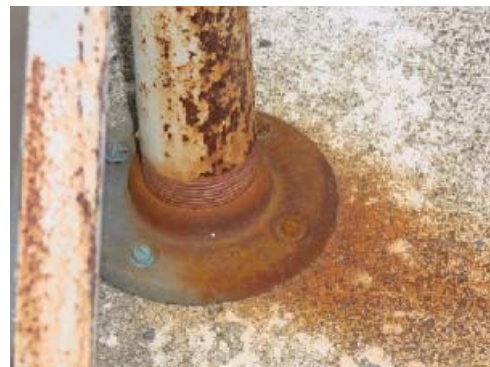
the top of the overhang using ferrous connectors (Images 11 and 12). Rusting of the connectors and framing member is not simply a visual issue but a conservation issue as rusting connectors will crack the concrete.

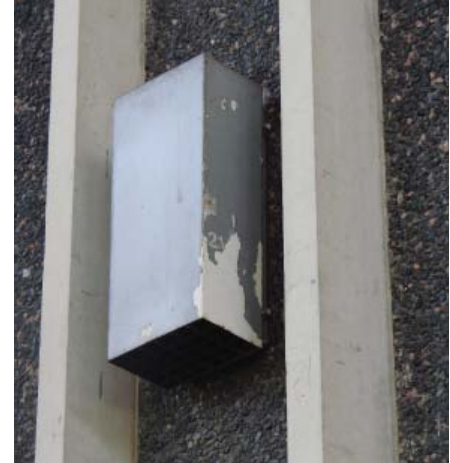
(Image 15)

There is a typical rectangular box wall sconce mounted on the central exposed aggregate pier of each bay. These rectangular boxes are now painted silver, however, bits of their original white finish are showing through (Image 15). These fixtures have been replaced on the north facade, and the new, cylindrical fixtures are noticeably different.

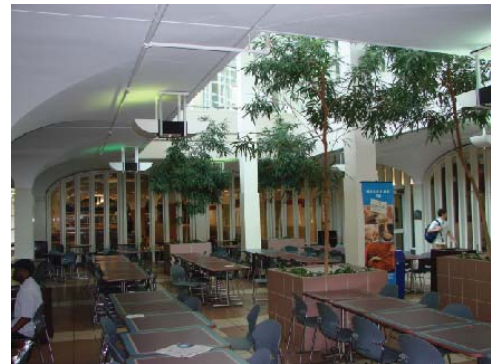
(Image 34)

This space was originally outdoor space open to the Podium level as a courtyard. The 1994 Campus Center extension filled in below the Podium above creating indoor circulation space to the two new wings at the southern corners. The open well was glazed with a barrel vaulted skylight and space now functions as a seating area for the cafeteria (Image 34), and concessions at this level. This space has six columns; two of them rise through a curved skylight to form the vaulted ceiling of the promenade

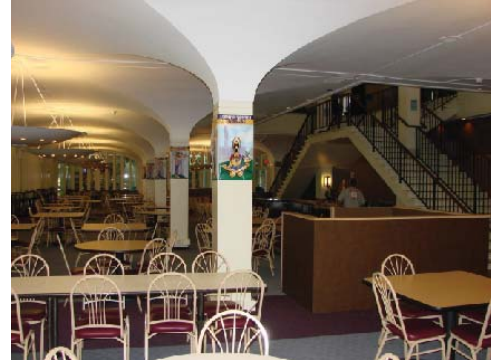
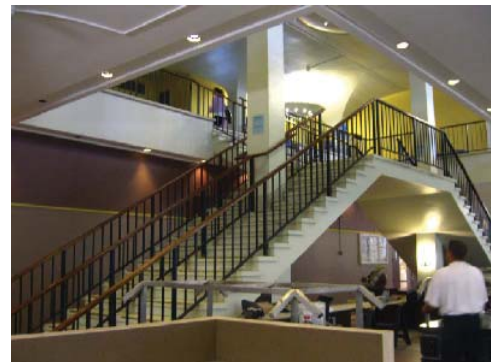
The cafeteria, now known as the commons, is a long space with twelve columns, two of which are double height and define the stairwell (Image 35 and 36). There is a saucer light fixture hanging in the center of the opening. The stair starts as two flights rising to a common landing followed by a quarter turn to a broad single flight leading up to the First Floor Lounge. The stairs have a concrete structure with pre-cast white terrazzo treads. The baluster consists of steel square stock balustrades and newels with a varnished rectangular wood handrail, which is the typical balustrade used through the building and campus.

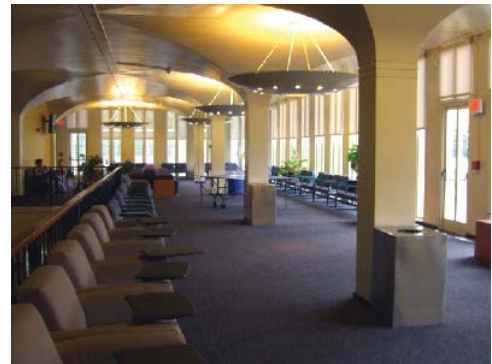
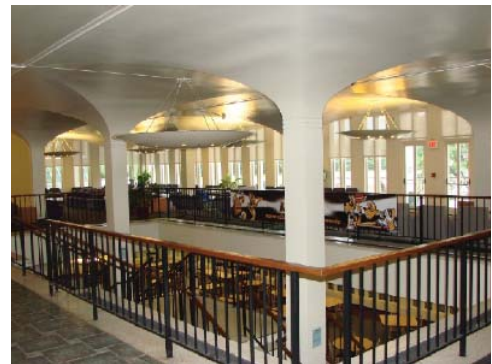
There is a small lobby separating this Lounge from the Entrance hall, all on the central north-south axis of the building (Image 38 and 39). At the front of the lobby there is a stair leading down to the commons. The stair well is surrounded by a balustrade of steel bar stock, which is a continuation of the stairway handrail. The floor slab extends past the balustrade with an approximate 3' boarder of terrazzo that frames the stairway well. Within the terrazzo boarder there is the remnant of an embedded planter box, which is now carpeted over. The planter box was an original feature of this space. Originally, the room encompassed the entire wing, similar to the Ballroom above, however, it was divided into interconnected spaces with a TV area to the east and a reading area to the west. The main seating area has been expanded into the southern portion of the original TV room when the separating wall was removed. The seating area now spans to the east window wall. The reading rooms, which were originally divided by separating walls, are now completely enclosed as separate room along the west side of the room. A single row of columns forms a vaulted ceiling down the center of the seating area. The Main Lounge now consists of fourteen columns (eight free standing) that form a vaulted ceiling. There are eight saucer light fixtures. Five of these light fixtures exist in the seating area and provide light as well as giving this large space a sense of human scale. The floor is mostly carpeted, however, the north entry bays are an artificial stone paving. The exterior south and east walls are the original pre-cast ribs and steel sash windows.

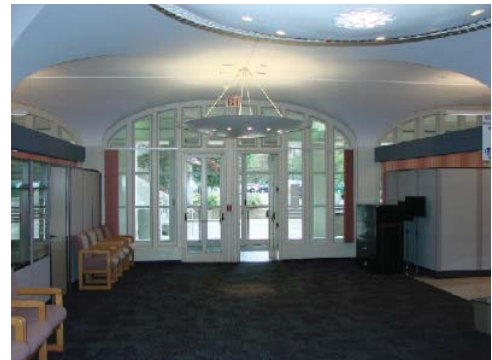
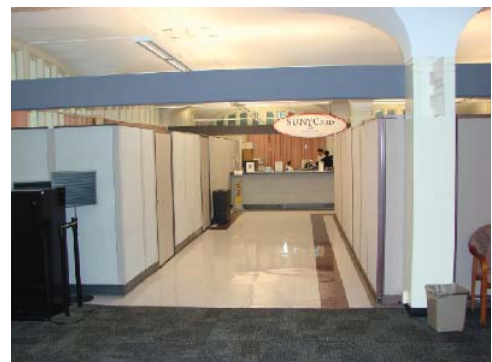
The space of the original campus bookstore is still intact, defined by the two rows columns and vaulted ceiling rising above the modern office landscape (Image 40 and 41). The columns and vaults form a large long center “nave” with side aisles, much like a church. This effect would have been reinforced by the original hanging saucer fixtures. The ceiling is the original plaster vaults rising from the column at the spring line just above the vestigial capital of three grooves. There is surface mounted conduit for smoke detectors and the alarm system strobes on the ceiling and walls. The floor is carpet in offices and lobby and vinyl tile is the public circulation areas.

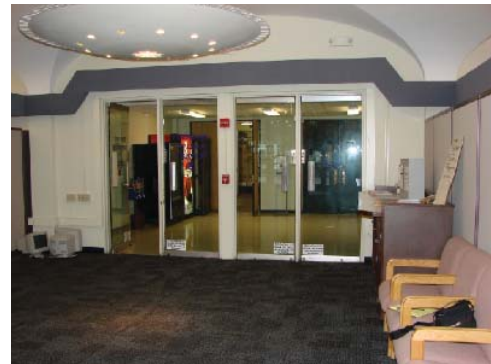
(Image 42)

The doors to the exterior corridor are the original glazed steel frame doors. The frameless glass doors to the elevator lobby are modern. They were part of the recent renovation and presumably replaced flush wood doors with a small vision panel (Image 42).

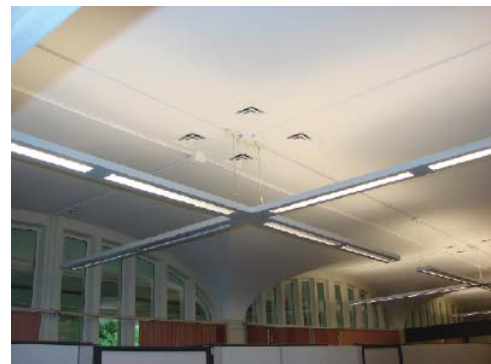
(Image 43)

The two saucer light fixtures in the lobby are original fixtures relocated to this position. The original room featured five such fixtures, a pair at the north and south bays and a single one in the central bay. The modern aircraft cable, cruciform fixtures provide both up and down light and are a good solution for overall lighting, which conforms to the structural grid of the original room (Image 43).

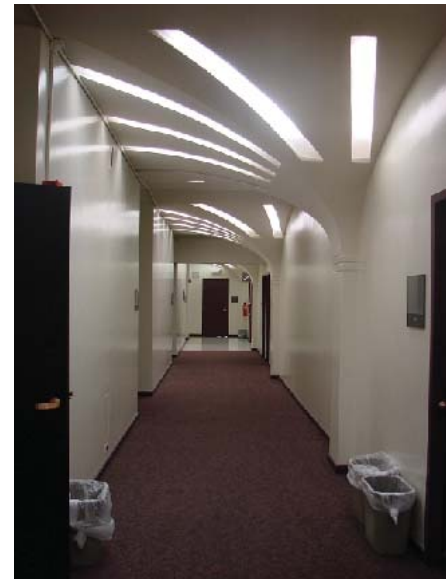
(Image 44)

These corridors typically have engaged columns on one side. The flaring capitals spring in three directions creating a half vaulted ceiling (Image 44). The typical recessed strip fluorescent lights with the tree branch formation in the vaulting are present. In some cases, there is a single row of recessed down lights. The floors range from carpet to terrazzo, but the walls are consistently painted plaster on both concrete masonry units and steel studs.

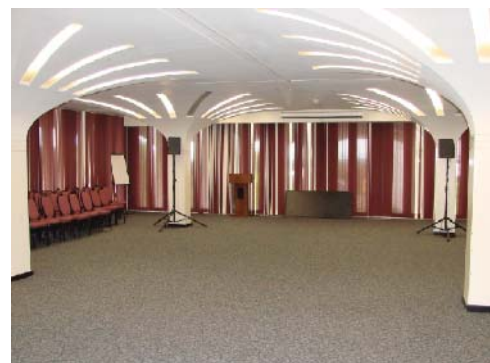
(Image 45)

This room is two bays wide and two and a half bays long (Image 45). The space is defined by the flared column capitals forming a rhythmic vaulted ceiling. There are exposed conduits on the ceiling for smoke detectors and alarm system. The square concrete columns divide the room into a large linear central space flanked by side aisles.

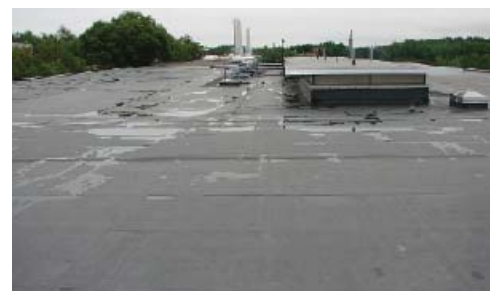
(Image 7)

The roof has recent EPDM roofing (.060 EPDM Carlisle) over tapered insulation (Image 7). There is considerable staining on the underside of the courtyard ceiling vaults on the west of the building on a line approximating the expansion joint between the Physics building and the Campus Center.

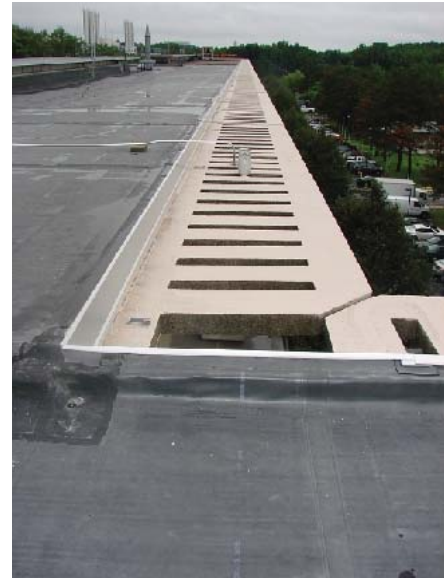
(Image 8)

There is some erosion of the top surface of the slab exposing the aggregate, and the top surface has been coated around the full perimeter of the building (Image 8). Water draining off the edge of the slab and at the perimeter of the perforation has stained the concrete and minor surface erosion has exposed the fine aggregate.

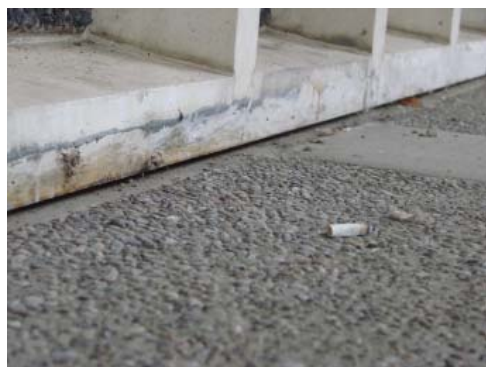
(Image 7)

On the north side, the paving has settled below the bottom of the precast panel. Normally, about 1" is exposed, but here 2.75" is exposed, and the joint runs underneath the panel (Image 7).

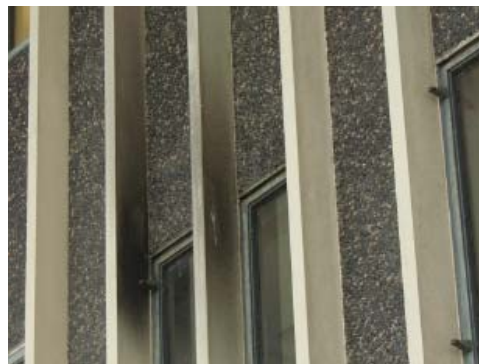
(Image 5)

There is some hairline cracking in the poured in place columns. One column on the west façade has deeper cracking and may require patching. Four ribs on the north façade are soiled by smoke (Image 5). The lower portion of one rib on the upper panels on the west façade is spalled (Image 6) which may indicate some fatigue in the steel angle supporting these panels.

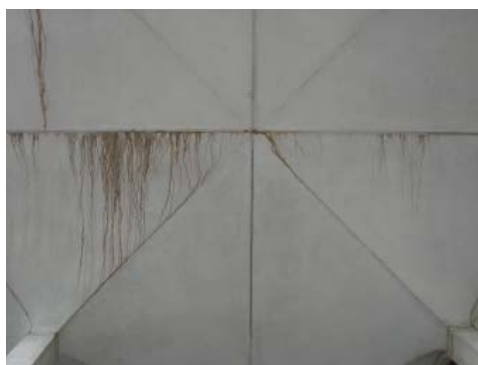
(Image 9)

The large flat roof extends past the footprint of the building to the edge of the flared capitals, forming vaults over the covered walkways (Image 8). This roof has an EPDM membrane laid over tapered insulation with stone ballast above. The membrane is separated from ballast by filter fabric. There was no standing water visible on the roof, nor was there any organic growth, which would indicate areas where water is collecting. There is some visible deterioration of the filter fabric where the edges are exposed to the sun. The roofing membrane is carried up about 24 inches to the underside of the concrete sill on the monitor and secured with a binder bar. This roof extends over the southeast courtyard where there are a number of indications of roof leaks including water stains at the joints between pours in the slabs (Image 9).

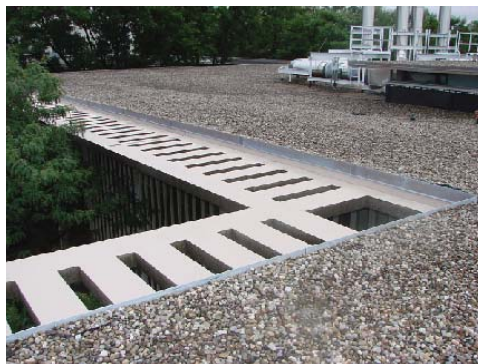
(Image 10)

The concrete roof slab extends beyond the drip edge of the roof and is exposed to the weather. This extension corresponds to the portion of the exterior overhang of the flared capitals, and the slab itself is perforated with a series of rectangles resolved as squares at the corners. Each perforation has a drip edge cast into the underside to avoid water staining on the underside of the slab. There is some erosion of the surface of the slab exposing the aggregate. The top surface has been coated with a brush applied sealant around the full perimeter of the building (Image 10).

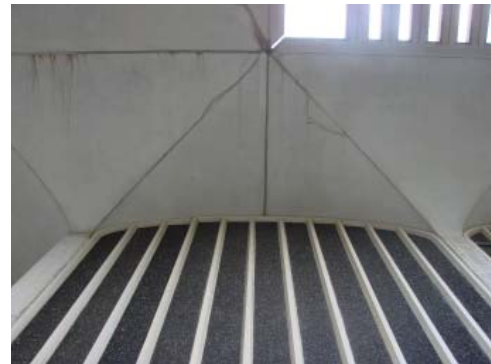
(Image 11)

The joint between sections of roof slab is open beyond the roof and water is following the ribs of the flared capital back against the building (Image 11). These joints need to be covered with a flexible gasket of some kind.

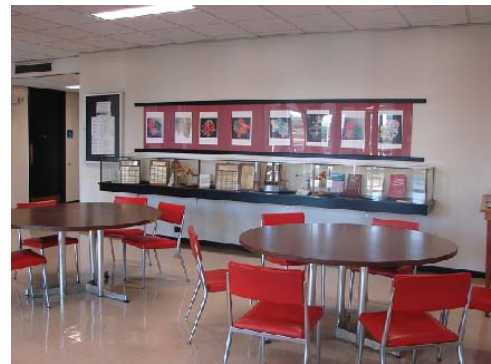
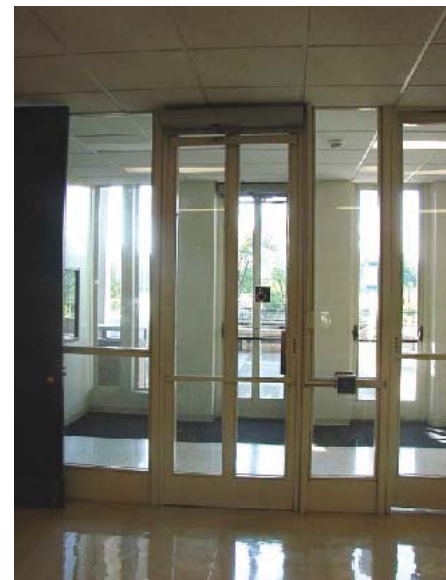
The Lobby is on the east side of the building (Images 12 and 13). The typical glass, metal, and concrete with terrazzo floor leads into this space. This space has a single column within. The original column has been enlarged in width and depth with a gypsum board enclosure. The floor is recent vinyl tile and the walls are original painted plaster on both concrete masonry units and metal studs. There is a low, painted, original wood baseboard that runs around the entire space. There is a new drop ceiling with acoustical tiles and strip fluorescent

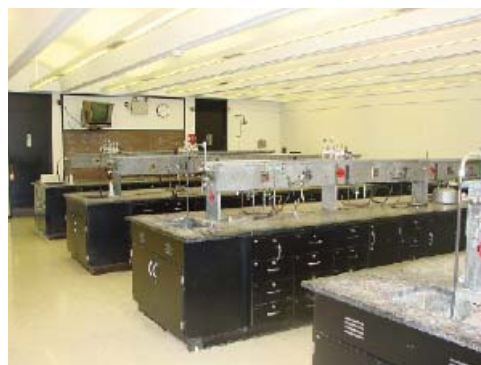
(Image 14)

The typical laboratory has original 8 inch square vinyl asbestos tile floors and a barrel vaulted ceiling with hanging strip lights down the center of the vaults (Images 14 and 15). There is the typical window wall and painted plaster walls. The doors that lead into the space and into prep rooms off of the lab are the typical solid wood doors with small vision panels. The original coat hooks arranged on painted boards (Image 16) are often present and tacked on one of the walls. There are fume hoods recessed within a wall and an original blackboard on another. There are usually four rows of lab stations in the center of the space. They are long with painted plywood cabinets and drawers with

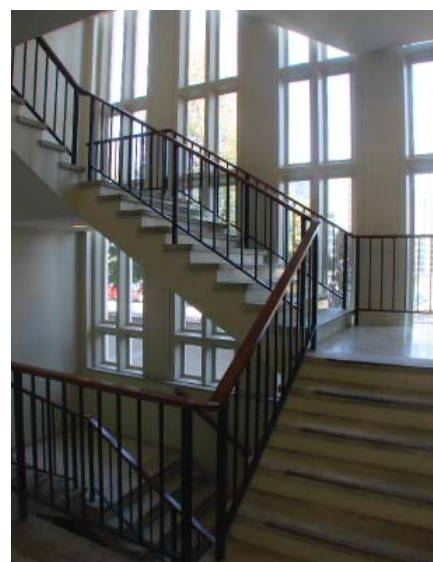
(Image 19)

These stairs are typical of the fire stairs in all the original podium buildings, and are the main public circulation stairs off the lobbies and central corridor (Image 19). These stairs were not affected when

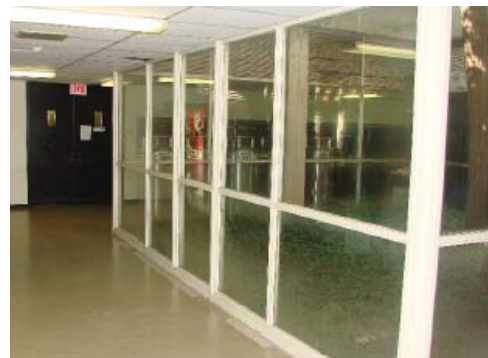
(Image 20)

The perimeter walls are all original plaster on both concrete block and metal studs with a low wood base. The interior walls are the typically detailed minimalist glazed walls. These walls use steel tube as mullions and steel bar stock as muntin bars and stops for the large panes of glass. The glass is arranged with a single horizontal muntin dividing the bays into a large square pane and a lower horizontal pane (Image 20). The walls in this case rest on a low wood base, which continues the base on the perimeter walls. The floor appears to be the original 8" x 8" vinyl asbestos tile.

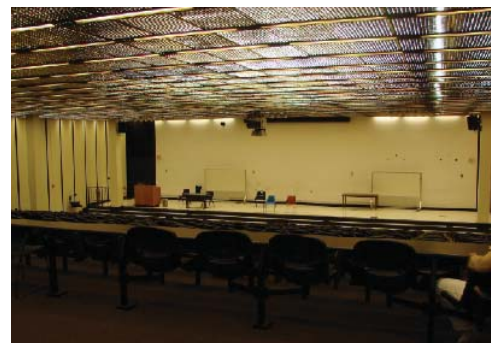
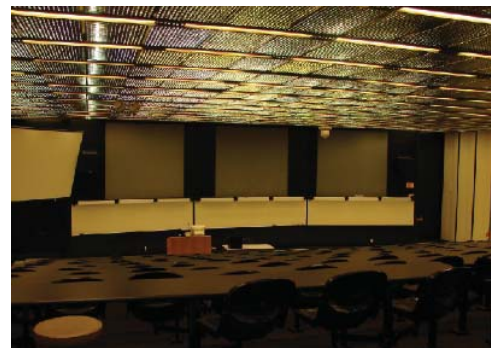
The original ceilings are perforated bronze, anodized aluminum sheet in an arched configuration with the strip fluorescent fixtures serving as the “beams” from which the arches spring (see Image 5). The strip fluorescent fixtures also incorporate heating and ventilation grilles between the typical plastic egg crate diffusers. The frame to hold the ceiling panel in place conforms to the pattern of the differ grilles. Several halls have replaced this ceiling with a gold plastic egg crate drop-in ceiling. These ceilings are suspended at the level of the strip lights and are aesthetically unsuccessful (Images 7 and 8). The lower height feels very uncomfortable in the lobby areas.

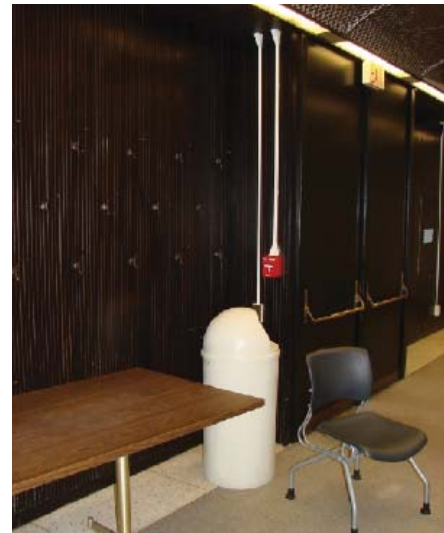
(Image 15)

Good. Maintenance leaves a little to be desired. There is a good deal of clutter and added wastebaskets, plastic signs, loose chairs etc. in many of the lecture halls (Image 15).

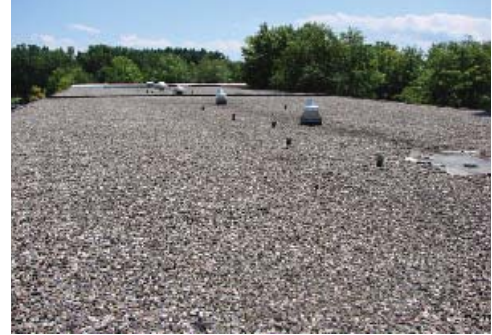
(Image 9)

The large flat roof extends past the footprint of the building to the edge of the flared capitals of the covered walkways and is terminated in a sheet metal drip edge. This roof appears to be an EPDM membrane above tapered insulation and stone ballast above (Image 9). This makes visual inspection of the roof membrane limited, although, the membrane has been exposed at one of the roof drains (Image 10). This roofing system encompasses both roofs above Mahican and Montauk, however, there is an expansion joint down the middle of the axial walkway. In many areas, pine needles, leaves, and debris has accumulated at the outside curb indicating drainage from these areas is also incomplete or very slow. There is some deterioration at the edges of the filter fabric where it is exposed to the sun. This roof is near the end of its useful lifetime.

- Cover open expansion joints in perforated roof overhang.
- Treat top surface of perforated roof overhang with liquid membrane.
- Replace roof with new tpo or built-up roof.

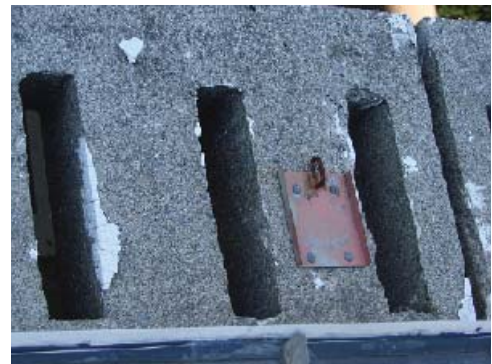
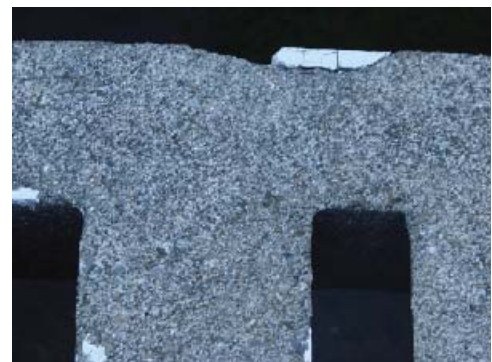
There is considerable erosion of the top surface of the slab on this building exposing the aggregate and in a few places where spalling (Images 11 and 12). There are a considerable number of patches with a white patching compound. This deterioration is no doubt accelerating and the exposed, rusting rebar represents a threat of significant damage. This surface need to be comprehensively repaired, building up any depressions caused by deteriorations or original casting and particularly in areas around the exposed rebar. This process must be treated as concrete repair not just surfacing. After patching of the concrete surfaces, the top surface of the overhangs should be treated with a liquid,

elastomeric membrane, which will help prevent the absorption of water by the concrete deck.

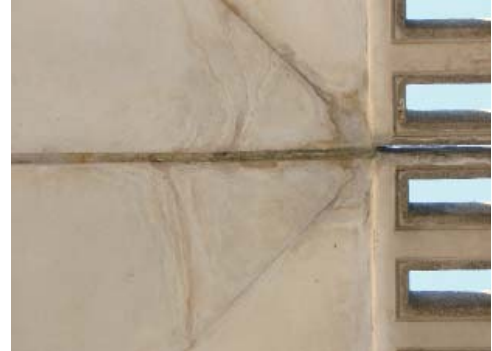
(Image 13)

It may become necessary at some point to patch the surfaces within the perforations and perhaps an integral drip at the edge could be design to allow water to drip clear of the concrete surface. The expansion joints between the individual slabs are open to the weather and water coming through these joints runs down the ribs of the vaulting to a column (Image 13). This open joint should be sealed in a manor that allows for movement, perhaps with a compressible rubber gasket.

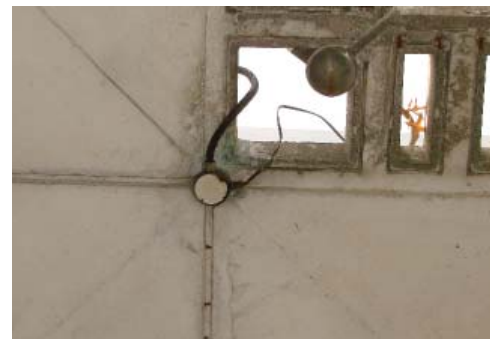
(Image 15)

Each of the corner courtyards was intended to have four of the iconic saucer light fixtures. These have all been removed, however, in many cases the electrical feed for the replacement spotlights are connected to the original box (Image 15). Restoration of these fixtures should be part of any building project.

- Clean facades using low pressure wash of water.
- Replace all caulked joints.
- Replace windows for energy conservation with double glazed sash of similar design and color to original steel sash.
- Replace doors with double glazed sash of similar design to original steel doors, maintaining frameless appearance and original width between concrete mullions.
- Fill arched panel between precast panels and vaults with stucco.
- Paint exterior concrete elements except exposed aggregate panels.
- Restore saucer light fixtures in courtyards.

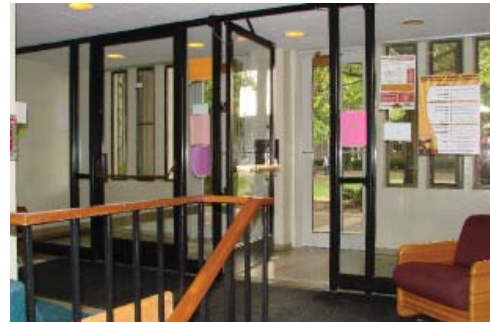
(Image 16)

This entrance space to the dormitory building has been renovated and the basic room dimensions altered c.2000. There is a small vestibule that leads into the space (Image 16). The vestibule is enclosed in painted aluminum framed glass walls with hollow metal doors which appear to date from a renovation c.2000 when the exterior doors were also replaced. The intent of this wall is to reproduce the visual imagery of the original minimalist steel and glass rectangle, however, the detailing uses stock shapes and sections which make the whole considerably more substantial and heavier in appearance. The floor in the vestibule is vinyl tiles and the ceiling is gypsum board with recessed lights.

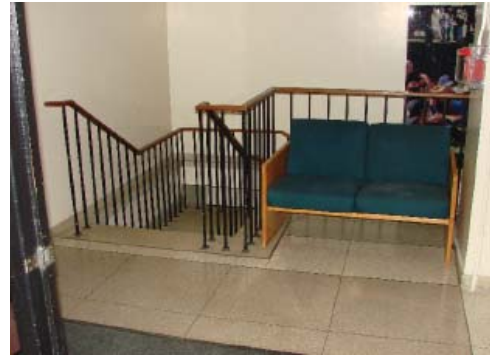
(Image 17)

There is a small seating area in front of the stairs, and a door to a short passage to the central corridor with a stair at both ends. The stair to the basement level rooms is original (Image 17). The stair has a concrete structure and precast concrete treads with balusters composed of steel bar stock shapes and a varnished wood handrail.

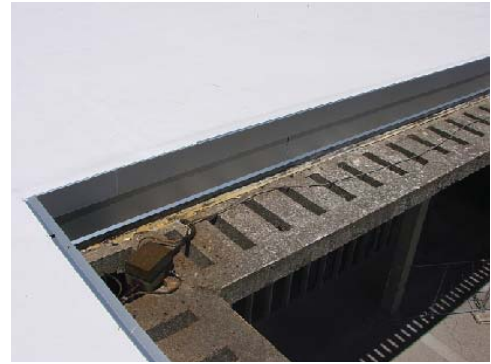
(Image 8)

The concrete roof slab extends beyond the drip edge of the roof and is exposed to the weather. There is considerable erosion of the top surface of the slab on this building, exposing the aggregate and in a few places spalling (Image 8). There are a considerable number of patches with a white patching compound. This deterioration is no doubt accelerating and the exposed and rusting rebar represent a threat of significant damage. This surface needs to be repaired, building up any depressions caused by deteriorations or original casting, particularly areas around the exposed rebar.

There are down-lights suspended from the four corners of the southwest courtyard, which are wired with exposed insulated wiring (Image 8). The boxes and other exposed ferrous elements are rusting, and although the anchors are not exposed, it is reasonable to assume from other indications that they may be ferrous metal. The whole issue of exterior lights should be studied and an overall solution designed. Any fixtures in these locations should be attached with non ferrous connectors, properly isolated from the concrete.

It may become necessary at some point to patch the surfaces within the perforations and perhaps an integral drip at the edge could be design to allow water to drip clear of the concrete surface. The expansion joints between the individual slabs are now open to the weather and water coming through these joints runs down the ribs of the vaulting to a column. This open joint should be sealed in a manor that allows for movement, perhaps with a compressible rubber gasket.

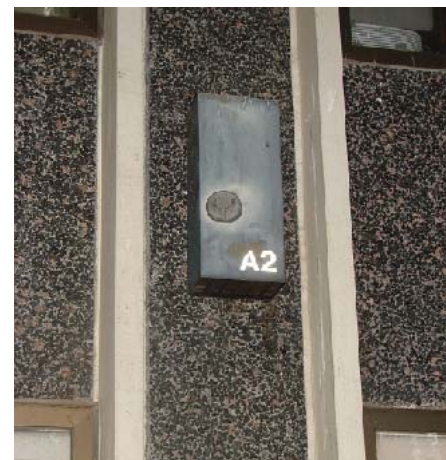
(Image 10)

Mounted on the exposed aggregate piers of are typical rectangular box wall sconce used through the campus (Image 10). These rectangular boxes are now painted a gray color, which appears to be their original finish. Although not dramatic, these geometrically simple, minimalist fixtures are part of the original appearance of the building, and where they have been replaced the new fixtures are conspicuous. These fixtures originally had both and up light and down light component, but now seemed to be fitted with incandescent spot pointed down.

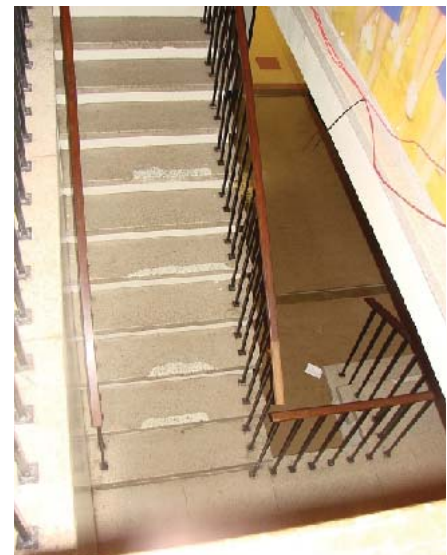
(Image 12)

The stair down to the basement level is an integral element of this space (Image 12). The treads are all the same buff colored terrazzo used in the floor. The balustrade is composed of 5/8" steel bar stock at 5-1/2" on center with a 1-3/4" square plate at the floor and a diminutive 1" x 2" wood handrail. There are some unfortunate repairs to the tread using a white terrazzo mix.

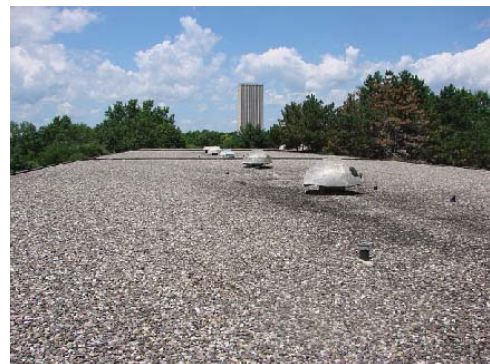
(Image 5)

This roof appears to be an EPDM membrane above tapered insulation and stone ballast above (Image 5). This roofing system encompasses not only the roofs above Seneca and Tuscarora, which are really one building, but the roof above the southwest courtyard. Although the roof above the occupied spaces appears to drain completely, there was standing water on the roof above the courtyard

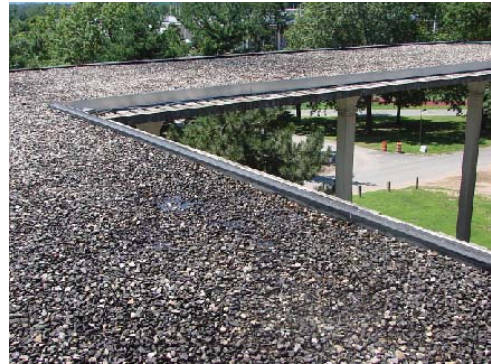
(Image 6)

on the day of inspection (Image 6). In many areas, pine needles, leaves and debris has accumulated at the outside curb indicating drainage from these areas is also incomplete or very slow. There is some deterioration at the edges of the filter fabric where it is exposed to the sun. This roof is near the end of its useful lifetime.

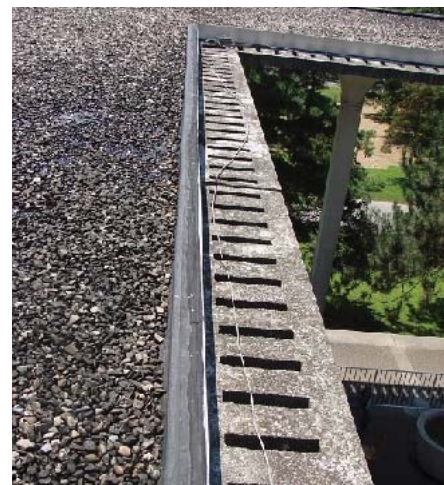
(Image 8)

There are down-lights mounted on the roof overhang at the four corners of the courtyard which are wired with exposed insulated wiring (see Image 8). The boxes and other exposed ferrous elements are rusting, and although the anchors are not exposed it is reasonable to assume from other indication that they may be ferrous metal.

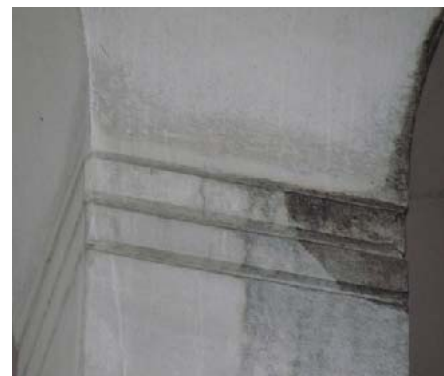
(Image 9)

There is now some staining and incipient deterioration in the columns capitals (Image 9). This open joint should be sealed in a manner that allows for movement, perhaps with a compressible rubber gasket.

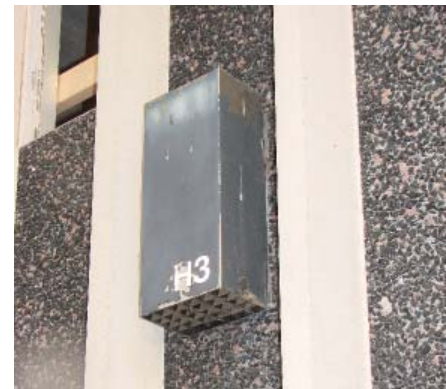
(Image 11)

There are typical rectangular box wall sconces mounted on the exposed aggregate piers. These rectangular boxes are now painted a gray color, which appears to be their original finish (Image 11). Although not dramatic, these geometrically simple minimalist fixtures are part of the original appearance of the building, and where they have been replaced the new fixtures are conspicuous (Image 12). These fixtures originally had both an up light and down light component, but now seemed to be fitted with incandescent spot pointed down.

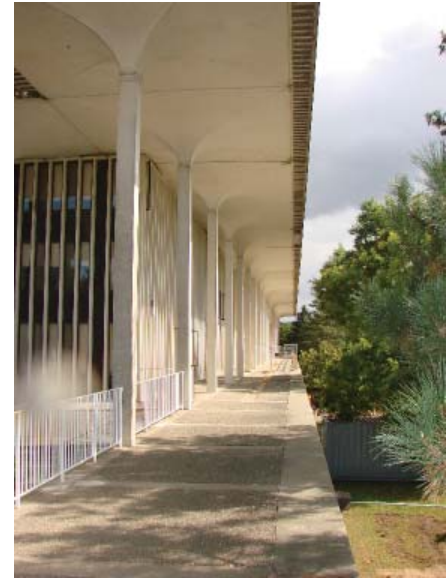
(Image 26)

quads. It should be noted that along the south side of this building there is a planter bed that has been completely abandoned (Image 26). Planting in this location could greatly soften the appearance of the buildings. The planter bed surrounding the courtyard was recently relined and replanted, however, not with the type of plant material that will spill over the edge as intended.

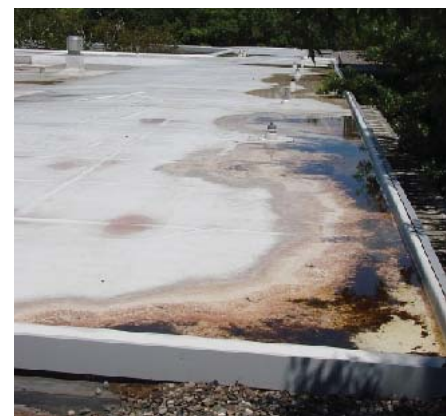
(Image 7)

Gently pitched flat roof with a modern TPO roofing membrane being installed c. 2000 over tapered insulation. There was some significant ponding of water on this roof, especially at the edges (Image 7). Although there are no indications the roof is leaking, this could be a problem when the membrane starts to age.

- Replacement roof over building footprint, walkways, monitor, and courtyards.
- Cover open expansion joints in perforated roof overhang.
- Treat top surface of perforated roof overhang with liquid membrane.

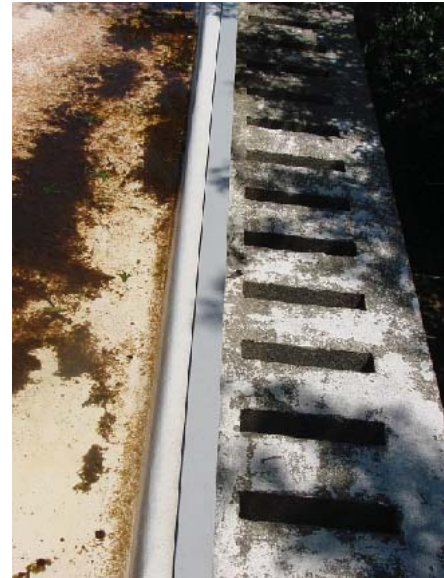
(Image 8)

The concrete roof slab extends beyond the drip edge of the roof and is exposed to the weather. This extension correspond the portion of the overhang outside of the flared capital (or vaulting), and the slab itself is perforated with a series of rectangles resolved as squares (each side equal to the long side of the rectangles) at the corners. Each perforation has a drip edge cast into the underside to avoid water staining on the underside of the slab. There is considerable erosion of the top surface of the slab on this building exposing the aggregate and in a few places where spalling (Image 8).

The expansion joints between the individual slabs are now open to the weather and water coming through these joints runs down the ribs of the vaulting to a column. This open joint should be sealed in a manor that allows for movement, perhaps with a compressible rubber gasket.

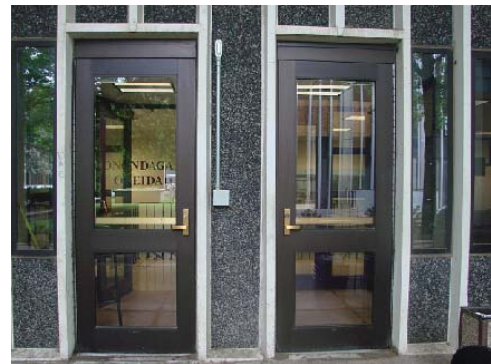
(Image 9)

The entrance doors at the central entry are modern aluminum doors. These doors have two rectangular lights with a horizontal lock rail and do not attempt to follow original design. They are also not quite as tall and there is a very thick frame at the top (Image 9). The doors are also a dark anodized aluminum as opposed to white, which seem more appropriate for the situation. Doors on the short sides are the typical white aluminum replacement door used throughout this quad.

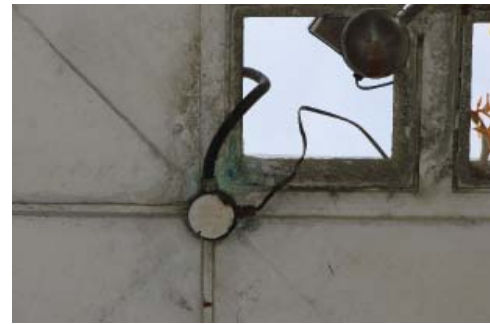
(Image 10)

Each of the corner courtyards were intended to have four of the saucer light fixtures. These have all been removed, however, in many cases the electrical feed for the replacement spotlights is connected to the original box (Image 10).

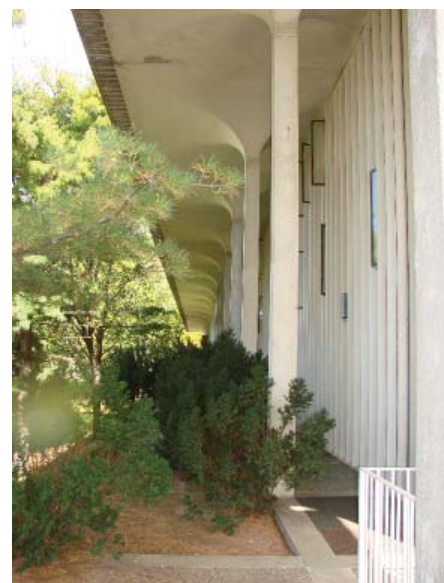
(Image 18)

The landscape, as with the Academic Podium, was an integral part of the dormitory quads. It should be noted that along the west side of this building there is a planter bed where the bushes have partially survived (Image 18), and it greatly softens the appearance of the buildings.

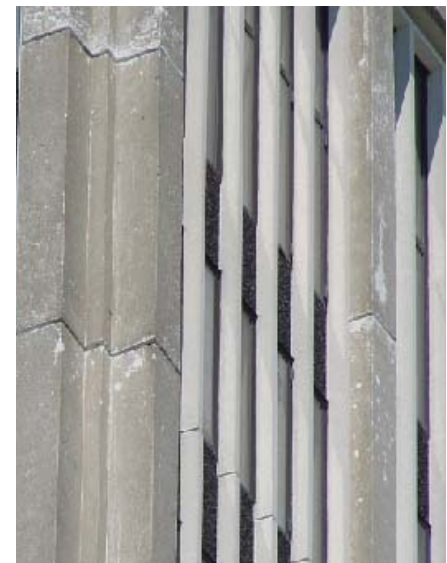
(Image 5)

There is considerable exterior surface weathering, particularly in the concrete piers. There are numerous small patches in a white patching mortar (Image 5), which varies a little with exposure. The precast elements are better but also show some weathering of surface finish. There is also sufficient moisture absorption to rust rebar placed close to

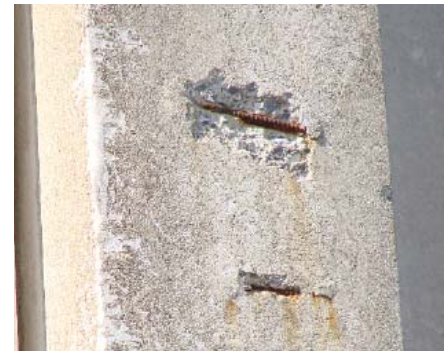
(Image 6)

the surface, and there are a number of cracks and surface spalling visible without careful inspection (Image 6).

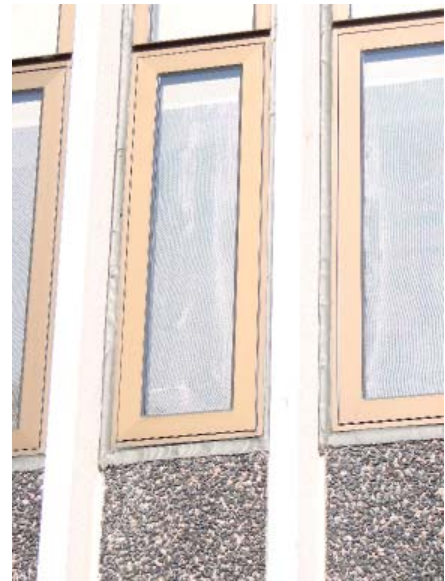
(Image 10)

All window sashes are single glazed in aluminum frames. These windows appear to have their original factory finish, and are generally in working order. Operable aluminum frame replacement windows were installed on the second floor in early 2008. These windows are a poor fit and the large caulked joints at the perimeters are visually and functionally unfortunate (Image 10).

The University has instituted a program of replacing these original single glazed units with an aluminum frame double glazed window unit, which has similar appearance; however, the sash installed here does not seem to be part of that program.

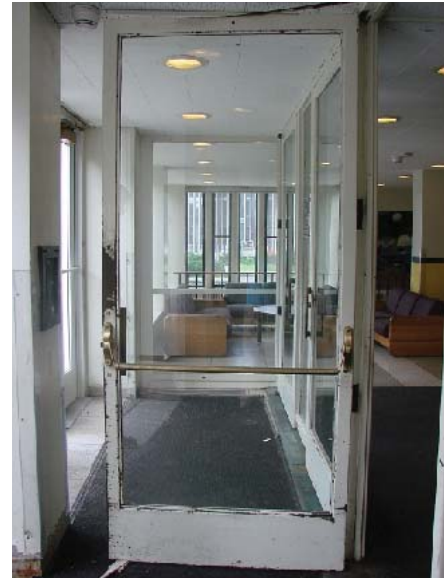
(Image 14)

This space is largely intact, but worn and in need of appropriate furniture. The lower portion of the steel doors have considerable rust and are badly in need of repainting and repair.

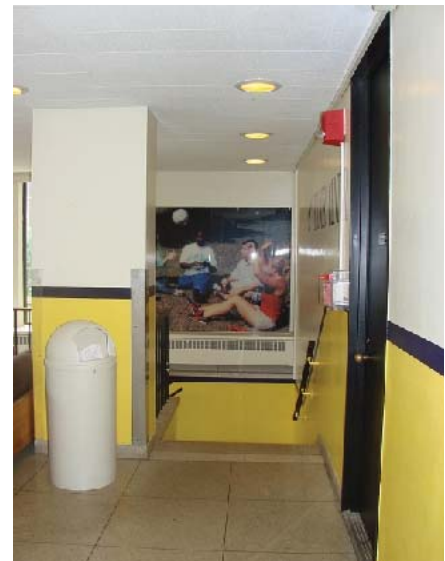
(Image 15)

The stair down to the basement level is an integral element of this space (Image 15). The treads are all the same buff colored terrazzo used in the floor. The balustrade is composed of 5/8" steel bar stock at 5-1/2" on center with a 1-3/4" square plate at the floor and a diminutive 1"x2" wood (walnut, mahogany?) handrail. There are some unfortunate repairs to the tread using a white terrazzo mix.

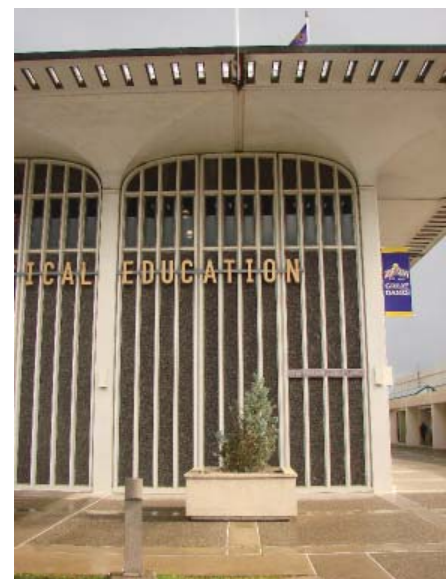
(Image 4)

The east and west facades are eight bays of typical panels (Image 4). The second and seventh bays of the east façade incorporate a pair of exit doors. The roof overhang defines the top of the façade when viewed from the plaza, however, the façade is taller and the wall extends past this level as a parapet. The top of the parapet is the actual level of the main roof to the building. The parapet is ringed with a series of flagpoles.

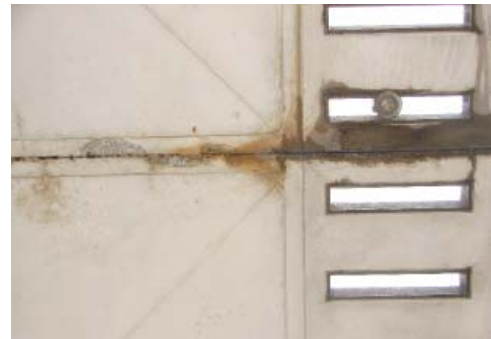
(Image 5)

underside of the roof slab overhang at many of the expansion joints between structural bays (Image 5). These joints that extend beyond the roof have not been maintained but allowed to deteriorate. These joints were intended to be filled and caulked. There is also some rust staining from moisture penetration within the body of the vaulting, which is indicative of roof leaks and will lead to spalling of the concrete. However, these may well predate the recent EPDM roof and may not be actively leaking.

- Fill all open expansion joints in roof overhang.
- Repair/replace caulk joint between paving and perimeter of building.
- Patch upper surface of roof overhang and coat with a liquid elastomeric roofing.

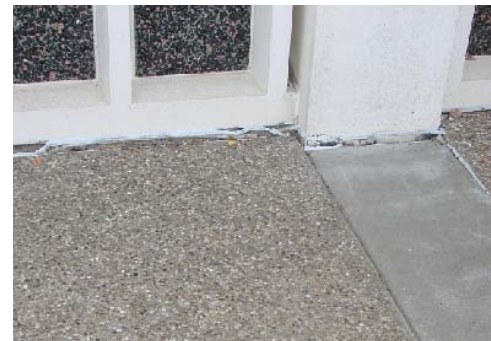
(Image 6)

There is settlement in the paving, presumably due to a lack of controlled surface water runoff. This settlement is most noticeable along the northern portion of the west elevation where the joint between the wall and the paving has opened exposing the backer rod (Image 6). There is also some scattered localized deterioration and some settlement and cracking in the slabs around the perimeter. It may be necessary to replace portions of the plaza and to add drains to prevent surface water from running back to the building.

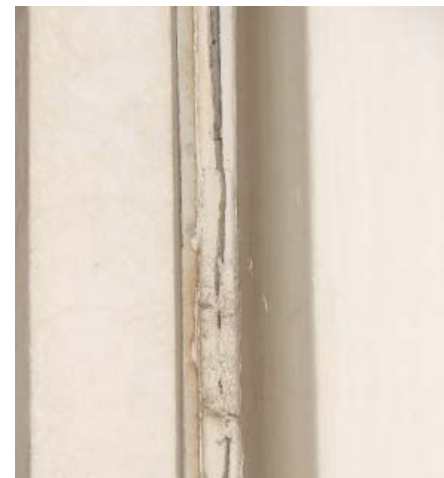
(Image 7)

The caulk joint between the building and plaza has been recently re-caulked, but the caulk has not bonded properly and the joint is now open almost the full perimeter of the building. Caulking between wall panels, the wall panels and concrete columns, and at the perimeter of the windows has not been maintained. The joints between the panels and the columns is often torn or not bonded on one side (Image 7).

- Replace caulked joints in elevation.
- Clean facades using low pressure wash of water.

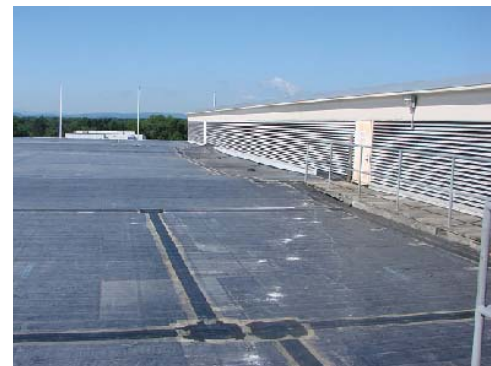
(Image 8)

The roof is a recent EPDM rubber roof (.060 Carlisle membrane) laid over tamped insulation (Image 8). The main roof is arranged in three levels: the lower level around the perimeter is the overhang for the terrace, the large raised area over the main gymnasium encompasses most of the building,

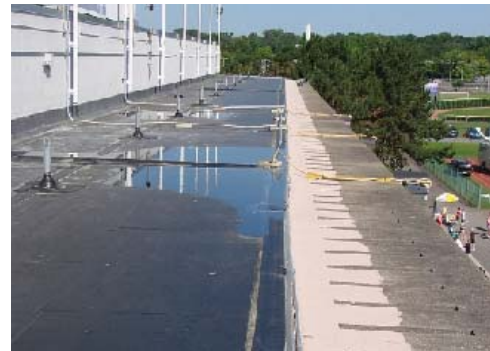
(Image 9)

and finally, the raised roof of the large mechanical monitor. This roof appears to be functioning well and there seems to be good positive drainage to the internal drains. There is some ponding along the outer edge on the lower walkway roof (Image 9), however, this is acceptable and in general, the workmanship on this roof is very good.

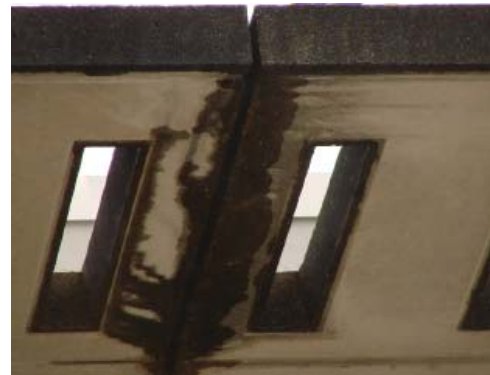
(Image 10)

There is significant staining and deterioration of the roof overhang (Image 10). A traditional drip edge at the outside edge would be visually unacceptable, so slow continued deterioration of the wash surfaces is inevitable.

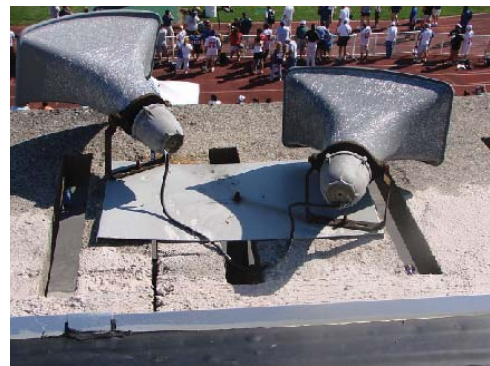
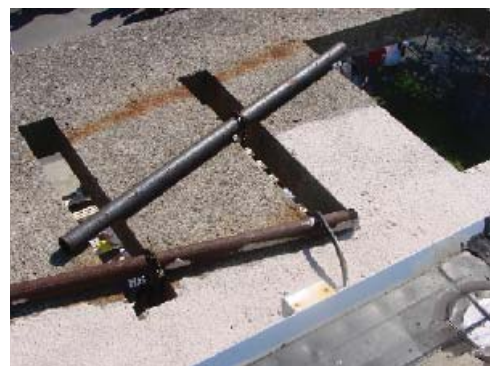
There are several down-lights suspended from galvanized channels and/or pipes, which are starting to rust. There are also speakers and lights mounted on the edge of the overhang, some using ferrous connectors, which are now rusting (Images 11 and 12). Every connector represents a potential problem, and all these added elements should be removed and a comprehensive system of improvements to the exterior lighting and sound system designed.

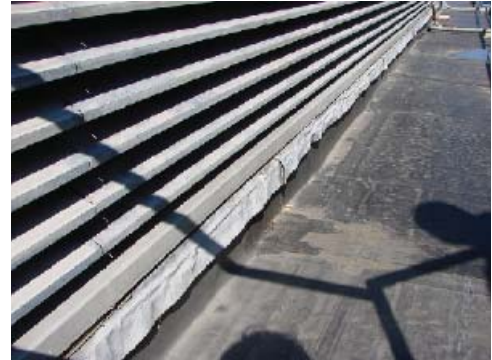
(Image 13)

There is a series of tie-backs around the lower roof, which are safety items added at the time of the EPDM roof. The large mechanical monitor is generally in good condition, however, the louvers could be painted. The original copper cap flashing at the base of the monitor was reused and the edge is now distorted and bent (Image 13). A replacement may involve removing the louvers. There is surface conduit to the added lights on the overhang.

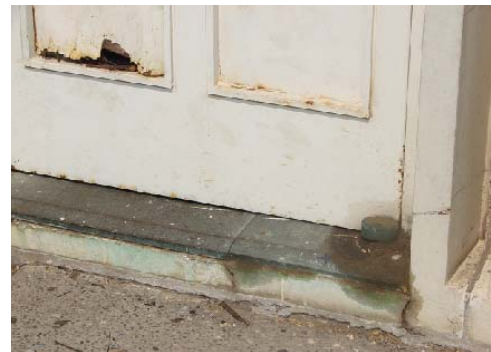
(Image 14)

There seems to be deterioration of the concrete under the sills with many of the anchoring screws now missing, and there is considerable water staining and some cracking of the concrete under the door (Image 14).

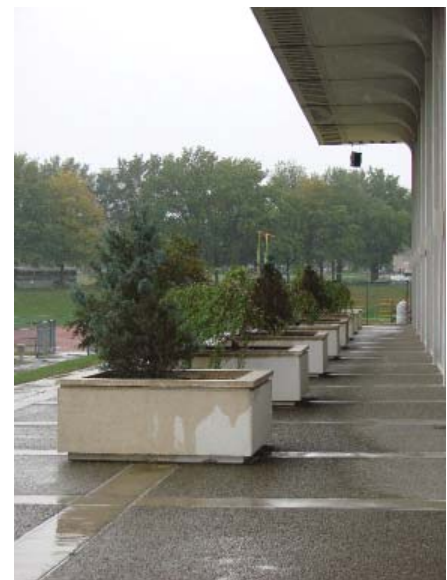
The precast concrete planters along the edges of the berm (Image 28) are no longer maintained as landscaped elements and many have been removed from the south and totally removed from the north sides. These were conceived as design elements of the building to both soften the rigid physical appearance and to use for dramatic night lighting of the campus.

The concrete paving is an integral design statement, however, there are many area of uneven settlement, particularly at the building's perimeter, some surface

weathering, and a lack of positive drainage away from the building. Like the podium water was controlled by very low slope in the paving, which even minor settlement disturbs. At some point, this paving will require replacement and at that time, a system of surface water drains should be stalled to help control runoff.
