**UNIVERSITY AT ALBANY
STATE UNIVERSITY OF NEW YORK**

**CAMPUS HERITAGE
PRESERVATION PLAN**

Mesick • Cohen • Wilson • Baker • Architects
388 Broadway Albany, NY 12207

April 2009

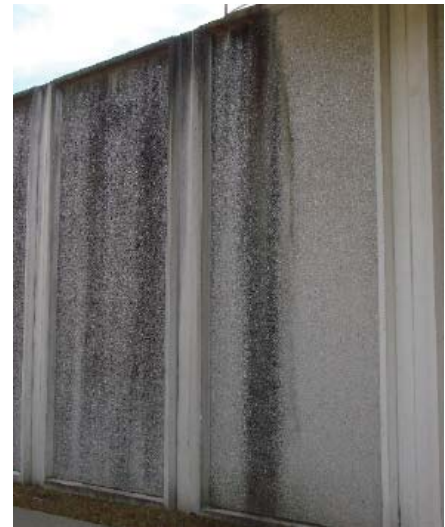
(Image 7)

The screen walls, which are not protected by the roof overhang, show considerable amounts of surface weathering and are much dirtier (Image 7). There is staining and streaking on overhang on all elevations. This is active and emulating from the open joints in the roof overhang, which may not have a roofing membrane (Image 8). This joint is typical and needs to be sealed with a gasket. Drainage flowing against the building rather than off the edge of the overhang is also problem in the northwest corner where the slab has been drilled and a down leader installed (Image 9 - this is not a well thought detail). The overhangs need to be dealt with comprehensively as part of a roofing project, and at a minimum these areas should be treated with a liquid elastomeric membrane. There may be a good deal of patching required to the concrete and perhaps a low pitch could be created to ensure proper flow.

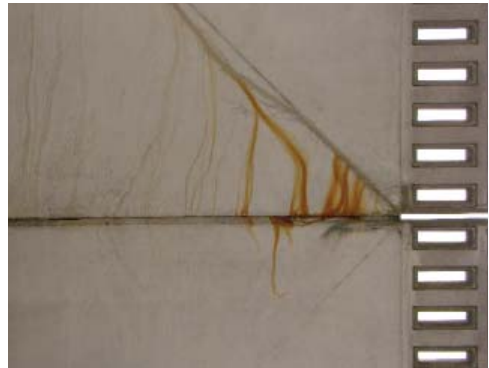
(Image 12)

There is staining and streaking on the ribs of the vaulted overhang on all elevations. This is active and emulating from the open joints in the roof overhang, not a failed roof membrane (Image 12). This open expansion joint is typical and needs to be sealed with a gasket.

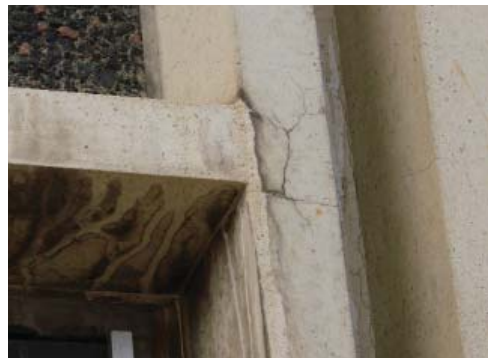
(Image 13)

The joint at the intersection of horizontal and vertical mullions above the doors and windows often has small vertical or horizontal hairline cracks, which may be from contraction rather than a structural problem, but should be monitored (Image 13). There are only two locations where deterioration is advanced at the southwest corner (Image 14) where spalling has occurred due to rusting rebar, and adjacent to the overhead door on the west façade (Image 15). This overhead door appears to have been cut in later and this panel appears to be later infill of an original opening and may simply not be of the same quality as the original construction.

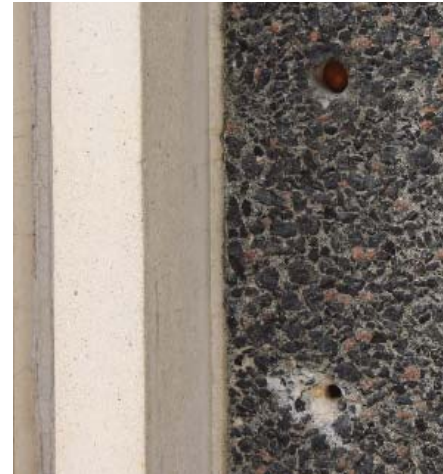
(Image 16)

Several panels on the east side of the building have been damaged by the rusting and expansion of steel bolts embedded into the walls, which were cut off flush rather than removed when the object they were supporting was removed (Image 16).

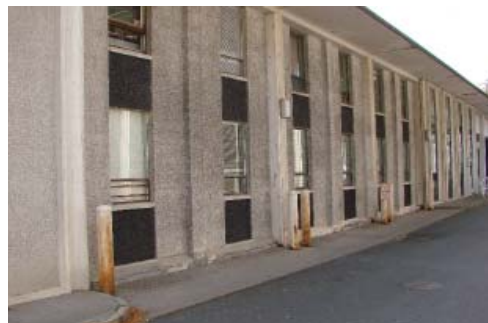
(Image 18)

This building originally functioned as the Commissary (Image 17), where much of the food preparation and cooking was centralized. The building has two loading docks, one for deliveries and a second for distribution of the prepared items to the many facilities serving food throughout the campus. The eastern loading dock has been filled in with concrete infill similar in appearance but not nearly so well executed (Image 18).

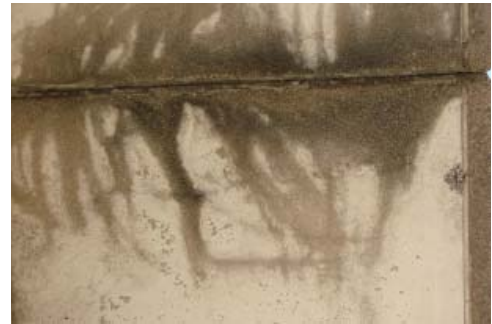
(Image 20)

There is staining and streaking on overhang on all elevations. This is active and emulating from the open joints in the roof overhang, which may not have a roofing membrane (Image 20). This joint is typical and needs to be sealed with a gasket.

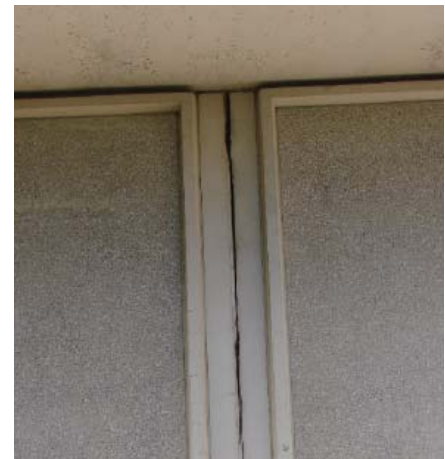
(Image 21)

There has been movement at the northeast corner where the panels appear to be tipping outward at the top either from settlement of the foundation or failure of the connections to the back up wall (Image 21). The anchoring system to the backup wall and structural frame should be examined to verify its condition.

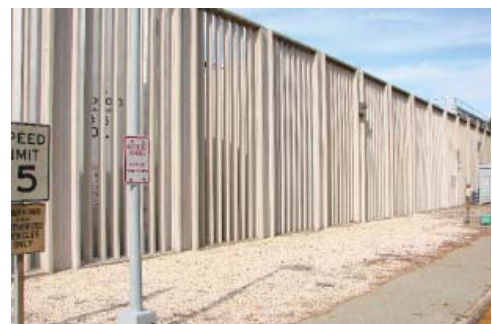
The eastern screen wall (Image 22) is generally in good condition. There is some loss of surface finish, but not as much as would be expected. The backside appears to have been coated with a thin parging, or cement paint, for protection. This coating is failing and needs to be renewed. Of greater concern is the movement indicated by

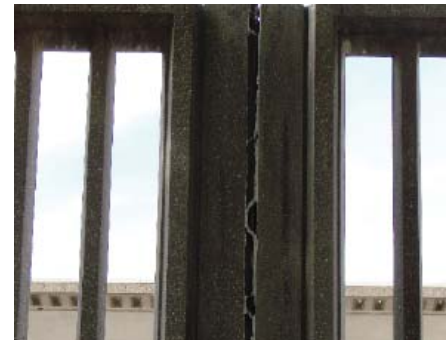
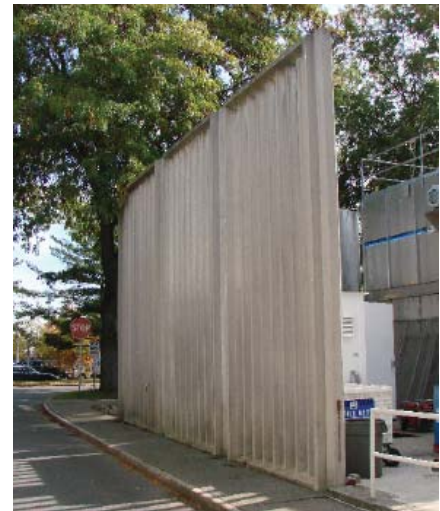
open caulk joints especially at the north side, which indicate that the return wall is tilting outward (Images 23 and 24). This tipping is either an indication of movement in the foundation or perhaps failure of the anchors attaching the panels to the foundation, and should be addressed quickly. The south return appears to be moving, but to a much lesser extent (Image 25). There are added connectors usually anchored with steel bolts, many of which are starting to rust and need to be systematically removed. A long term plan should include opening a joint to inspect connections between panels. A well was built around the oil storage tanks with an EPDM liner to contain spills. The excavation exposes the backside of the foundation for the screen and it is now covered with EPDM. However, the depth of the footing is unknown and if this area was not originally excavated may expose the footing to frost (original construction drawings do not appear to be in archives).

The construction drawings for the service building do not seem to be in the archives; however if they can be located the system for anchoring these wall to each other and to the foundation and the design of the foundation should be reviewed by a structural engineer.

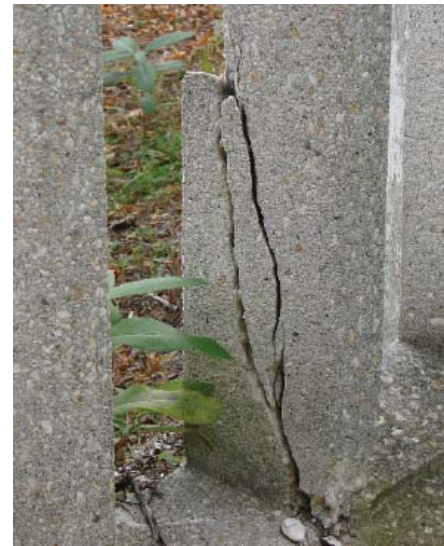
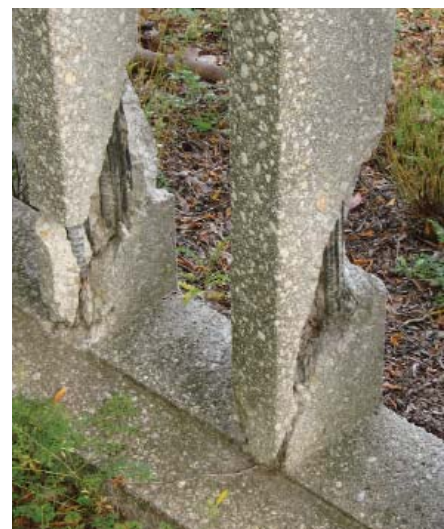
wall has numerous slats and sill members which have spalled or are deteriorating (Images 27 and 28). Again, on this screen, the original parging on the backside is deteriorating and needs to be renewed.

The walls are very slender and tall and unbraced except at the corners of the east screen wall. Additional bracing may well be required in the form of piers or columns on the backside. The parging on backside of all screens panels needs to be renewed. The panels on the northern portion of the screen wall need extensive patching, however, complete replacement may be a more prudent long term solution.

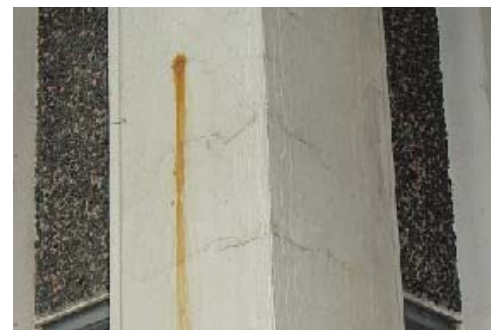
(Image 5)

There is some hairline cracking in the poured in place columns, and in a few instances is accompanied by rust stains from the embedded rebar (Image 5). The source of moisture here may be wind blown water or runoff through the open expansion joints in the overhang.

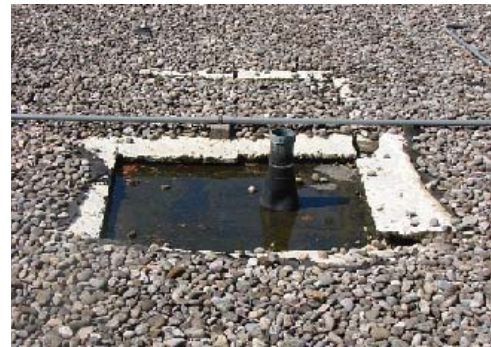
standing water visible around the roof vent (Image 7) were the insulation had been removed, and there is considerable growth of moss and grass under the overhang, which would indicate these areas are staying wet (Image 8). This condition is noticeable more advanced in the areas shaded by trees, which stay wet longer, and a number of shrubs over the roof surface. There is visible failure of the filter fabric and the insulation has several expansion cracks above which the filter fabric has torn and the ballast and dirt have been washed into.

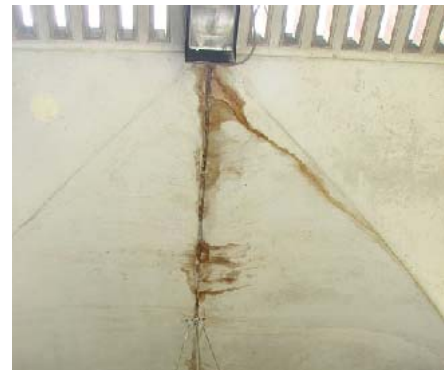
(Image 9)

At the east entry, the expansion joint between capitals is badly streaked with water stains. This could be from failure of the membrane at this location or it could be an outlet for a leak nearby (Image 9). The leak at the roof of the main entrance is of particular concern, where it appears to be rusting the anchors for the saucer light.

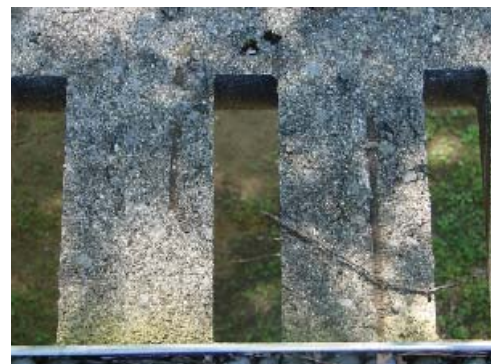
(Image 10)

There is considerable erosion of the top surface of the slab on this building exposing the aggregate and in a few places rebar that was placed to close to the surface of the concrete (Image 10). There are a number of patches with a white patching

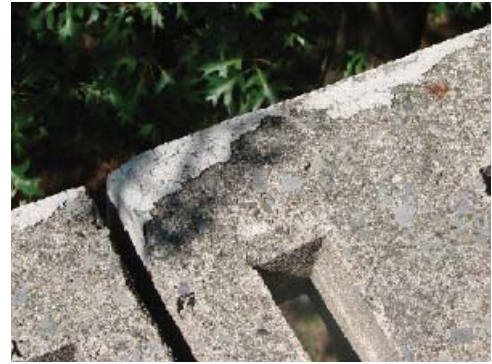
(Image 11)

compound (Image 11). This deterioration is no doubt accelerating and the exposed and rusting rebar represent a threat of significant damage.

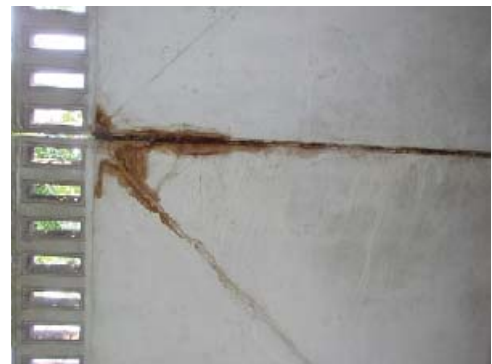
(Image 12)

Water running through open expansion joints in the roof overhang follows the ribs of the flared capitals back to the columns in the walkways (Image 12). Water on these concrete surfaces causes problems of deterioration of the surface of the concrete or can rust rebar embedded close to the surface causing spalling of the concrete. These joints need to be sealed; perhaps with a flexible rubber gasket.

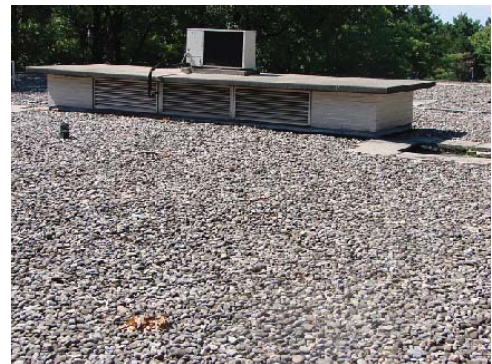
(Image 13)

There are two original roof monitors and several added air conditioning units as well as plumbing vents. The roof monitors, which are all original, are faced in brick incorporating aluminum grilles, and have concrete roof slabs (Image 13). These roof slabs are starting to weather and protecting them

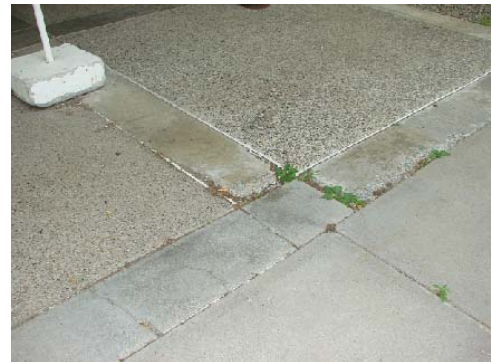
(Image 14)

There is significant settlement in the paving at the front entry, presumably due to surface water runoff (Image 14). There is also some scattered localized deterioration and some settlement and cracking in the grade beams around the perimeter. It appears that the construction of the new dormitories to the north has altered the surface drainage at the northwest corner of the building. The surface water is running over the sidewalk and against the building.

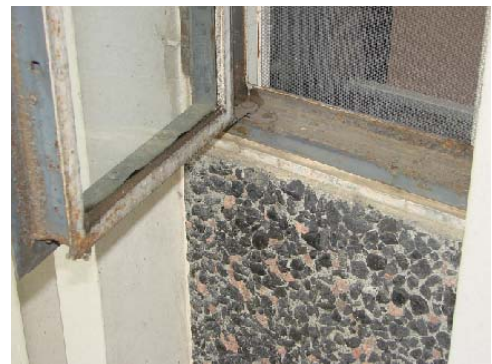
The Windows are all single glazed steel sash and alternate between fixed and operable casement sash. All sashes on the facades are the entire width of the exposed aggregate panels and are fitted with a caulked joint between the sash and concrete rib. The sill and lower portions of frame are rusting (Image 15) and the perimeter caulking

has not been maintained. These windows appear to have their original factory finish, and need to be repainted. The perimeter caulking needs to be replaced as well.

- Clean facades using low pressure wash of water.
- Replace all caulked joints.
- Replace windows for energy conservation with double glazed sash of similar design and color to original steel sash.
- Replace doors with double glazed sash of similar design to original steel doors, maintaining frameless appearance and original width between concrete ribs.
- Paint exterior concrete elements except exposed aggregate panels.

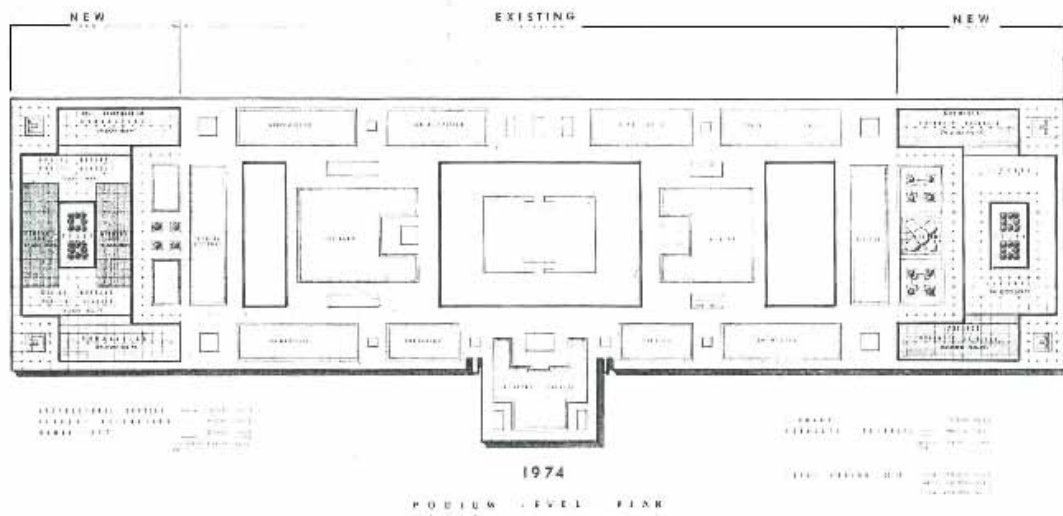
Stone's plan for the expansion of the east and west ends of the Academic Podium from the 1974 Comprehensive Site Plan Updating the State University of New York at Albany (1968).

Although the construction of the Life Science Building eliminated the possibility of carrying out Stone's expansion plan for the east end, the possibility still exists for the west end and this should be taken into consideration when planning for any additions to the site.

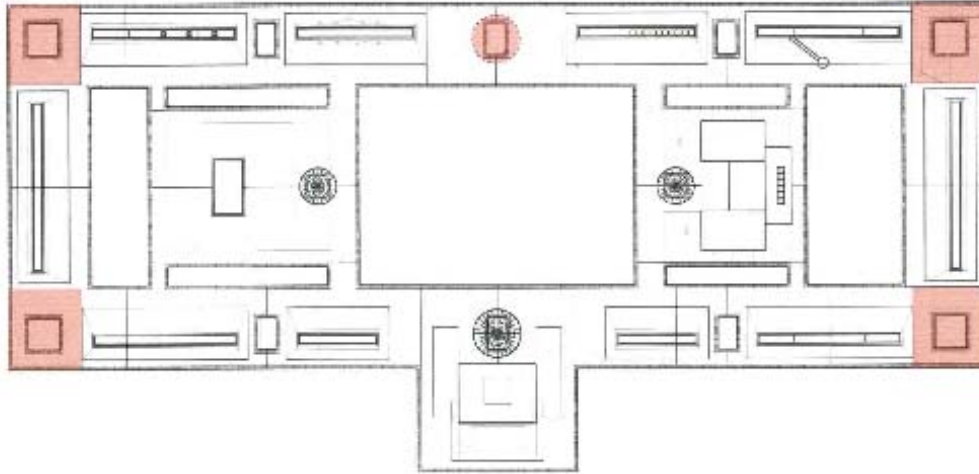
Podium roof plan showing locations for the proposed skylight domes from the Robert Siegel Podium Skylight Dome report.

The installation of skylight domes will not only provide shelter for the areas below, but will also protect and prolong the life of the stairs. Since the original drawings and details for the skylight domes exist in the SUNY archives, it is recommended that Stone's design be used if skylights are installed on the Podium.
