# Condition Assessment Report

**Stormwater, Sanitary  
Sewer, Water and  
Irrigation Systems**

**University at Albany  
(Uptown Campus)**

**SUCF Project No. 01834**

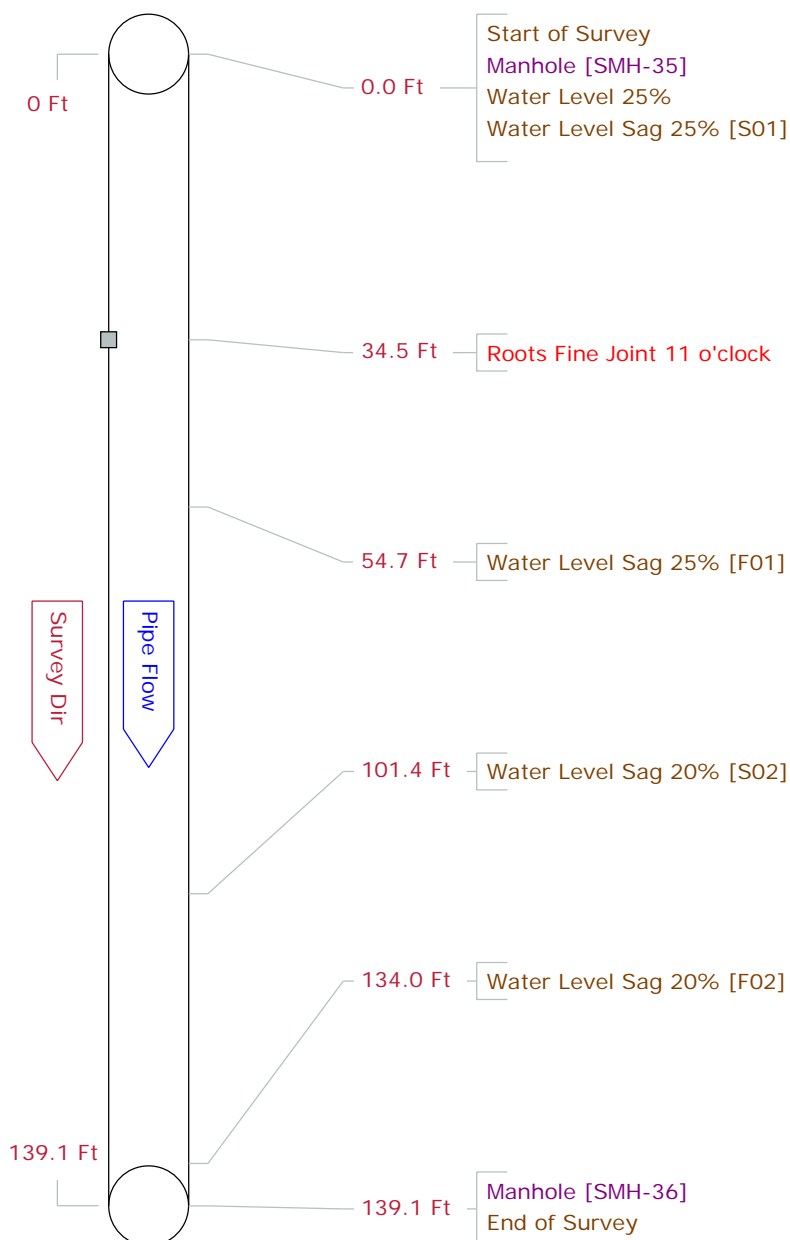
<b>Setup</b> 1	<b>Surveyor</b> WP	<b>Certificate #</b> T-001-002	<b>System Owner</b> ALBANY UNIVERSITY
<b>Drainage</b> CAMPUS GRC	<b>Survey Customer</b> WOODARD & CURRAN		
<b>P/O #</b>	<b>Date</b> 2007/07/18	<b>Time</b> 10:47	<b>Street</b> SUNY OF ALBANY
<b>Locality</b> CAMPUS GROUNDS	<b>Further location details</b>		
<b>Start</b> SMH-35	<b>Rim to invert</b>	<b>Grade to invert</b>	<b>Rim to grade</b> <b>Ft</b>
<b>Finish</b> SMH-36	<b>Rim to invert</b>	<b>Grade to invert</b>	<b>Rim to grade</b> <b>Ft</b>
<b>Use</b> Sanitary	<b>Direction</b> Downstream	<b>Flow control</b> Not Controlled	<b>Tape/Media #</b> WP-01
<b>Shape</b> Circular	<b>Height</b> 10	<b>Width</b> ins	<b>Preclean</b> J <b>Year Cleaned</b>
<b>Material</b> Vitrified Clay Pipe	<b>Joint length</b> <b>Ft</b>	<b>Total length</b> 139.1 <b>Ft</b>	<b>Length Surveyed</b> 139.10
<b>Lining</b>	<b>Year laid</b>	<b>Year rehabilitated</b>	<b>Weather</b> Damp

<b>Purpose</b> Infiltration/Inflow Investigation	<b>Cat</b>		
<b>Additional info</b>		<b>Structural</b>	<b>O&amp;M</b> <b>Constructional</b>
<b>Location</b> Light Highway		<b>Miscellaneous</b>	<b>Hydraulic</b>

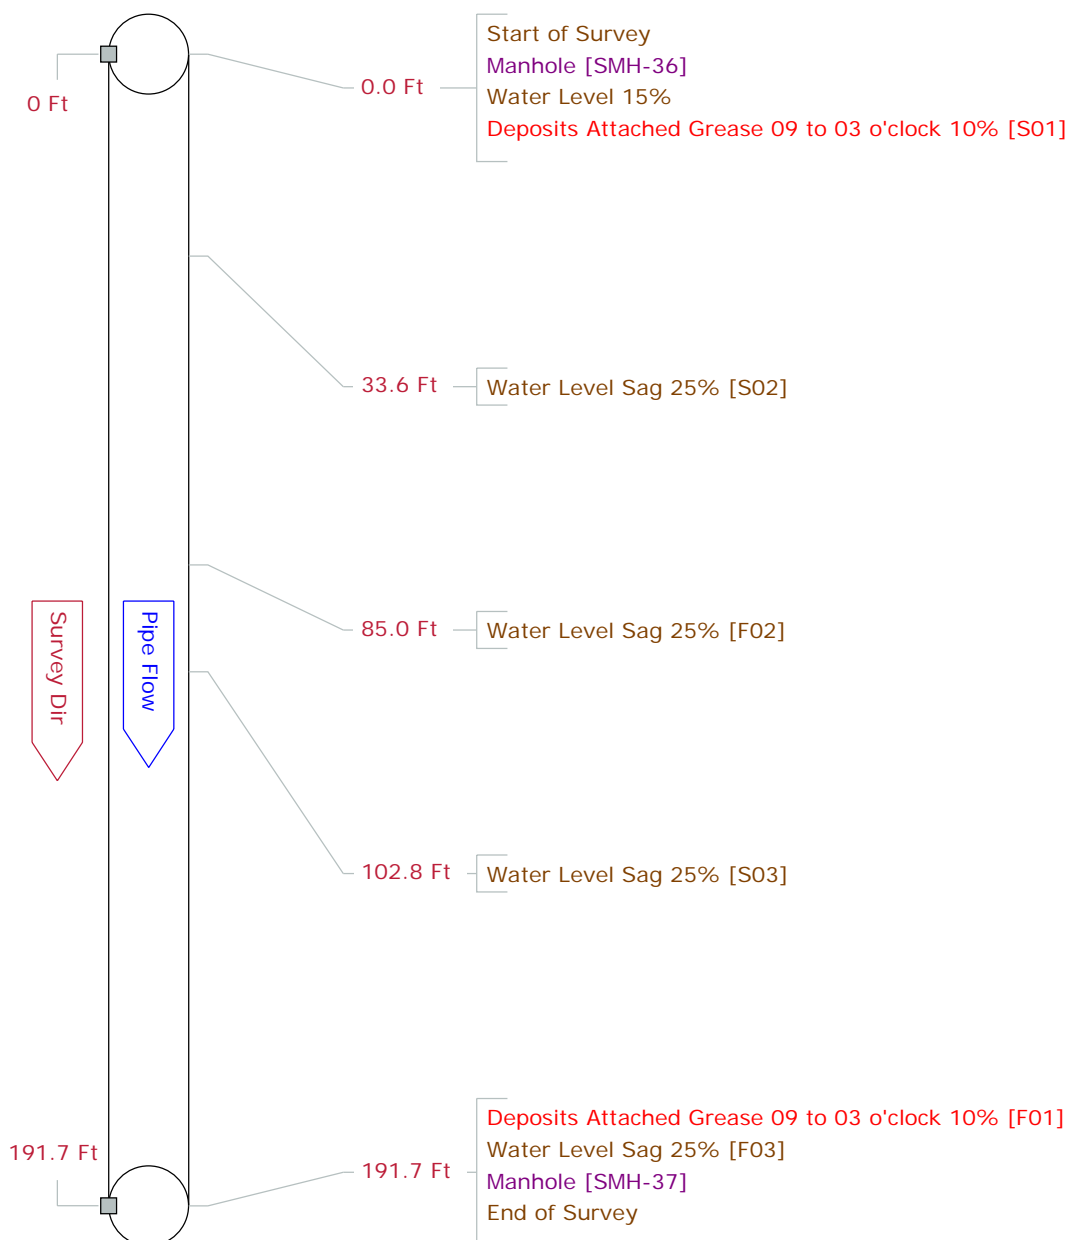
# Pipe Graphic Report of PLR SMH-36 X for WOODARD & CURRAN

<b>Setup</b> 2	<b>Surveyor</b> WP	<b>Certificate #</b> T-001-002	<b>System Owner</b> ALBANY UNIVERSITY
<b>Drainage</b> CAMPUS GRC	<b>Survey Customer</b> WOODARD & CURRAN		
<b>P/O #</b>	<b>Date</b> 2007/07/18	<b>Time</b> 10:59	<b>Street</b> SUNY OF ALBANY
<b>Locality</b> CAMPUS GROUNDS	<b>Further location details</b>		
<b>Start</b> SMH-36	<b>Rim to invert</b>	<b>Grade to invert</b>	<b>Rim to grade</b> <b>Ft</b>
<b>Finish</b> SMH-37	<b>Rim to invert</b>	<b>Grade to invert</b>	<b>Rim to grade</b> <b>Ft</b>
<b>Use</b> Sanitary	<b>Direction</b> Downstream	<b>Flow control</b> Not Controlled	<b>Tape/Media #</b> WP-01
<b>Shape</b> Circular	<b>Height</b> 10	<b>Width</b> ins	<b>Preclean</b> J <b>Year Cleaned</b>
<b>Material</b> Vitrified Clay Pipe	<b>Joint length</b> <b>Ft</b>	<b>Total length</b> 191.7 <b>Ft</b>	<b>Length Surveyed</b> 191.70
<b>Lining</b>	<b>Year laid</b>	<b>Year rehabilitated</b>	<b>Weather</b> Damp

<b>Purpose</b> Infiltration/Inflow Investigation	<b>Cat</b>		
<b>Additional info</b>		<b>Structural</b>	<b>O&amp;M</b> <b>Constructional</b>
<b>Location</b> Light Highway		<b>Miscellaneous</b>	<b>Hydraulic</b>

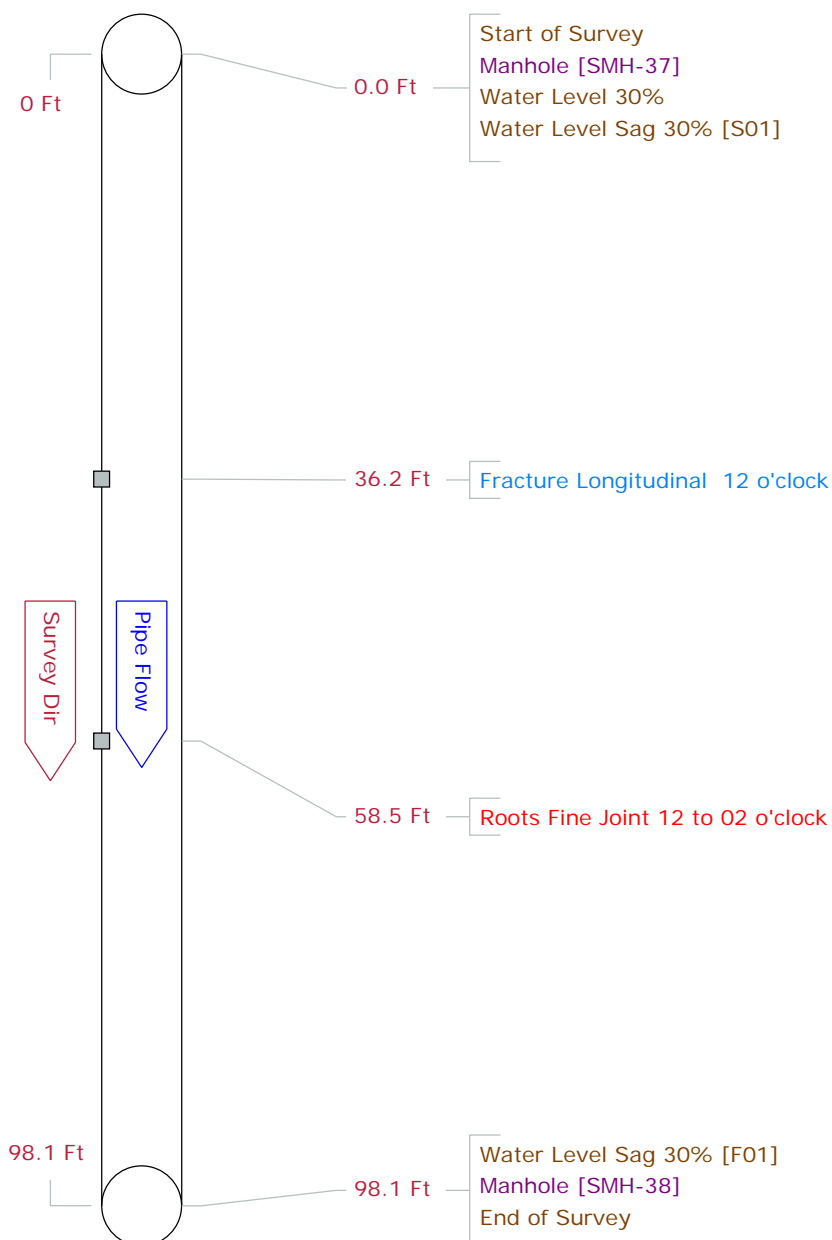
# Pipe Graphic Report of PLR SMH-37 X for WOODARD & CURRAN

<b>Setup</b> 3	<b>Surveyor</b> WP	<b>Certificate #</b> T-001-002	<b>System Owner</b> ALBANY UNIVERSITY
<b>Drainage</b> CAMPUS GRC	<b>Survey Customer</b> WOODARD & CURRAN		
<b>P/O #</b>	<b>Date</b> 2007/07/18	<b>Time</b> 11:07	<b>Street</b> SUNY OF ALBANY
<b>Locality</b> CAMPUS GROUNDS	<b>Further location details</b>		
<b>Start</b> SMH-37	<b>Rim to invert</b>	<b>Grade to invert</b>	<b>Rim to grade</b> <b>Ft</b>
<b>Finish</b> SMH-38	<b>Rim to invert</b>	<b>Grade to invert</b>	<b>Rim to grade</b> <b>Ft</b>
<b>Use</b> Sanitary	<b>Direction</b> Downstream	<b>Flow control</b> Not Controlled	<b>Tape/Media #</b> WP-01
<b>Shape</b> Circular	<b>Height</b> 10	<b>Width</b> ins	<b>Preclean</b> J <b>Year Cleaned</b>
<b>Material</b> Vitrified Clay Pipe	<b>Joint length</b> <b>Ft</b>	<b>Total length</b> 98.1 <b>Ft</b>	<b>Length Surveyed</b> 98.10
<b>Lining</b>	<b>Year laid</b>	<b>Year rehabilitated</b>	<b>Weather</b> Damp

<b>Purpose</b> Infiltration/Inflow Investigation	<b>Cat</b>		
<b>Additional info</b>		<b>Structural</b>	<b>O&amp;M</b> <b>Constructional</b>
<b>Location</b> Light Highway		<b>Miscellaneous</b>	<b>Hydraulic</b>

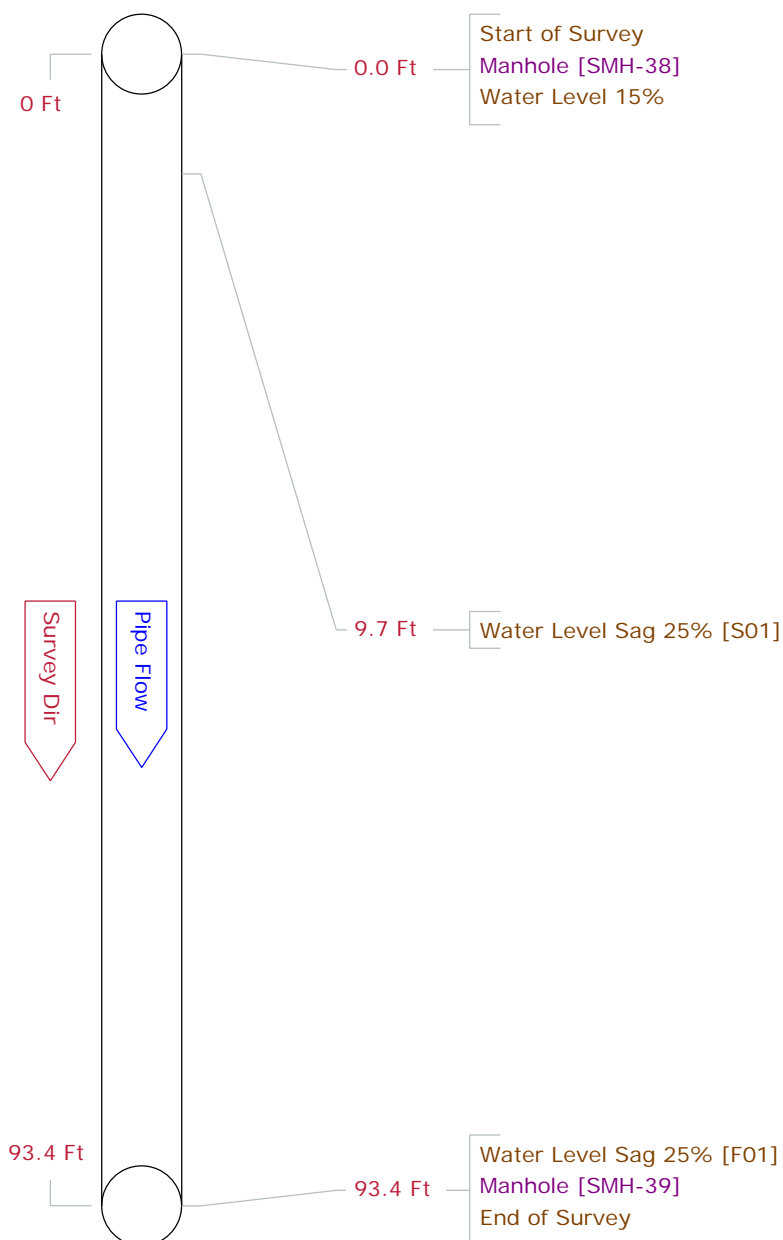
# Pipe Graphic Report of PLR SMH-38 X for WOODARD & CURRAN

<b>Setup</b> 4	<b>Surveyor</b> WP	<b>Certificate #</b> T-001-002	<b>System Owner</b> ALBANY UNIVERSITY
<b>Drainage</b> CAMPUS GRC	<b>Survey Customer</b> WOODARD & CURRAN		
<b>P/O #</b>	<b>Date</b> 2007/07/18	<b>Time</b> 11:13	<b>Street</b> SUNY OF ALBANY
<b>Locality</b> CAMPUS GROUNDS	<b>Further location details</b>		
<b>Start</b> SMH-38	<b>Rim to invert</b>	<b>Grade to invert</b>	<b>Rim to grade</b> <b>Ft</b>
<b>Finish</b> SMH-39	<b>Rim to invert</b>	<b>Grade to invert</b>	<b>Rim to grade</b> <b>Ft</b>
<b>Use</b> Sanitary	<b>Direction</b> Downstream	<b>Flow control</b> Not Controlled	<b>Tape/Media #</b> WP-01
<b>Shape</b> Circular	<b>Height</b> 10	<b>Width</b> ins	<b>Preclean</b> J <b>Year Cleaned</b>
<b>Material</b> Vitrified Clay Pipe	<b>Joint length</b> <b>Ft</b>	<b>Total length</b> 93.4 <b>Ft</b>	<b>Length Surveyed</b> 93.40
<b>Lining</b>	<b>Year laid</b>	<b>Year rehabilitated</b>	<b>Weather</b> Damp

<b>Purpose</b> Infiltration/Inflow Investigation	<b>Cat</b>		
<b>Additional info</b>		<b>Structural</b>	<b>O&amp;M</b> <b>Constructional</b>
<b>Location</b> Light Highway		<b>Miscellaneous</b>	<b>Hydraulic</b>

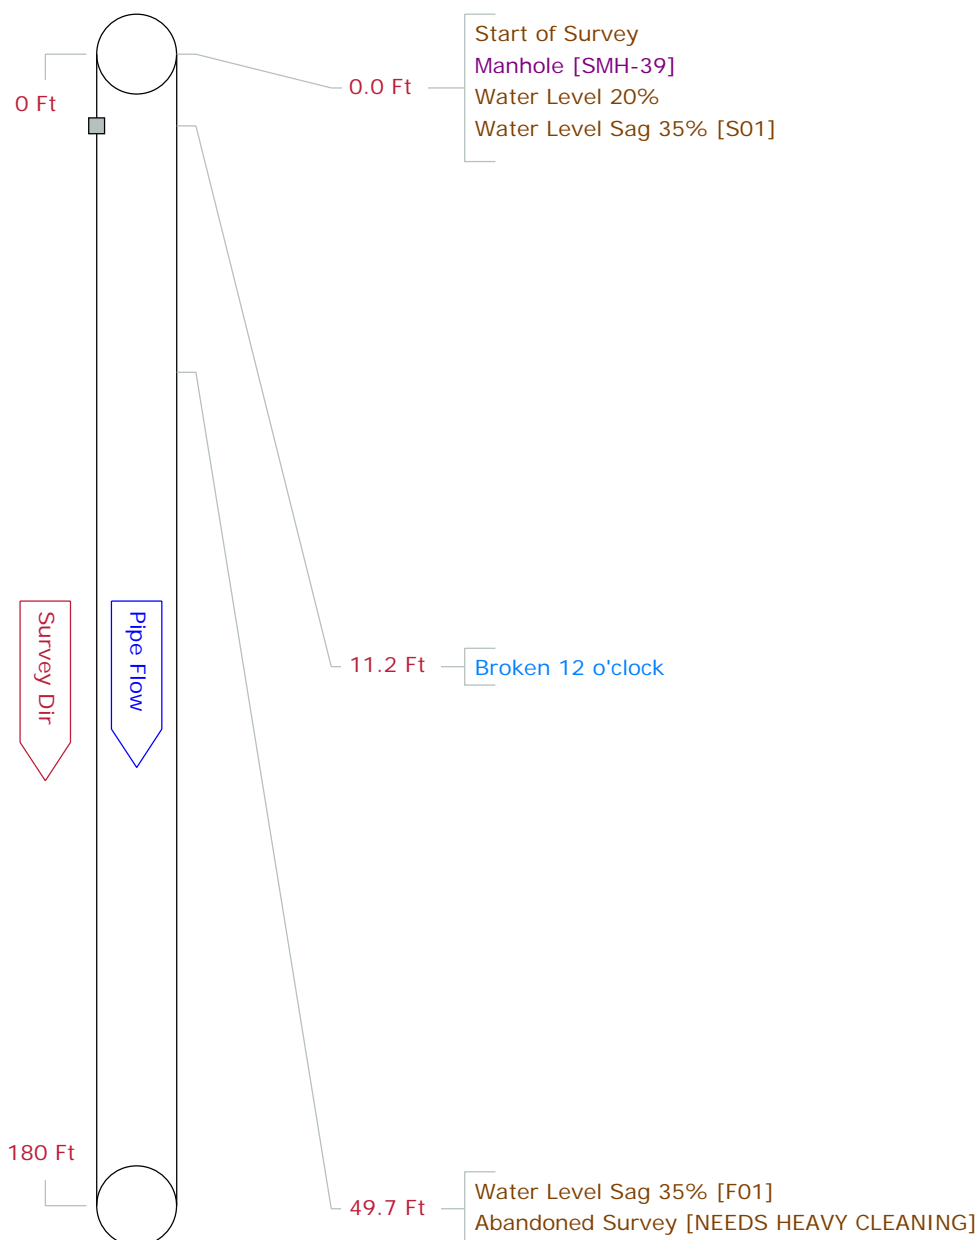
# Pipe Graphic Report of PLR SMH-39 X for WOODARD & CURRAN

<b>Setup</b> 5	<b>Surveyor</b> WP	<b>Certificate #</b> T-001-002	<b>System Owner</b> ALBANY UNIVERSITY
<b>Drainage</b> CAMPUS GRC	<b>Survey Customer</b> WOODARD & CURRAN		
<b>P/O #</b>	<b>Date</b> 2007/07/18	<b>Time</b> 2:27	<b>Street</b> SUNY OF ALBANY
<b>Locality</b> CAMPUS GROUNDS	<b>Further location details</b>		
<b>Start</b> SMH-39	<b>Rim to invert</b>	<b>Grade to invert</b>	<b>Rim to grade</b> <b>Ft</b>
<b>Finish</b> SMH-82	<b>Rim to invert</b>	<b>Grade to invert</b>	<b>Rim to grade</b> <b>Ft</b>
<b>Use</b> Sanitary	<b>Direction</b> Downstream	<b>Flow control</b> Not Controlled	<b>Tape/Media #</b> WP-01
<b>Shape</b> Circular	<b>Height</b> 12	<b>Width</b> ins	<b>Preclean</b> J <b>Year Cleaned</b>
<b>Material</b> Vitrified Clay Pipe	<b>Joint length</b> <b>Ft</b>	<b>Total length</b> 180.0 <b>Ft</b>	<b>Length Surveyed</b> 49.70
<b>Lining</b>	<b>Year laid</b>	<b>Year rehabilitated</b>	<b>Weather</b> Damp

<b>Purpose</b> Infiltration/Inflow Investigation	<b>Cat</b>		
<b>Additional info</b>		<b>Structural</b>	<b>O&amp;M</b> <b>Constructional</b>
<b>Location</b> Light Highway		<b>Miscellaneous</b>	<b>Hydraulic</b>

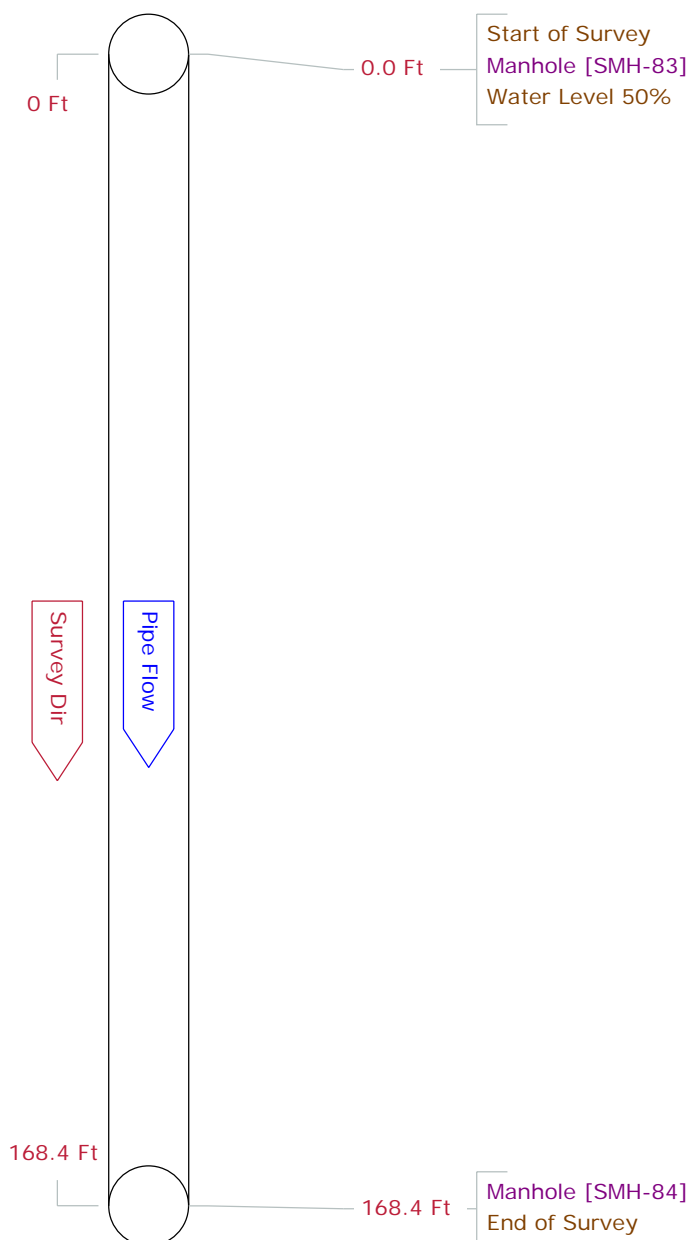
# Pipe Graphic Report of PLR SMH-83 X for WOODARD & CURRAN

<b>Setup</b> 8	<b>Surveyor</b> WP	<b>Certificate #</b> T-001-002	<b>System Owner</b> ALBANY UNIVERSITY
<b>Drainage</b> CAMPUS GRC	<b>Survey Customer</b> WOODARD & CURRAN		
<b>P/O #</b>	<b>Date</b> 2007/07/19	<b>Time</b> 10:05	<b>Street</b> SUNY OF ALBANY
<b>Locality</b> CAMPUS GROUNDS	<b>Further location details</b>		
<b>Start</b> SMH-83	<b>Rim to invert</b>	<b>Grade to invert</b>	<b>Rim to grade</b> <b>Ft</b>
<b>Finish</b> SMH-84	<b>Rim to invert</b>	<b>Grade to invert</b>	<b>Rim to grade</b> <b>Ft</b>
<b>Use</b> Sanitary	<b>Direction</b> Downstream	<b>Flow control</b> Not Controlled	<b>Tape/Media #</b> WP-01
<b>Shape</b> Circular	<b>Height</b> 12	<b>Width</b> ins	<b>Preclean</b> J <b>Year Cleaned</b>
<b>Material</b> Vitrified Clay Pipe	<b>Joint length</b> <b>Ft</b>	<b>Total length</b> 168.4 <b>Ft</b>	<b>Length Surveyed</b> 168.40
<b>Lining</b>	<b>Year laid</b>	<b>Year rehabilitated</b>	<b>Weather</b> Damp

<b>Purpose</b> Infiltration/Inflow Investigation	<b>Cat</b>		
<b>Additional info</b>		<b>Structural</b>	<b>O&amp;M</b> <b>Constructional</b>
<b>Location</b> Light Highway		<b>Miscellaneous</b>	<b>Hydraulic</b>

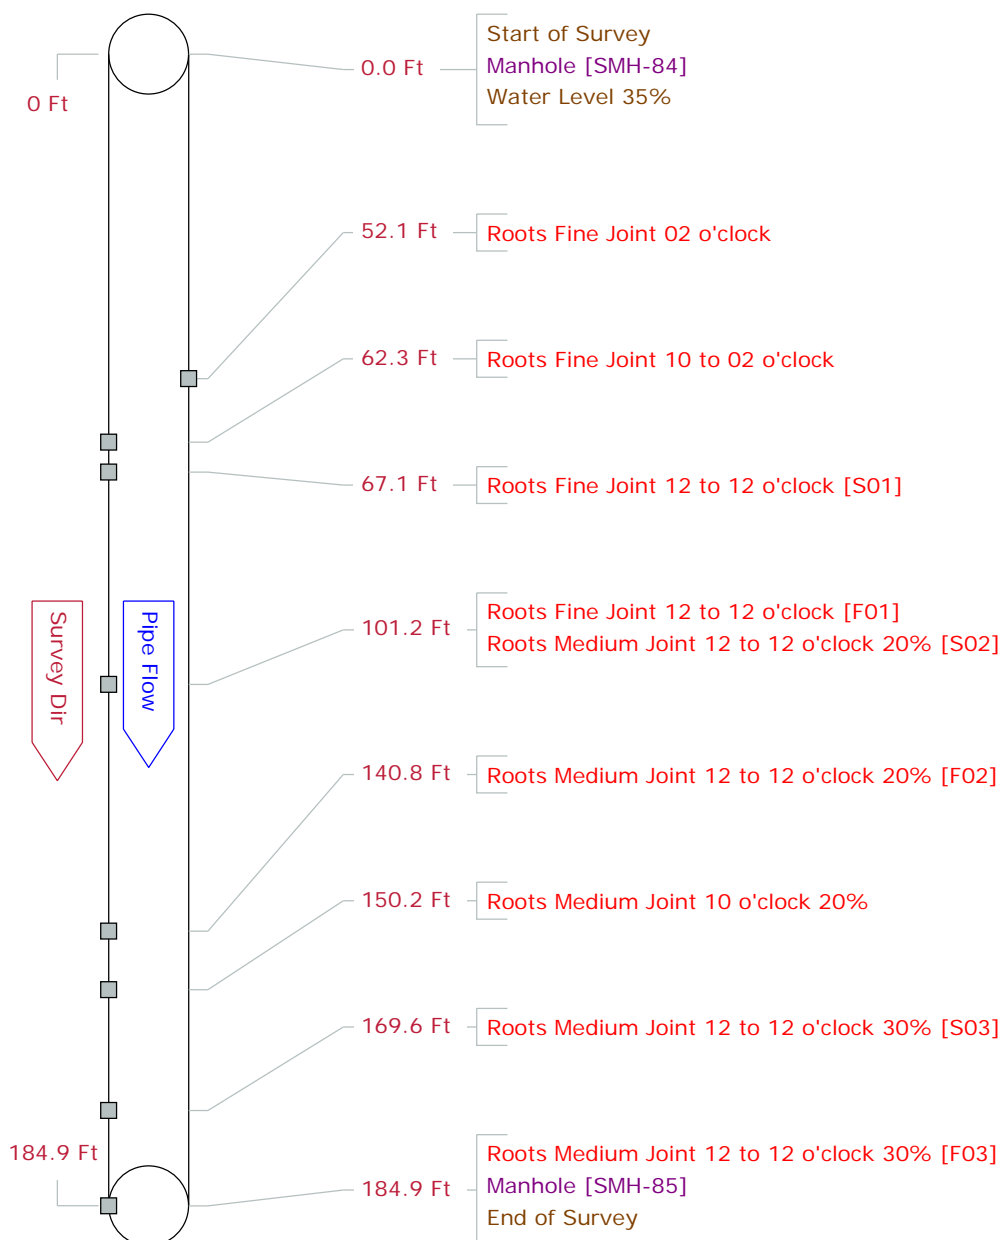
# Pipe Graphic Report of PLR SMH-84 X for WOODARD & CURRAN

<b>Setup</b> 9	<b>Surveyor</b> WP	<b>Certificate #</b> T-001-002	<b>System Owner</b> ALBANY UNIVERSITY
<b>Drainage</b> CAMPUS GRC	<b>Survey Customer</b> WOODARD & CURRAN		
<b>P/O #</b>	<b>Date</b> 2007/07/19	<b>Time</b> 10:19	<b>Street</b> SUNY OF ALBANY
<b>Locality</b> CAMPUS GROUNDS	<b>Further location details</b>		
<b>Start</b> SMH-84	<b>Rim to invert</b>	<b>Grade to invert</b>	<b>Rim to grade</b> <b>Ft</b>
<b>Finish</b> SMH-85	<b>Rim to invert</b>	<b>Grade to invert</b>	<b>Rim to grade</b> <b>Ft</b>
<b>Use</b> Sanitary	<b>Direction</b> Downstream	<b>Flow control</b> Not Controlled	<b>Tape/Media #</b> WP-01
<b>Shape</b> Circular	<b>Height</b> 12	<b>Width</b> ins	<b>Preclean</b> J <b>Year Cleaned</b>
<b>Material</b> Vitrified Clay Pipe	<b>Joint length</b> <b>Ft</b>	<b>Total length</b> 184.9 <b>Ft</b>	<b>Length Surveyed</b> 184.90
<b>Lining</b>	<b>Year laid</b>	<b>Year rehabilitated</b>	<b>Weather</b> Damp

<b>Purpose</b> Infiltration/Inflow Investigation	<b>Cat</b>		
<b>Additional info</b>		<b>Structural</b>	<b>O&amp;M</b>
<b>Location</b> Light Highway		<b>Miscellaneous</b>	<b>Hydraulic</b>
		<b>Constructional</b>

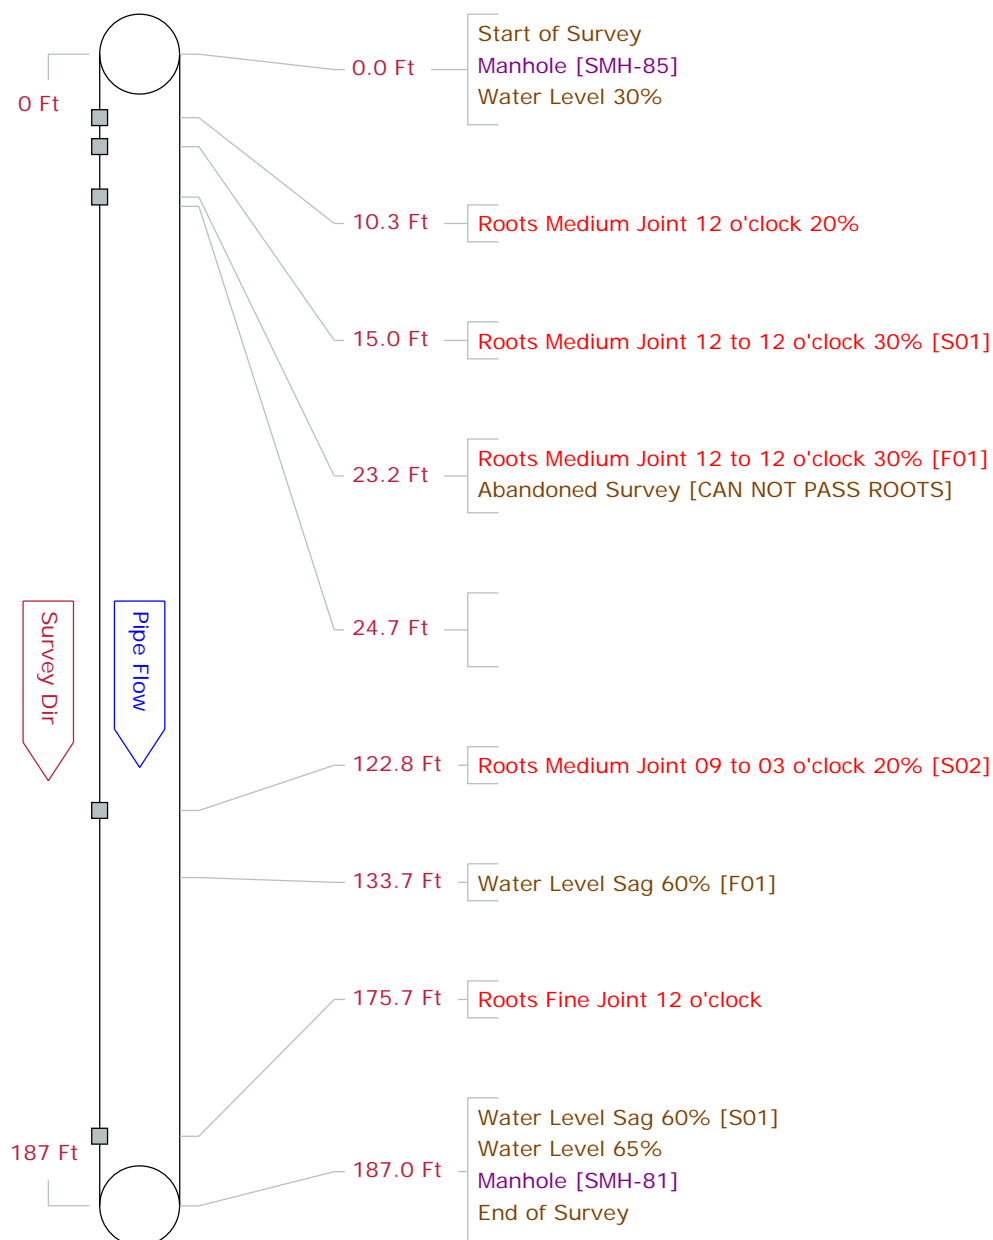
# Pipe Graphic Report of PLR SMH-85 X for WOODARD & CURRAN

<b>Setup</b>	10/11	<b>Surveyor</b>	WP	<b>Certificate #</b>	T-001-002	<b>System Owner</b>	ALBANY UNIVERSITY
<b>Drainage</b>	CAMPUS GRC	<b>Survey Customer</b>	WOODARD & CURRAN				
<b>P/O #</b>		<b>Date</b>	2007/07/19	<b>Time</b>	10:31	<b>Street</b>	SUNY OF ALBANY
<b>Locality</b>	CAMPUS GROUNDS	<b>Further location details</b>					
<b>Start</b>	SMH-85	<b>Rim to invert</b>		<b>Grade to invert</b>		<b>Rim to grade</b>	<b>Ft</b>
<b>Finish</b>	SMH-81	<b>Rim to invert</b>		<b>Grade to invert</b>		<b>Rim to grade</b>	<b>Ft</b>
<b>Use</b>	Sanitary	<b>Direction</b>	Downstream	<b>Flow control</b>	Not Controlled	<b>Tape/Media #</b>	WP-01
<b>Shape</b>	Circular	<b>Height</b>	12	<b>Width</b>	ins	<b>Preclean</b>	J
<b>Material</b>	Vitrified Clay Pipe	<b>Joint length</b>		<b>Ft</b>	<b>Total length</b>	187.0	<b>Ft</b>
<b>Lining</b>		<b>Year laid</b>		<b>Year rehabilitated</b>		<b>Weather</b>	Light Rain
<b>Purpose</b>	Infiltration/Inflow Investigation	<b>Cat</b>

<b>Additional info</b>							
<b>Location</b>	Light Highway

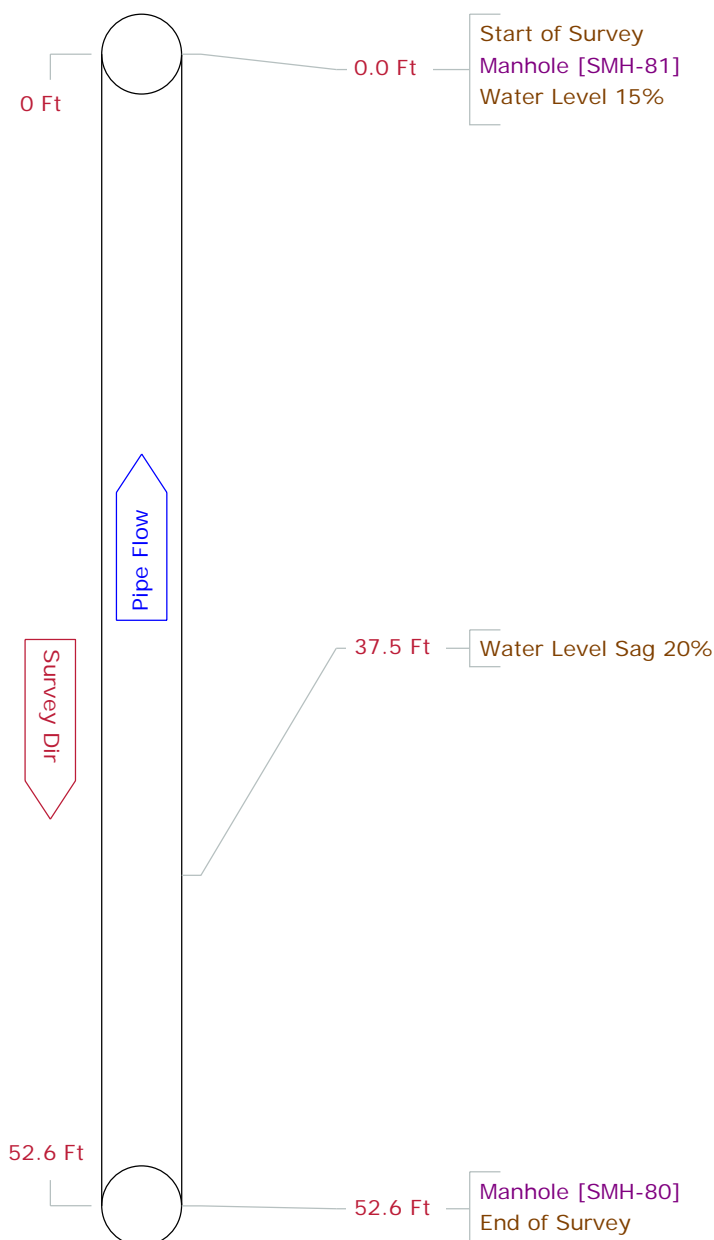
# Pipe Graphic Report of PLR SMH-80 X for WOODARD & CURRAN

<b>Setup</b> 12	<b>Surveyor</b> WP	<b>Certificate #</b> T-001-002	<b>System Owner</b> ALBANY UNIVERSITY
<b>Drainage</b> CAMPUS GRC	<b>Survey Customer</b> WOODARD & CURRAN		
<b>P/O #</b>	<b>Date</b> 2007/07/19	<b>Time</b> 11:17	<b>Street</b> SUNY OF ALBANY
<b>Locality</b> CAMPUS GROUNDS	<b>Further location details</b>		
<b>Start</b> SMH-81	<b>Rim to invert</b>	<b>Grade to invert</b>	<b>Rim to grade</b> <b>Ft</b>
<b>Finish</b> SMH-80	<b>Rim to invert</b>	<b>Grade to invert</b>	<b>Rim to grade</b> <b>Ft</b>
<b>Use</b> Sanitary	<b>Direction</b> Upstream	<b>Flow control</b> Not Controlled	<b>Tape/Media #</b> WP-01
<b>Shape</b> Circular	<b>Height</b> 12	<b>Width</b> ins	<b>Preclean</b> J <b>Year Cleaned</b>
<b>Material</b> Vitrified Clay Pipe	<b>Joint length</b> <b>Ft</b>	<b>Total length</b> 52.6	<b>Ft</b> <b>Length Surveyed</b> 52.60
<b>Lining</b>	<b>Year laid</b>	<b>Year rehabilitated</b>	<b>Weather</b> Light Rain

<b>Purpose</b> Infiltration/Inflow Investigation	<b>Cat</b>		
<b>Additional info</b>		<b>Structural</b>	<b>O&amp;M</b> <b>Constructional</b>
<b>Location</b> Light Highway		<b>Miscellaneous</b>	<b>Hydraulic</b>

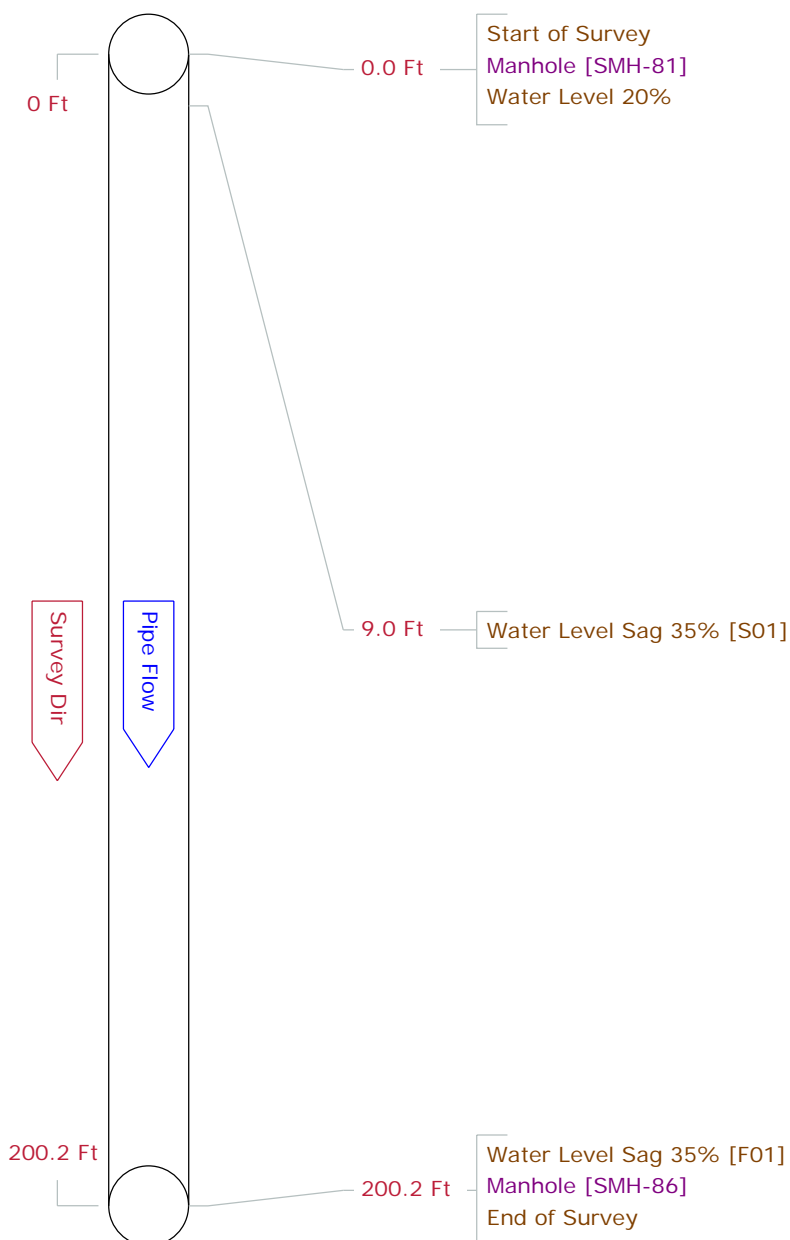
# Pipe Graphic Report of PLR SMH-81 X for WOODARD & CURRAN

<b>Setup</b> 13	<b>Surveyor</b> WP	<b>Certificate #</b> T-001-002	<b>System Owner</b> ALBANY UNIVERSITY
<b>Drainage</b> CAMPUS GRC	<b>Survey Customer</b> WOODARD & CURRAN		
<b>P/O #</b>	<b>Date</b> 2007/07/19	<b>Time</b> 11:21	<b>Street</b> SUNY OF ALBANY
<b>Locality</b> CAMPUS GROUNDS	<b>Further location details</b>		
<b>Start</b> SMH-81	<b>Rim to invert</b>	<b>Grade to invert</b>	<b>Rim to grade</b> <b>Ft</b>
<b>Finish</b> SMH-86	<b>Rim to invert</b>	<b>Grade to invert</b>	<b>Rim to grade</b> <b>Ft</b>
<b>Use</b> Sanitary	<b>Direction</b> Downstream	<b>Flow control</b> Not Controlled	<b>Tape/Media #</b> WP-01
<b>Shape</b> Circular	<b>Height</b> 12	<b>Width</b> ins	<b>Preclean</b> J <b>Year Cleaned</b>
<b>Material</b> Vitrified Clay Pipe	<b>Joint length</b> <b>Ft</b>	<b>Total length</b> 200.2 <b>Ft</b>	<b>Length Surveyed</b> 200.20
<b>Lining</b>	<b>Year laid</b>	<b>Year rehabilitated</b>	<b>Weather</b> Light Rain

<b>Purpose</b> Infiltration/Inflow Investigation	<b>Cat</b>		
<b>Additional info</b>		<b>Structural</b>	<b>O&amp;M</b> <b>Constructional</b>
<b>Location</b> Light Highway		<b>Miscellaneous</b>	<b>Hydraulic</b>

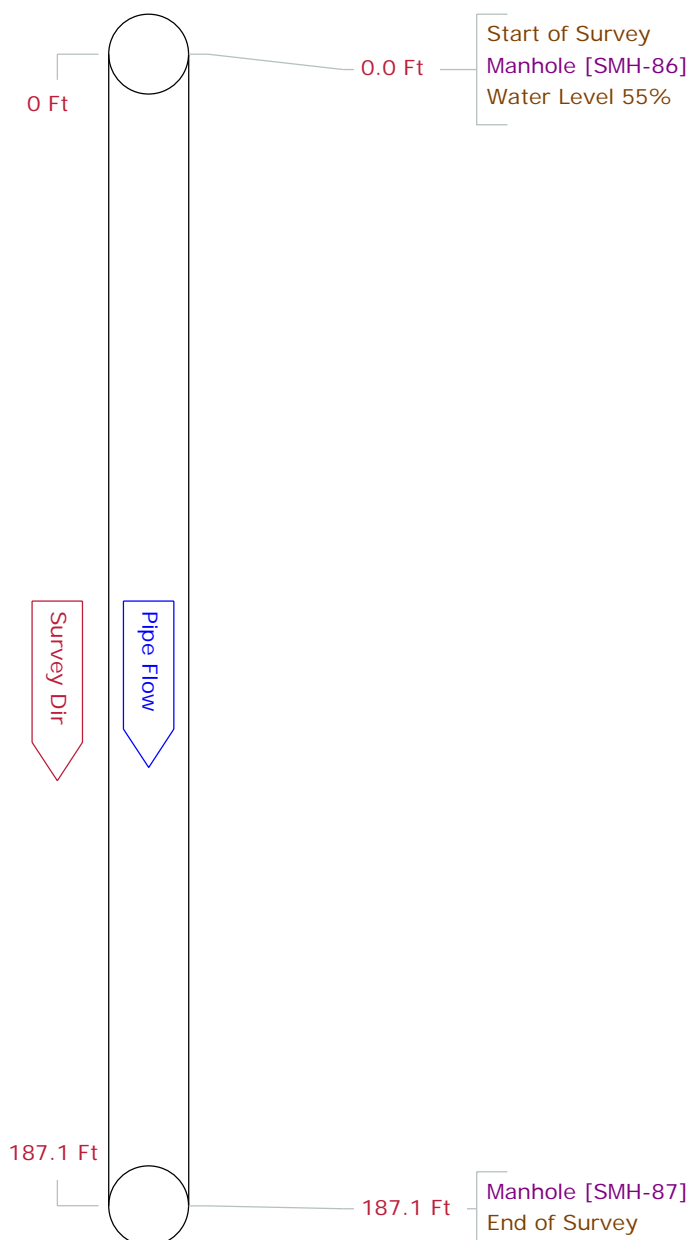
# Pipe Graphic Report of PLR SMH-86 X for WOODARD & CURRAN

<b>Setup</b> 14	<b>Surveyor</b> WP	<b>Certificate #</b> T-001-002	<b>System Owner</b> ALBANY UNIVERSITY
<b>Drainage</b> CAMPUS GRC	<b>Survey Customer</b> WOODARD & CURRAN		
<b>P/O #</b>	<b>Date</b> 2007/07/19	<b>Time</b> 11:41	<b>Street</b> SUNY OF ALBANY
<b>Locality</b> CAMPUS GROUNDS	<b>Further location details</b>		
<b>Start</b> SMH-86	<b>Rim to invert</b>	<b>Grade to invert</b>	<b>Rim to grade</b> <b>Ft</b>
<b>Finish</b> SMH-87	<b>Rim to invert</b>	<b>Grade to invert</b>	<b>Rim to grade</b> <b>Ft</b>
<b>Use</b> Sanitary	<b>Direction</b> Downstream	<b>Flow control</b> Not Controlled	<b>Tape/Media #</b> WP-01
<b>Shape</b> Circular	<b>Height</b> 12	<b>Width</b> ins	<b>Preclean</b> J <b>Year Cleaned</b>
<b>Material</b> Vitrified Clay Pipe	<b>Joint length</b> <b>Ft</b>	<b>Total length</b> 187.1 <b>Ft</b>	<b>Length Surveyed</b> 187.10
<b>Lining</b>	<b>Year laid</b>	<b>Year rehabilitated</b>	<b>Weather</b> Light Rain

<b>Purpose</b> Infiltration/Inflow Investigation	<b>Cat</b>		
<b>Additional info</b>		<b>Structural</b>	<b>O&amp;M</b> <b>Constructional</b>
<b>Location</b> Light Highway		<b>Miscellaneous</b>	<b>Hydraulic</b>

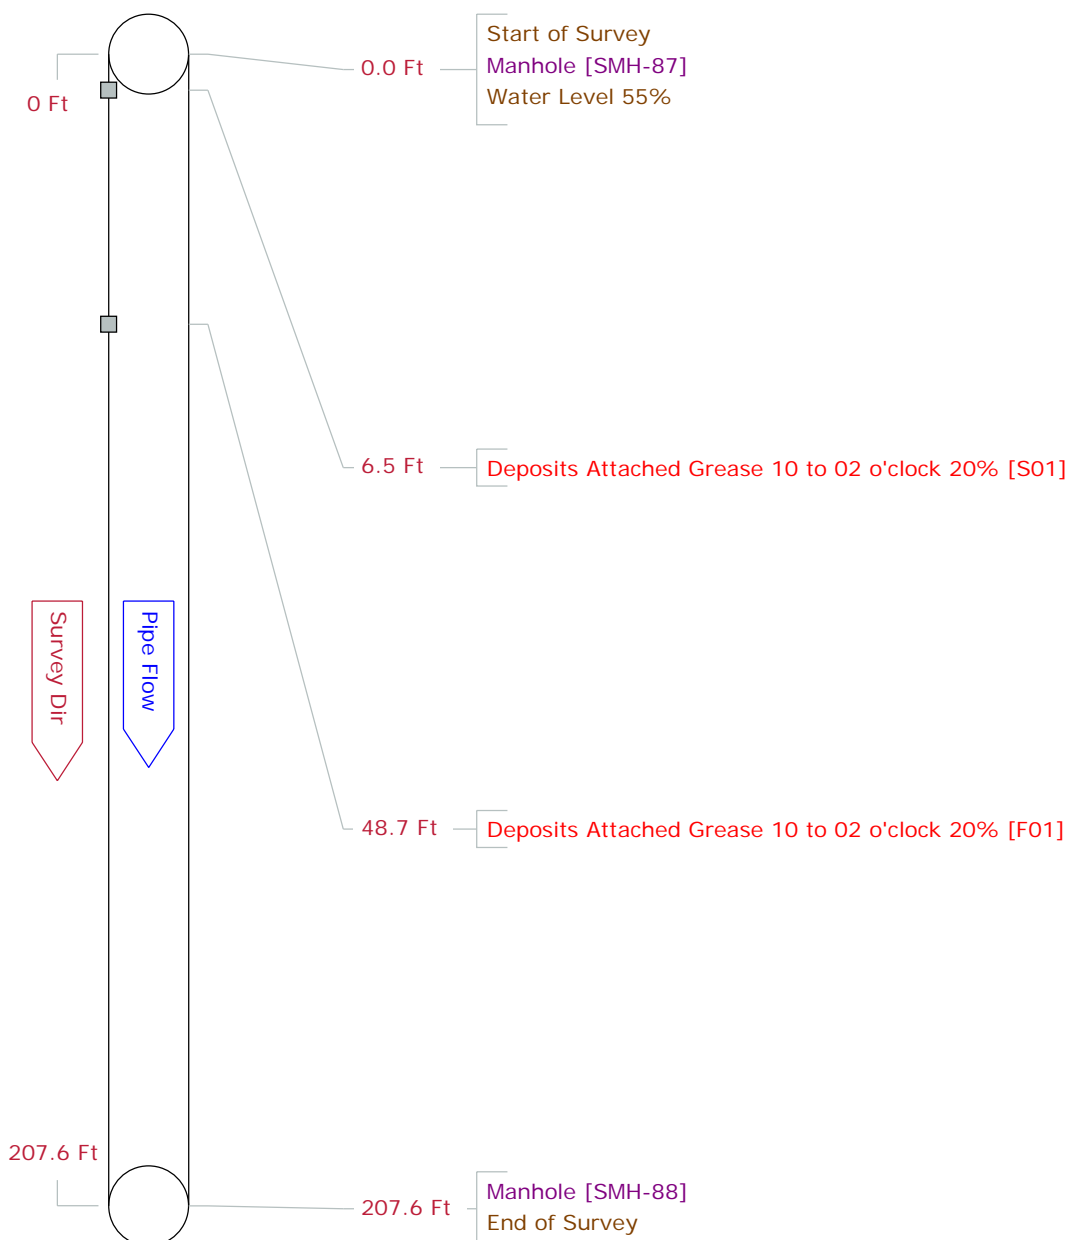
# Pipe Graphic Report of PLR SMH-87 X for WOODARD & CURRAN

<b>Setup</b> 15	<b>Surveyor</b> WP	<b>Certificate #</b> T-001-002	<b>System Owner</b> ALBANY UNIVERSITY
<b>Drainage</b> CAMPUS GRC	<b>Survey Customer</b> WOODARD & CURRAN		
<b>P/O #</b>	<b>Date</b> 2007/07/19	<b>Time</b> 11:52	<b>Street</b> SUNY OF ALBANY
<b>Locality</b> CAMPUS GROUNDS	<b>Further location details</b>		
<b>Start</b> SMH-87	<b>Rim to invert</b>	<b>Grade to invert</b>	<b>Rim to grade</b> <b>Ft</b>
<b>Finish</b> SMH-88	<b>Rim to invert</b>	<b>Grade to invert</b>	<b>Rim to grade</b> <b>Ft</b>
<b>Use</b> Sanitary	<b>Direction</b> Downstream	<b>Flow control</b> Not Controlled	<b>Tape/Media #</b> WP-01
<b>Shape</b> Circular	<b>Height</b> 12	<b>Width</b> ins	<b>Preclean</b> J <b>Year Cleaned</b>
<b>Material</b> Vitrified Clay Pipe	<b>Joint length</b> <b>Ft</b>	<b>Total length</b> 207.6 <b>Ft</b>	<b>Length Surveyed</b> 207.60
<b>Lining</b>	<b>Year laid</b>	<b>Year rehabilitated</b>	<b>Weather</b> Heavy Rain

<b>Purpose</b> Infiltration/Inflow Investigation	<b>Cat</b>		
<b>Additional info</b>		<b>Structural</b>	<b>O&amp;M</b> <b>Constructional</b>
<b>Location</b> Light Highway		<b>Miscellaneous</b>	<b>Hydraulic</b>

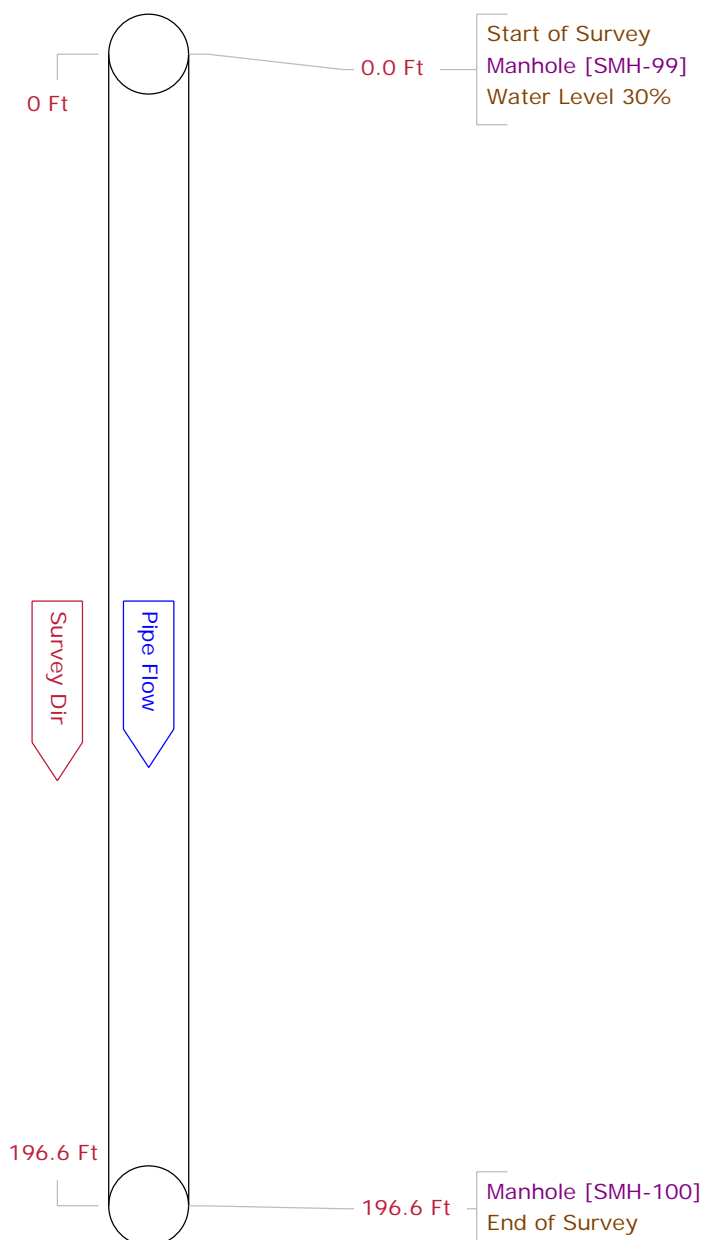
# Pipe Graphic Report of PLR SMH-99 X for WOODARD & CURRAN

<b>Setup</b> 16	<b>Surveyor</b> WP	<b>Certificate #</b> T-001-002	<b>System Owner</b> ALBANY UNIVERSITY
<b>Drainage</b> CAMPUS GRC	<b>Survey Customer</b> WOODARD & CURRAN		
<b>P/O #</b>	<b>Date</b> 2007/07/19	<b>Time</b> 12:31	<b>Street</b> SUNY OF ALBANY
<b>Locality</b> CAMPUS GROUNDS	<b>Further location details</b>		
<b>Start</b> SMH-99	<b>Rim to invert</b>	<b>Grade to invert</b>	<b>Rim to grade</b> <b>Ft</b>
<b>Finish</b> SMH-100	<b>Rim to invert</b>	<b>Grade to invert</b>	<b>Rim to grade</b> <b>Ft</b>
<b>Use</b> Sanitary	<b>Direction</b> Downstream	<b>Flow control</b> Not Controlled	<b>Tape/Media #</b> WP-01
<b>Shape</b> Circular	<b>Height</b> 12	<b>Width</b> ins	<b>Preclean</b> J <b>Year Cleaned</b>
<b>Material</b> Vitrified Clay Pipe	<b>Joint length</b> <b>Ft</b>	<b>Total length</b> 196.6 <b>Ft</b>	<b>Length Surveyed</b> 196.60
<b>Lining</b>	<b>Year laid</b>	<b>Year rehabilitated</b>	<b>Weather</b> Heavy Rain

<b>Purpose</b> Infiltration/Inflow Investigation	<b>Cat</b>		
<b>Additional info</b>		<b>Structural</b>	<b>O&amp;M</b> <b>Constructional</b>
<b>Location</b> Light Highway		<b>Miscellaneous</b>	<b>Hydraulic</b>

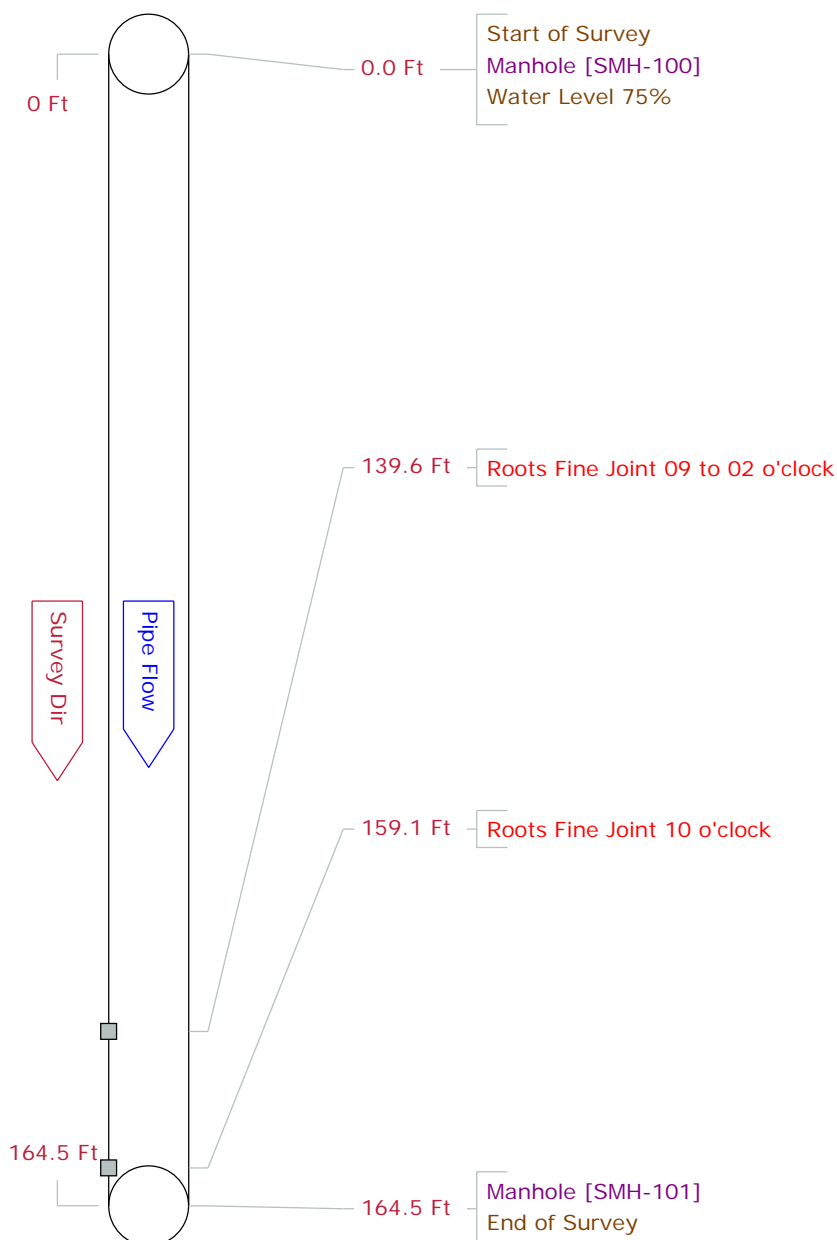
# Pipe Graphic Report of PLR SMH-100 X for WOODARD & CURRAN

<b>Setup</b> 17	<b>Surveyor</b> WP	<b>Certificate #</b> T-001-002	<b>System Owner</b> ALBANY UNIVERSITY
<b>Drainage</b> CAMPUS GRC	<b>Survey Customer</b> WOODARD & CURRAN		
<b>P/O #</b>	<b>Date</b> 2007/07/19	<b>Time</b> 12:31	<b>Street</b> SUNY OF ALBANY
<b>Locality</b> CAMPUS GROUNDS	<b>Further location details</b>		
<b>Start</b> SMH-100	<b>Rim to invert</b>	<b>Grade to invert</b>	<b>Rim to grade</b> <b>Ft</b>
<b>Finish</b> SMH-101	<b>Rim to invert</b>	<b>Grade to invert</b>	<b>Rim to grade</b> <b>Ft</b>
<b>Use</b> Sanitary	<b>Direction</b> Downstream	<b>Flow control</b> Not Controlled	<b>Tape/Media #</b> WP-01
<b>Shape</b> Circular	<b>Height</b> 12	<b>Width</b> ins	<b>Preclean</b> J <b>Year Cleaned</b>
<b>Material</b> Vitrified Clay Pipe	<b>Joint length</b> <b>Ft</b>	<b>Total length</b> 164.5 <b>Ft</b>	<b>Length Surveyed</b> 164.50
<b>Lining</b>	<b>Year laid</b>	<b>Year rehabilitated</b>	<b>Weather</b> Heavy Rain

<b>Purpose</b> Infiltration/Inflow Investigation	<b>Cat</b>		
<b>Additional info</b>		<b>Structural</b>	<b>O&amp;M</b> <b>Constructional</b>
<b>Location</b> Light Highway		<b>Miscellaneous</b>	<b>Hydraulic</b>

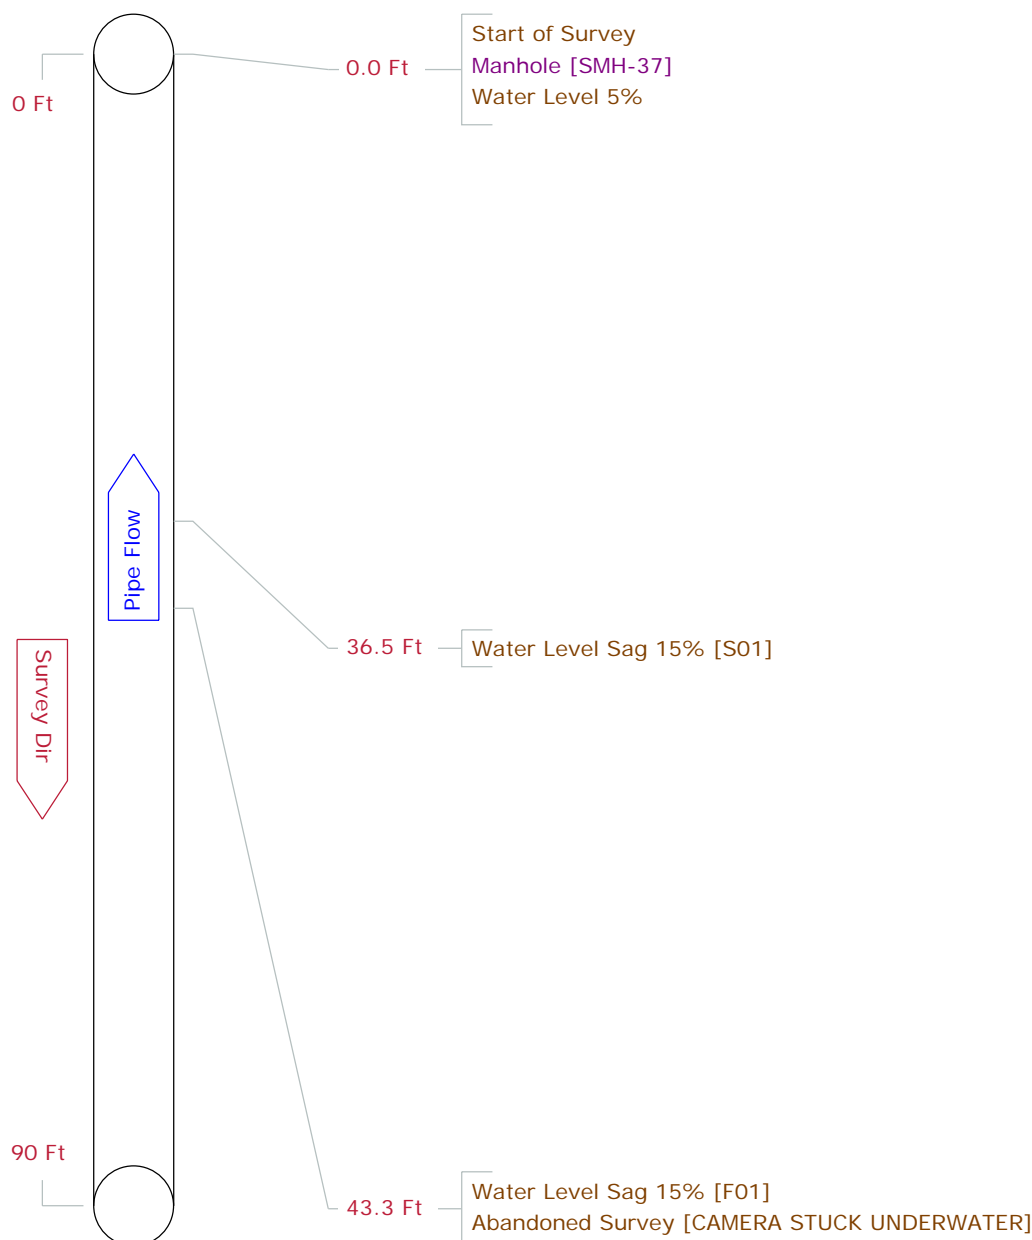
# Pipe Graphic Report of PLR STUB X for WOODARD & CURRAN

<b>Setup</b> 18	<b>Surveyor</b> WP	<b>Certificate #</b> T-001-002	<b>System Owner</b> ALBANY UNIVERSITY
<b>Drainage</b> CAMPUS GRC	<b>Survey Customer</b> WOODARD & CURRAN		
<b>P/O #</b>	<b>Date</b> 2007/07/23	<b>Time</b> 8:56	<b>Street</b> SUNY OF ALBANY
<b>Locality</b> CAMPUS GROUNDS	<b>Further location details</b>		
<b>Start</b> SMH-37	<b>Rim to invert</b>	<b>Grade to invert</b>	<b>Rim to grade</b> <b>Ft</b>
<b>Finish</b> STUB	<b>Rim to invert</b>	<b>Grade to invert</b>	<b>Rim to grade</b> <b>Ft</b>
<b>Use</b> Sanitary	<b>Direction</b> Upstream	<b>Flow control</b> Not Controlled	<b>Tape/Media #</b> WP-01
<b>Shape</b> Circular	<b>Height</b> 8	<b>Width</b> ins	<b>Preclean</b> J <b>Year Cleaned</b>
<b>Material</b> Cast Iron	<b>Joint length</b> <b>Ft</b>	<b>Total length</b> 90.0 <b>Ft</b>	<b>Length Surveyed</b> 43.30
<b>Lining</b>	<b>Year laid</b>	<b>Year rehabilitated</b>	<b>Weather</b> Dry
<b>Purpose</b> Infiltration/Inflow Investigation	<b>Cat</b>

<b>Additional info</b>		<b>Structural</b>	<b>O&amp;M</b> <b>Constructional</b>
<b>Location</b> Light Highway		<b>Miscellaneous</b>	<b>Hydraulic</b>

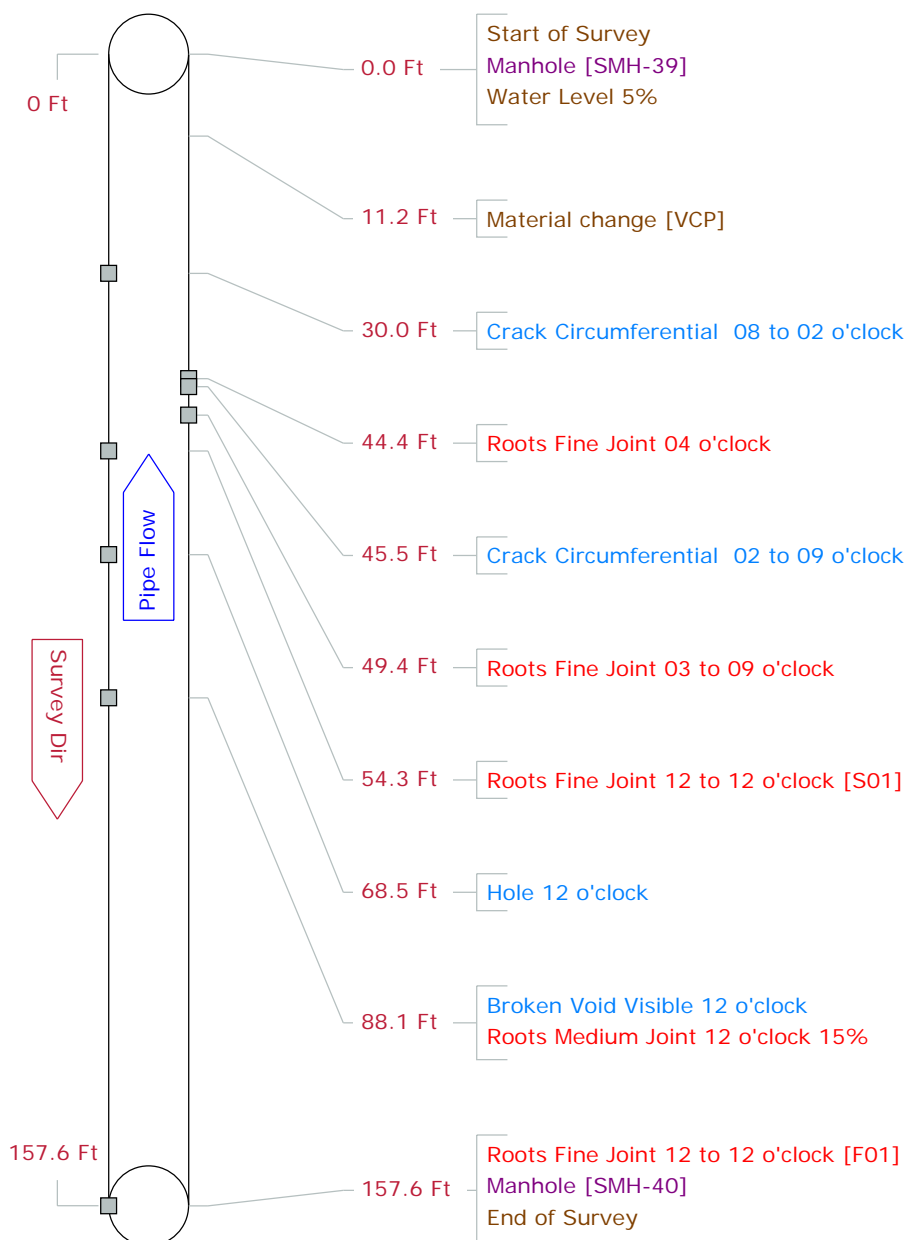
# Pipe Graphic Report of PLR SMH-40 X for WOODARD & CURRAN

<b>Setup</b> 19	<b>Surveyor</b> WP	<b>Certificate #</b> T-001-002	<b>System Owner</b> ALBANY UNIVERSITY
<b>Drainage</b> CAMPUS GRC	<b>Survey Customer</b> WOODARD & CURRAN		
<b>P/O #</b>	<b>Date</b> 2007/07/23	<b>Time</b> 9:23	<b>Street</b> SUNY OF ALBANY
<b>Locality</b> CAMPUS GROUNDS	<b>Further location details</b>		
<b>Start</b> SMH-39	<b>Rim to invert</b>	<b>Grade to invert</b>	<b>Rim to grade</b> <b>Ft</b>
<b>Finish</b> SMH-40	<b>Rim to invert</b>	<b>Grade to invert</b>	<b>Rim to grade</b> <b>Ft</b>
<b>Use</b> Sanitary	<b>Direction</b> Upstream	<b>Flow control</b> Not Controlled	<b>Tape/Media #</b> WP-01
<b>Shape</b> Circular	<b>Height</b> 8 <b>Width</b> ins	<b>Preclean</b> J	<b>Year Cleaned</b>
<b>Material</b> Polyvinyl Chloride	<b>Joint length</b> <b>Ft</b>	<b>Total length</b> 157.6 <b>Ft</b>	<b>Length Surveyed</b> 157.60
<b>Lining</b>	<b>Year laid</b>	<b>Year rehabilitated</b>	<b>Weather</b> Dry

<b>Purpose</b> Infiltration/Inflow Investigation	<b>Cat</b>		
<b>Additional info</b>		<b>Structural</b>	<b>O&amp;M</b> <b>Constructional</b>
<b>Location</b> Light Highway		<b>Miscellaneous</b>	<b>Hydraulic</b>
