# Condition Assessment Report

**Stormwater, Sanitary  
Sewer, Water and  
Irrigation Systems**

**University at Albany  
(Uptown Campus)**

**SUCF Project No. 01834**

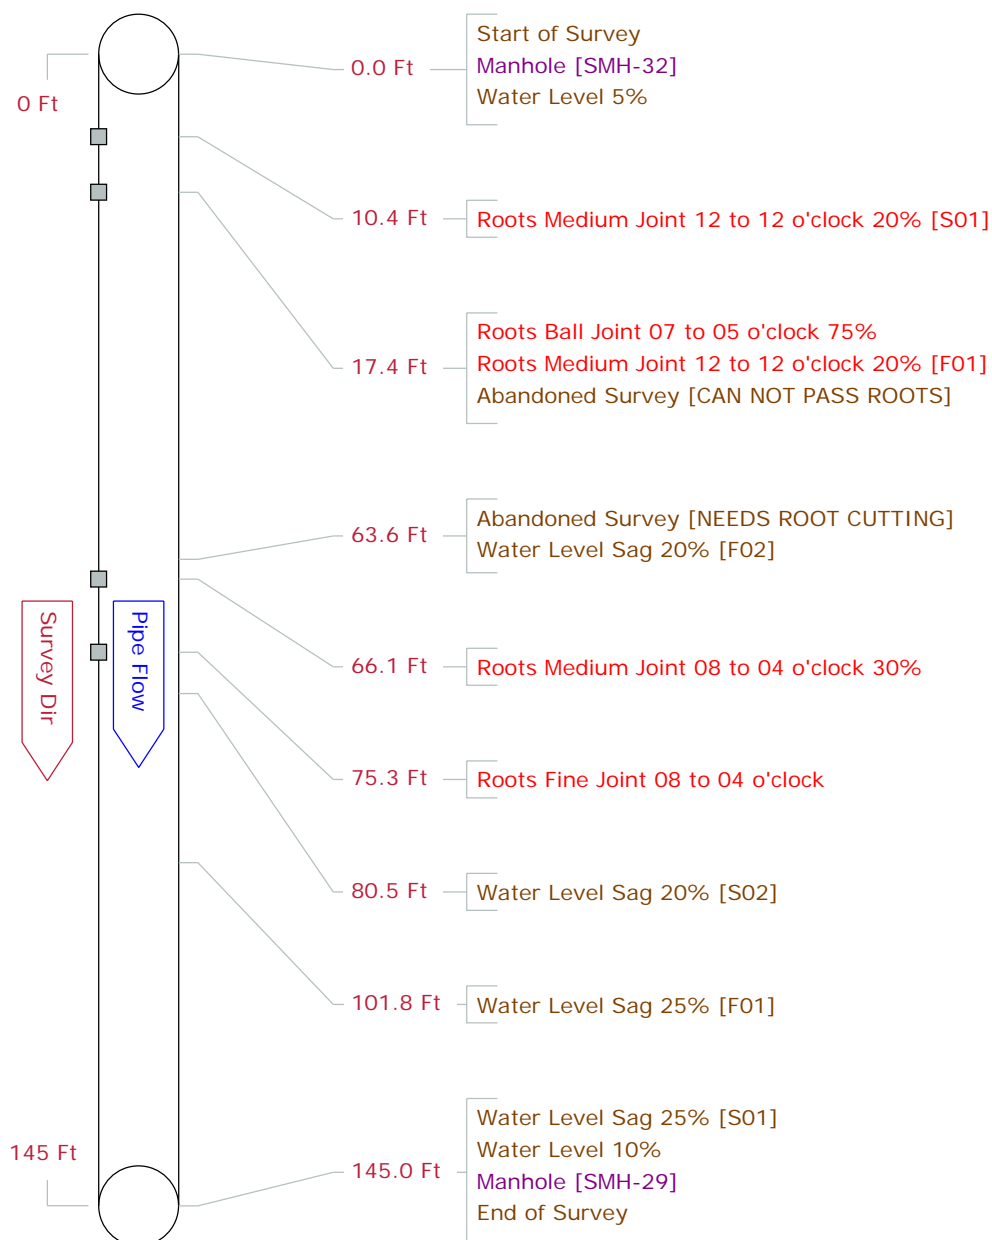
# Pipe Graphic Report of PLR SMH-32 X for WOODARD & CURRAN

<b>Setup</b> 27/26	<b>Surveyor</b> WP	<b>Certificate #</b> T-001-002	<b>System Owner</b> ALBANY UNIVERSITY
<b>Drainage</b> CAMPUS GRC	<b>Survey Customer</b> WOODARD & CURRAN		
<b>P/O #</b>	<b>Date</b> 2007/07/23	<b>Time</b> 15:19	<b>Street</b> SUNY OF ALBANY
<b>Locality</b> CAMPUS GROUNDS	<b>Further location details</b>		
<b>Start</b> SMH-29	<b>Rim to invert</b>	<b>Grade to invert</b>	<b>Rim to grade</b> <b>Ft</b>
<b>Finish</b> SMH-32	<b>Rim to invert</b>	<b>Grade to invert</b>	<b>Rim to grade</b> <b>Ft</b>
<b>Use</b> Sanitary	<b>Direction</b> Upstream	<b>Flow control</b> Not Controlled	<b>Tape/Media #</b> WP-01
<b>Shape</b> Circular	<b>Height</b> 8	<b>Width</b> ins	<b>Preclean</b> J <b>Year Cleaned</b>
<b>Material</b> Vitrified Clay Pipe	<b>Joint length</b>	<b>Ft</b> <b>Total length</b> 145.0	<b>Ft</b> <b>Length Surveyed</b> 81.40
<b>Lining</b>	<b>Year laid</b>	<b>Year rehabilitated</b>	<b>Weather</b> Heavy Rain

<b>Purpose</b> Infiltration/Inflow Investigation	<b>Cat</b>		
<b>Additional info</b> Reverse set up on sheet:26		<b>Structural</b>	<b>O&amp;M</b> <b>Constructional</b>
<b>Location</b> Light Highway		<b>Miscellaneous</b>	<b>Hydraulic</b>

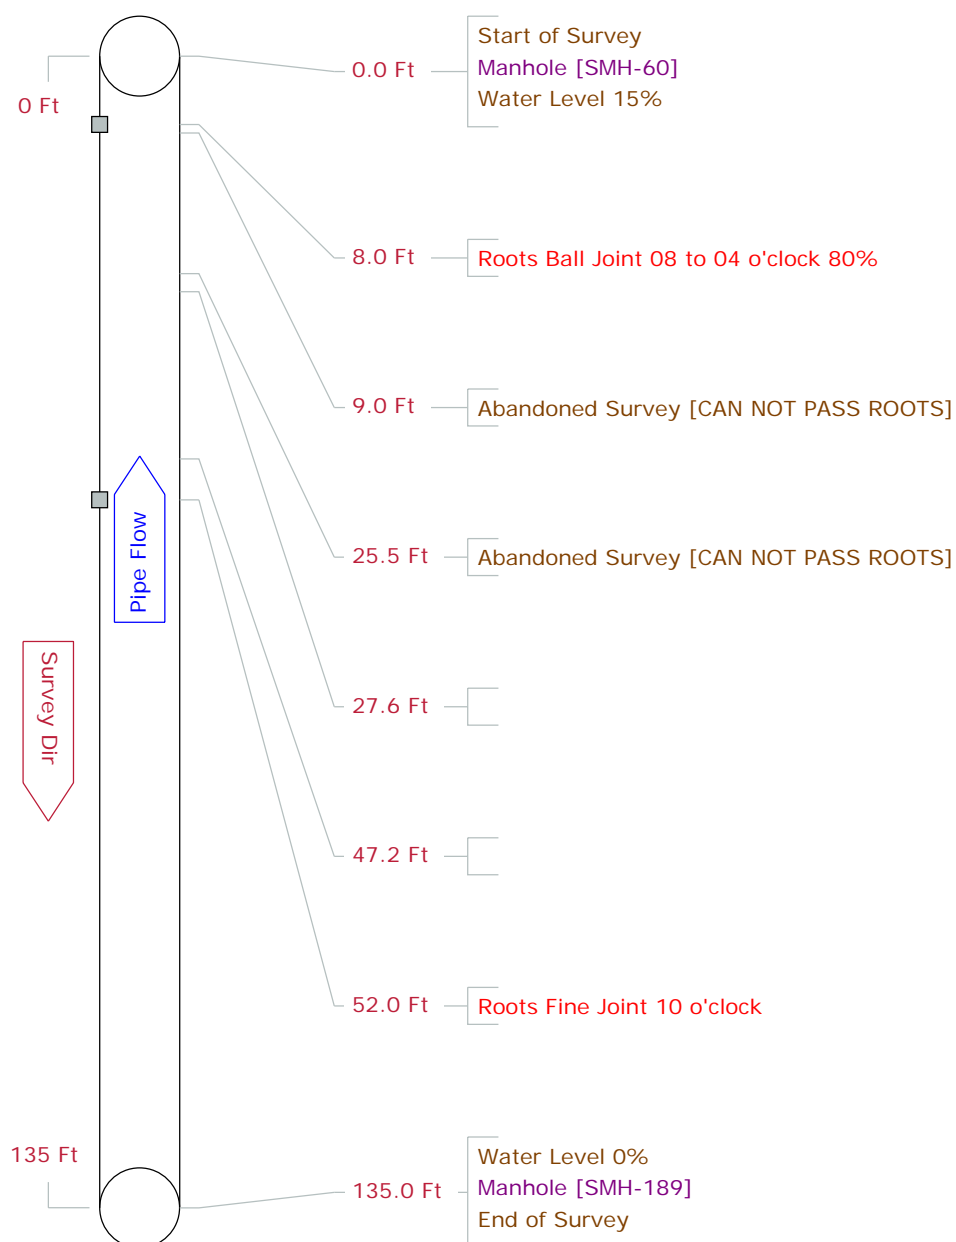
# Pipe Graphic Report of PLR SMH-189 X for WOODARD & CURRAN

<b>Setup</b> 32/31	<b>Surveyor</b> WP	<b>Certificate #</b> T-001-002	<b>System Owner</b> ALBANY UNIVERSITY
<b>Drainage</b> CAMPUS GRC	<b>Survey Customer</b> WOODARD & CURRAN		
<b>P/O #</b>	<b>Date</b> 2007/07/23	<b>Time</b> 6:28	<b>Street</b> SUNY OF ALBANY
<b>Locality</b> CAMPUS GROUNDS	<b>Further location details</b>		
<b>Start</b> SMH-189	<b>Rim to invert</b>	<b>Grade to invert</b>	<b>Rim to grade</b> <b>Ft</b>
<b>Finish</b> SMH-60	<b>Rim to invert</b>	<b>Grade to invert</b>	<b>Rim to grade</b> <b>Ft</b>
<b>Use</b> Sanitary	<b>Direction</b> Downstream	<b>Flow control</b> Not Controlled	<b>Tape/Media #</b> WP-01
<b>Shape</b> Circular	<b>Height</b> 8	<b>Width</b> ins	<b>Preclean</b> J <b>Year Cleaned</b>
<b>Material</b> Vitrified Clay Pipe	<b>Joint length</b> <b>Ft</b>	<b>Total length</b> 135.0 <b>Ft</b>	<b>Length Surveyed</b> 109.50
<b>Lining</b>	<b>Year laid</b>	<b>Year rehabilitated</b>	<b>Weather</b> Heavy Rain

<b>Purpose</b> Infiltration/Inflow Investigation	<b>Cat</b>		
<b>Additional info</b> Reverse set up on sheet:31		<b>Structural</b>	<b>O&amp;M</b>
<b>Location</b> Light Highway		<b>Miscellaneous</b>	<b>Hydraulic</b>
		<b>Constructional</b>

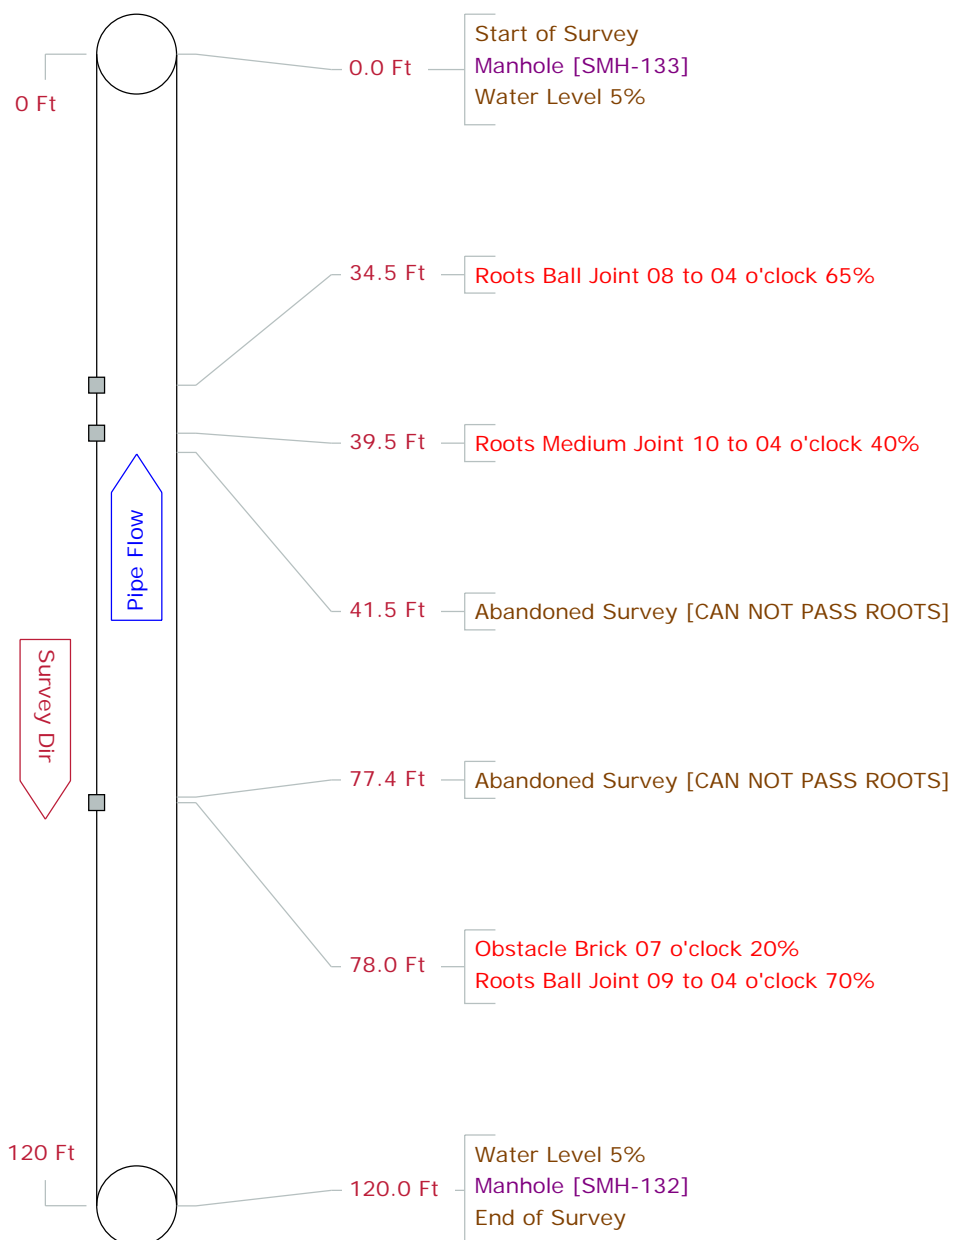
# Pipe Graphic Report of PLR SMH-132 W for WOODARD & CURRAN

<b>Setup</b> 40/39	<b>Surveyor</b> WP	<b>Certificate #</b> T-001-002	<b>System Owner</b> ALBANY UNIVERSITY
<b>Drainage</b> CAMPUS GRC	<b>Survey Customer</b> WOODARD & CURRAN		
<b>P/O #</b>	<b>Date</b> 2007/07/25	<b>Time</b> 11:14	<b>Street</b> SUNY OF ALBANY
<b>Locality</b> CAMPUS GROUNDS	<b>Further location details</b>		
<b>Start</b> SMH-133	<b>Rim to invert</b>	<b>Grade to invert</b>	<b>Rim to grade</b> <b>Ft</b>
<b>Finish</b> SMH-132	<b>Rim to invert</b>	<b>Grade to invert</b>	<b>Rim to grade</b> <b>Ft</b>
<b>Use</b> Sanitary	<b>Direction</b> Upstream	<b>Flow control</b> Not Controlled	<b>Tape/Media #</b> WP-01
<b>Shape</b> Circular	<b>Height</b> 8	<b>Width</b> ins	<b>Preclean</b> J <b>Year Cleaned</b>
<b>Material</b> Vitrified Clay Pipe	<b>Joint length</b> <b>Ft</b>	<b>Total length</b> 120.0 <b>Ft</b>	<b>Length Surveyed</b> 41.50
<b>Lining</b>	<b>Year laid</b>	<b>Year rehabilitated</b>	<b>Weather</b> Dry

<b>Purpose</b> Infiltration/Inflow Investigation	<b>Cat</b>		
<b>Additional info</b> Reverse set up on sheet:39		<b>Structural</b>	<b>O&amp;M</b> <b>Constructional</b>
<b>Location</b> Light Highway		<b>Miscellaneous</b>	<b>Hydraulic</b>

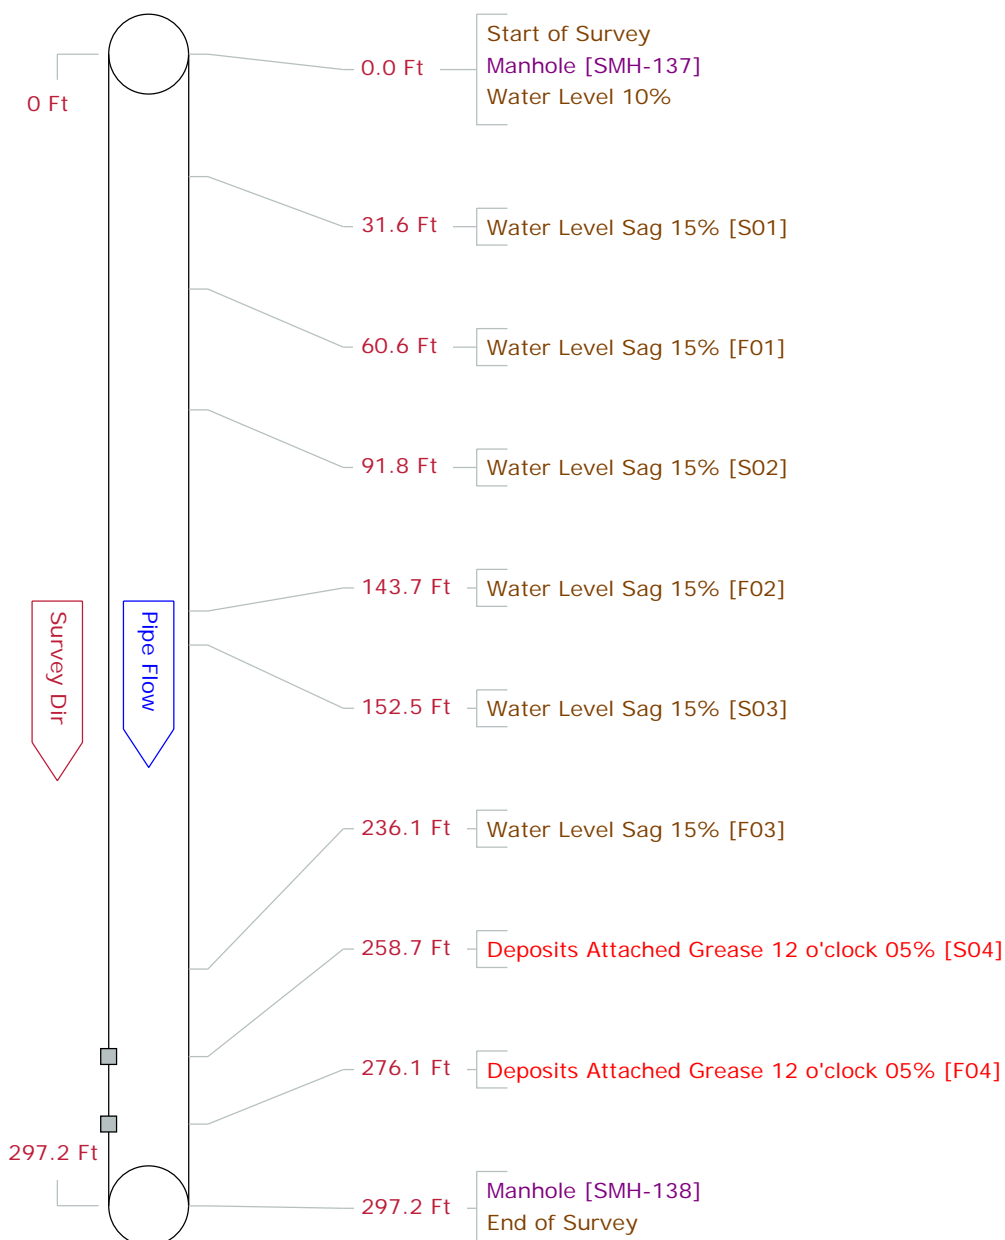
# Pipe Graphic Report of PLR SMH-137 W for WOODARD & CURRAN

<b>Setup</b> 46	<b>Surveyor</b> WP	<b>Certificate #</b> T-001-002	<b>System Owner</b> ALBANY UNIVERSITY
<b>Drainage</b> CAMPUS GRC	<b>Survey Customer</b> WOODARD & CURRAN		
<b>P/O #</b>	<b>Date</b> 2007/07/25	<b>Time</b> 14:04	<b>Street</b> SUNY OF ALBANY
<b>Locality</b> CAMPUS GROUNDS	<b>Further location details</b>		
<b>Start</b> SMH-137	<b>Rim to invert</b>	<b>Grade to invert</b>	<b>Rim to grade</b> <b>Ft</b>
<b>Finish</b> SMH-138	<b>Rim to invert</b>	<b>Grade to invert</b>	<b>Rim to grade</b> <b>Ft</b>
<b>Use</b> Sanitary	<b>Direction</b> Downstream	<b>Flow control</b> Not Controlled	<b>Tape/Media #</b> WP-01
<b>Shape</b> Circular	<b>Height</b> 8	<b>Width</b> ins	<b>Preclean</b> J <b>Year Cleaned</b>
<b>Material</b> Vitrified Clay Pipe	<b>Joint length</b>	<b>Ft</b> <b>Total length</b> 297.2	<b>Ft</b> <b>Length Surveyed</b> 297.20
<b>Lining</b>	<b>Year laid</b>	<b>Year rehabilitated</b>	<b>Weather</b> Dry

<b>Purpose</b> Infiltration/Inflow Investigation	<b>Cat</b>		
<b>Additional info</b>		<b>Structural</b>	<b>O&amp;M</b> <b>Constructional</b>
<b>Location</b> Light Highway		<b>Miscellaneous</b>	<b>Hydraulic</b>

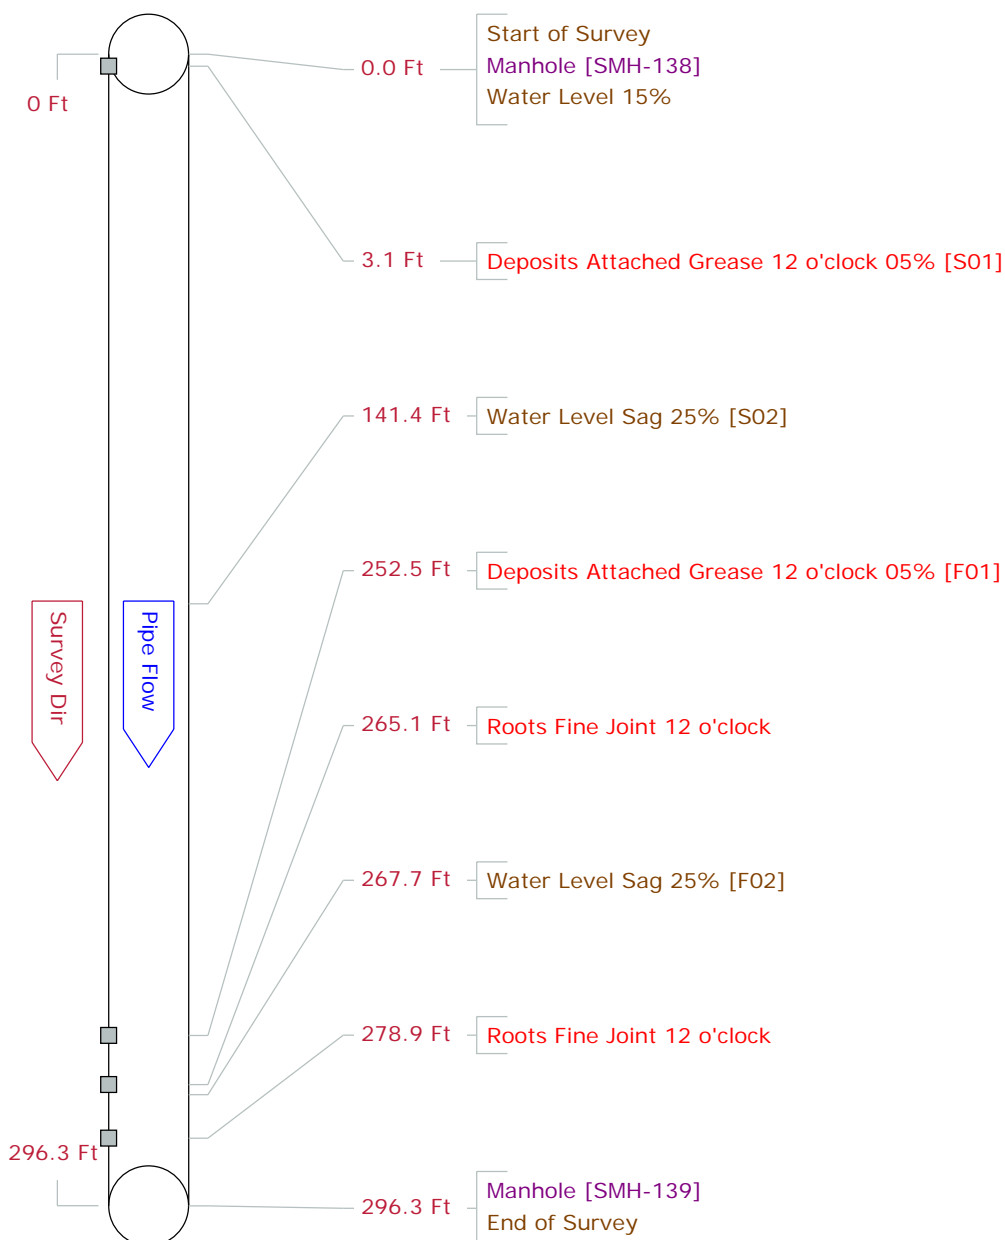
# Pipe Graphic Report of PLR SMH-138 X for WOODARD & CURRAN

<b>Setup</b> 47	<b>Surveyor</b> WP	<b>Certificate #</b> T-001-002	<b>System Owner</b> ALBANY UNIVERSITY
<b>Drainage</b> CAMPUS GRC	<b>Survey Customer</b> WOODARD & CURRAN		
<b>P/O #</b>	<b>Date</b> 2007/07/25	<b>Time</b> 14:13	<b>Street</b> SUNY OF ALBANY
<b>Locality</b> CAMPUS GROUNDS	<b>Further location details</b>		
<b>Start</b> SMH-138	<b>Rim to invert</b>	<b>Grade to invert</b>	<b>Rim to grade</b> <b>Ft</b>
<b>Finish</b> SMH-139	<b>Rim to invert</b>	<b>Grade to invert</b>	<b>Rim to grade</b> <b>Ft</b>
<b>Use</b> Sanitary	<b>Direction</b> Downstream	<b>Flow control</b> Not Controlled	<b>Tape/Media #</b> WP-01
<b>Shape</b> Circular	<b>Height</b> 8	<b>Width</b> ins	<b>Preclean</b> J <b>Year Cleaned</b>
<b>Material</b> Vitrified Clay Pipe	<b>Joint length</b> <b>Ft</b>	<b>Total length</b> 296.3 <b>Ft</b>	<b>Length Surveyed</b> 296.30
<b>Lining</b>	<b>Year laid</b>	<b>Year rehabilitated</b>	<b>Weather</b> Dry

<b>Purpose</b> Infiltration/Inflow Investigation	<b>Cat</b>		
<b>Additional info</b>		<b>Structural</b>	<b>O&amp;M</b> <b>Constructional</b>
<b>Location</b> Light Highway		<b>Miscellaneous</b>	<b>Hydraulic</b>

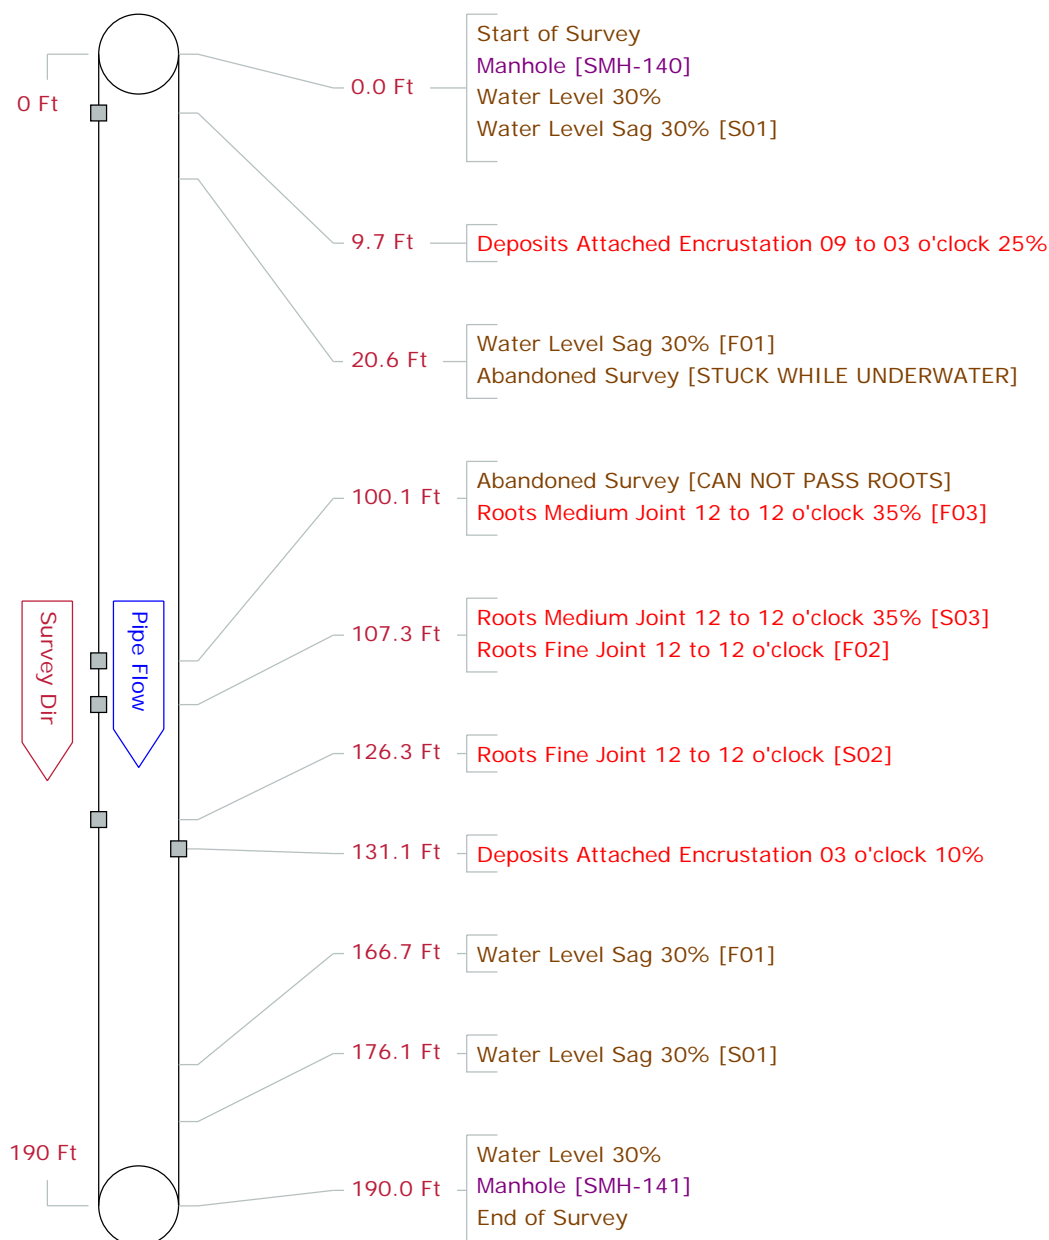
# Pipe Graphic Report of PLR SMH-140 X for WOODARD & CURRAN

<b>Setup</b> 48/49	<b>Surveyor</b> WP	<b>Certificate #</b> T-001-002	<b>System Owner</b> ALBANY UNIVERSITY
<b>Drainage</b> CAMPUS GRC	<b>Survey Customer</b> WOODARD & CURRAN		
<b>P/O #</b>	<b>Date</b> 2007/07/25	<b>Time</b> 14:57	<b>Street</b> SUNY OF ALBANY
<b>Locality</b> CAMPUS GROUNDS	<b>Further location details</b>		
<b>Start</b> SMH-140	<b>Rim to invert</b>	<b>Grade to invert</b>	<b>Rim to grade</b> <b>Ft</b>
<b>Finish</b> SMH-141	<b>Rim to invert</b>	<b>Grade to invert</b>	<b>Rim to grade</b> <b>Ft</b>
<b>Use</b> Sanitary	<b>Direction</b> Downstream	<b>Flow control</b> Not Controlled	<b>Tape/Media #</b> WP-01
<b>Shape</b> Circular	<b>Height</b> 10	<b>Width</b> ins	<b>Preclean</b> J <b>Year Cleaned</b>
<b>Material</b> Vitrified Clay Pipe	<b>Joint length</b> <b>Ft</b>	<b>Total length</b> 190.0 <b>Ft</b>	<b>Length Surveyed</b> 20.60
<b>Lining</b>	<b>Year laid</b>	<b>Year rehabilitated</b>	<b>Weather</b> Dry

<b>Purpose</b> Infiltration/Inflow Investigation	<b>Cat</b>		
<b>Additional info</b>		<b>Structural</b>	<b>O&amp;M</b> <b>Constructional</b>
<b>Location</b> Light Highway		<b>Miscellaneous</b>	<b>Hydraulic</b>

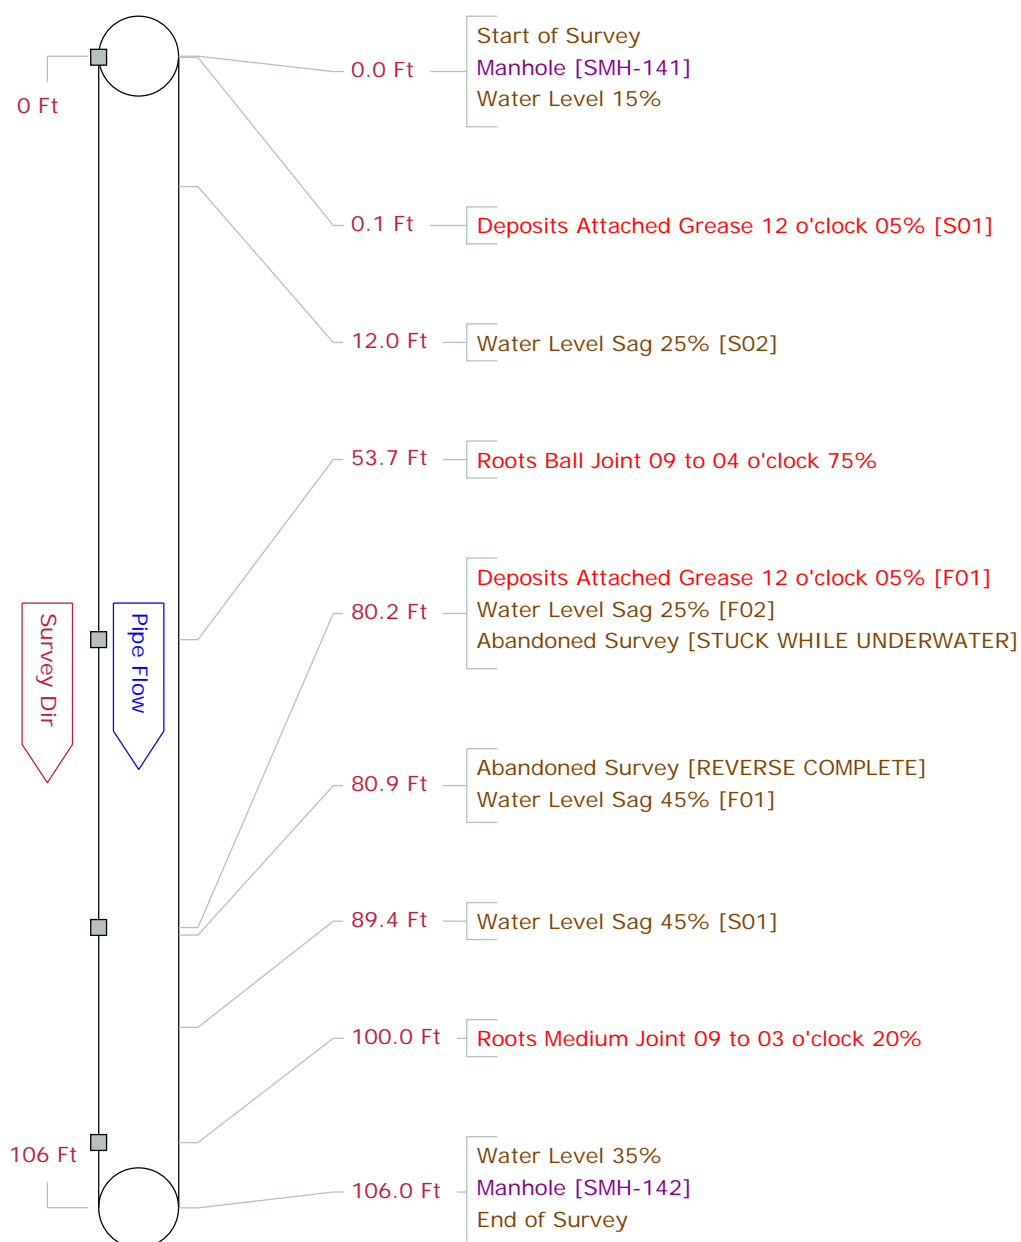
# Pipe Graphic Report of PLR SMH-141 X for WOODARD & CURRAN

<b>Setup</b> 50/51	<b>Surveyor</b> WP	<b>Certificate #</b> T-001-002	<b>System Owner</b> ALBANY UNIVERSITY
<b>Drainage</b> CAMPUS GRC	<b>Survey Customer</b> WOODARD & CURRAN		
<b>P/O #</b>	<b>Date</b> 2007/07/25	<b>Time</b> 3:33	<b>Street</b> SUNY OF ALBANY
<b>Locality</b> CAMPUS GROUNDS	<b>Further location details</b>		
<b>Start</b> SMH-141	<b>Rim to invert</b>	<b>Grade to invert</b>	<b>Rim to grade</b> <b>Ft</b>
<b>Finish</b> SMH-142	<b>Rim to invert</b>	<b>Grade to invert</b>	<b>Rim to grade</b> <b>Ft</b>
<b>Use</b> Sanitary	<b>Direction</b> Downstream	<b>Flow control</b> Not Controlled	<b>Tape/Media #</b> WP-02
<b>Shape</b> Circular	<b>Height</b> 10	<b>Width</b> ins	<b>Preclean</b> J <b>Year Cleaned</b>
<b>Material</b> Vitrified Clay Pipe	<b>Joint length</b>	<b>Ft</b> <b>Total length</b> 106.0	<b>Ft</b> <b>Length Surveyed</b> 80.20
<b>Lining</b>	<b>Year laid</b>	<b>Year rehabilitated</b>	<b>Weather</b> Dry

<b>Purpose</b> Infiltration/Inflow Investigation	<b>Cat</b>		
<b>Additional info</b>		<b>Structural</b>	<b>O&amp;M</b> <b>Constructional</b>
<b>Location</b> Light Highway		<b>Miscellaneous</b>	<b>Hydraulic</b>

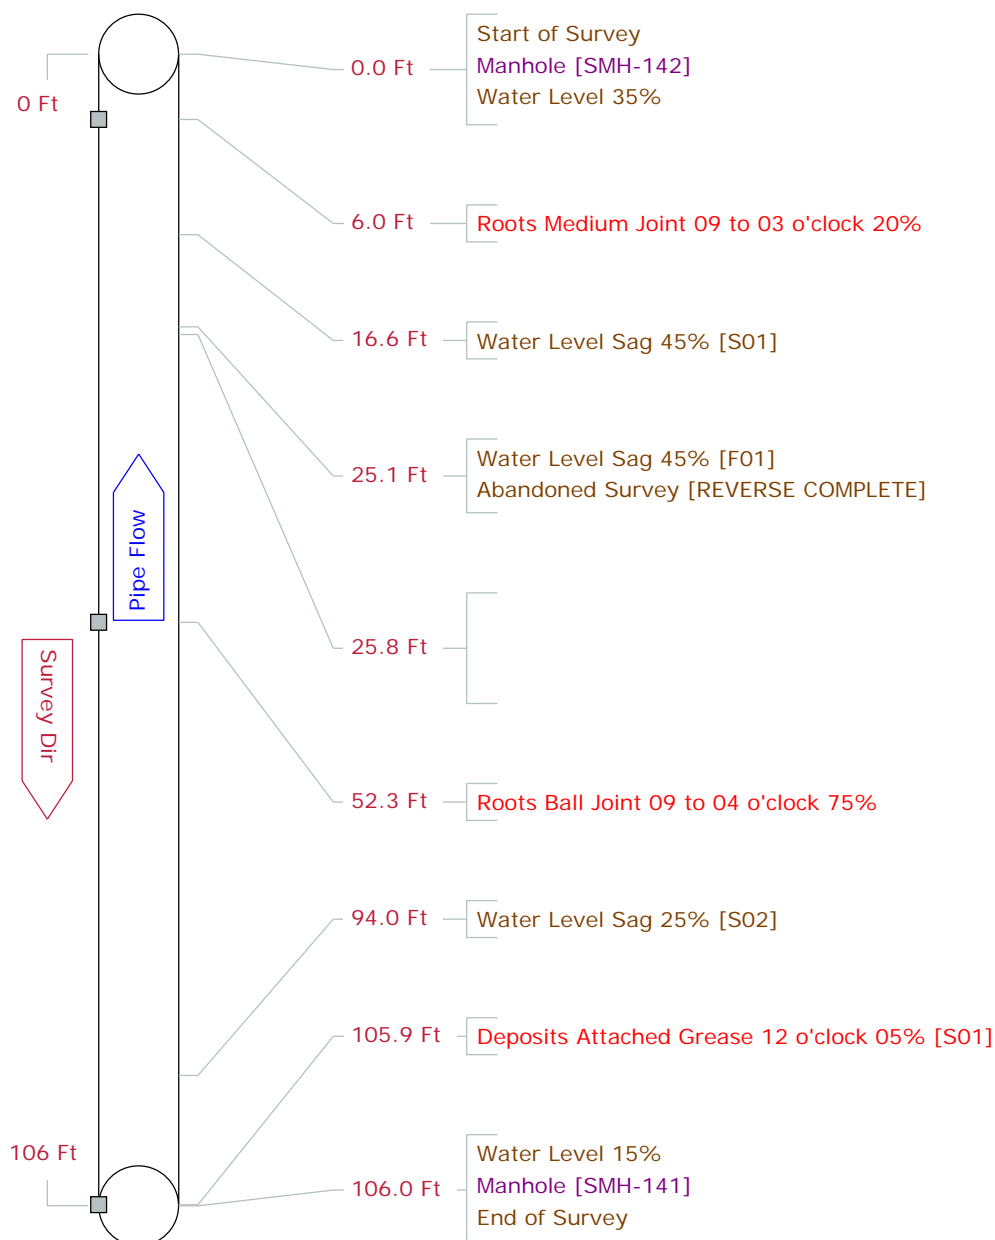
# Pipe Graphic Report of PLR SMH-141 X for WOODARD & CURRAN

<b>Setup</b> 51/50	<b>Surveyor</b> WP	<b>Certificate #</b> T-001-002	<b>System Owner</b> ALBANY UNIVERSITY
<b>Drainage</b> CAMPUS GRC	<b>Survey Customer</b> WOODARD & CURRAN		
<b>P/O #</b>	<b>Date</b> 2007/07/25	<b>Time</b> 4:00	<b>Street</b> SUNY OF ALBANY
<b>Locality</b> CAMPUS GROUNDS	<b>Further location details</b>		
<b>Start</b> SMH-142	<b>Rim to invert</b>	<b>Grade to invert</b>	<b>Rim to grade</b> <b>Ft</b>
<b>Finish</b> SMH-141	<b>Rim to invert</b>	<b>Grade to invert</b>	<b>Rim to grade</b> <b>Ft</b>
<b>Use</b> Sanitary	<b>Direction</b> Upstream	<b>Flow control</b> Not Controlled	<b>Tape/Media #</b> WP-02
<b>Shape</b> Circular	<b>Height</b> 10	<b>Width</b> ins	<b>Preclean</b> J <b>Year Cleaned</b>
<b>Material</b> Vitrified Clay Pipe	<b>Joint length</b>	<b>Ft</b> <b>Total length</b> 106.0	<b>Ft</b> <b>Length Surveyed</b> 25.10
<b>Lining</b>	<b>Year laid</b>	<b>Year rehabilitated</b>	<b>Weather</b> Dry

<b>Purpose</b> Infiltration/Inflow Investigation	<b>Cat</b>		
<b>Additional info</b> Reverse set up on sheet:50		<b>Structural</b>	<b>O&amp;M</b> <b>Constructional</b>
<b>Location</b> Light Highway		<b>Miscellaneous</b>	<b>Hydraulic</b>

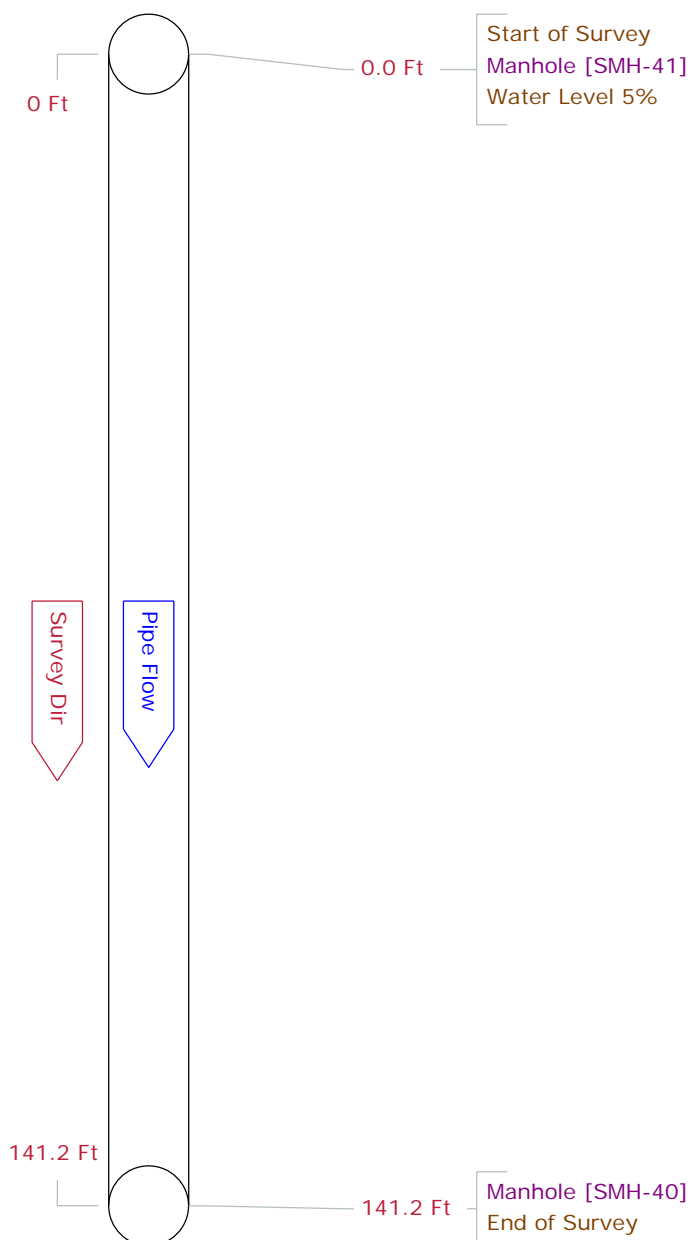
# Pipe Graphic Report of PLR SMH-41 X for WOODARD & CURRAN

<b>Setup</b> 52	<b>Surveyor</b> WP	<b>Certificate #</b> T-001-002	<b>System Owner</b> ALBANY UNIVERSITY
<b>Drainage</b> CAMPUS GRC	<b>Survey Customer</b> WOODARD & CURRAN		
<b>P/O #</b>	<b>Date</b> 2007/07/31	<b>Time</b> 12:51	<b>Street</b> SUNY OF ALBANY
<b>Locality</b> CAMPUS GROUNDS	<b>Further location details</b>		
<b>Start</b> SMH-41	<b>Rim to invert</b>	<b>Grade to invert</b>	<b>Rim to grade</b> <b>Ft</b>
<b>Finish</b> SMH-40	<b>Rim to invert</b>	<b>Grade to invert</b>	<b>Rim to grade</b> <b>Ft</b>
<b>Use</b> Sanitary	<b>Direction</b> Downstream	<b>Flow control</b> Not Controlled	<b>Tape/Media #</b> WP-02
<b>Shape</b> Circular	<b>Height</b> 8	<b>Width</b> ins	<b>Preclean</b> J <b>Year Cleaned</b>
<b>Material</b> Vitrified Clay Pipe	<b>Joint length</b> <b>Ft</b>	<b>Total length</b> 141.2 <b>Ft</b>	<b>Length Surveyed</b> 141.20
<b>Lining</b>	<b>Year laid</b>	<b>Year rehabilitated</b>	<b>Weather</b> Dry

<b>Purpose</b> Infiltration/Inflow Investigation	<b>Cat</b>		
<b>Additional info</b>		<b>Structural</b>	<b>O&amp;M</b> <b>Constructional</b>
<b>Location</b> Light Highway		<b>Miscellaneous</b>	<b>Hydraulic</b>

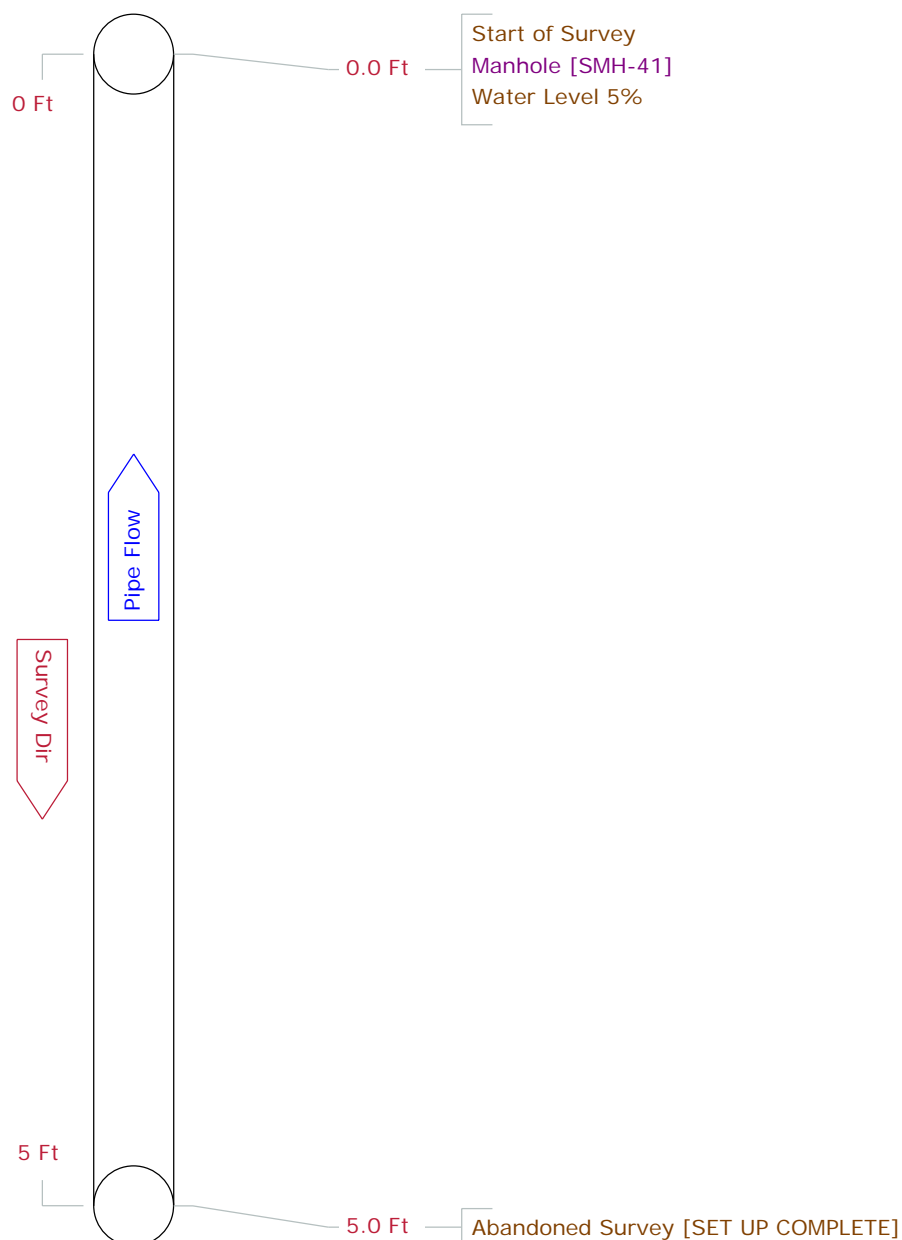
# Pipe Graphic Report of PLR STUB S for WOODARD & CURRAN

<b>Setup</b> 53	<b>Surveyor</b> WP	<b>Certificate #</b> T-001-002	<b>System Owner</b> ALBANY UNIVERSITY
<b>Drainage</b> CAMPUS GRC	<b>Survey Customer</b> WOODARD & CURRAN		
<b>P/O #</b>	<b>Date</b> 2007/07/31	<b>Time</b> 1:00	<b>Street</b> SUNY OF ALBANY
<b>Locality</b> CAMPUS GROUNDS	<b>Further location details</b>		
<b>Start</b> SMH-41	<b>Rim to invert</b>	<b>Grade to invert</b>	<b>Rim to grade</b> <b>Ft</b>
<b>Finish</b> STUB	<b>Rim to invert</b>	<b>Grade to invert</b>	<b>Rim to grade</b> <b>Ft</b>
<b>Use</b> Sanitary	<b>Direction</b> Upstream	<b>Flow control</b> Not Controlled	<b>Tape/Media #</b> WP-02
<b>Shape</b> Circular	<b>Height</b> 8 <b>Width</b> ins	<b>Preclean</b> J	<b>Year Cleaned</b>
<b>Material</b> Vitrified Clay Pipe	<b>Joint length</b> <b>Ft</b>	<b>Total length</b> 5.0 <b>Ft</b>	<b>Length Surveyed</b> 05.00
<b>Lining</b>	<b>Year laid</b>	<b>Year rehabilitated</b>	<b>Weather</b> Dry

<b>Purpose</b> Infiltration/Inflow Investigation	<b>Cat</b>		
<b>Additional info</b>		<b>Structural</b>	<b>O&amp;M</b> <b>Constructional</b>
<b>Location</b> Light Highway		<b>Miscellaneous</b>	<b>Hydraulic</b>

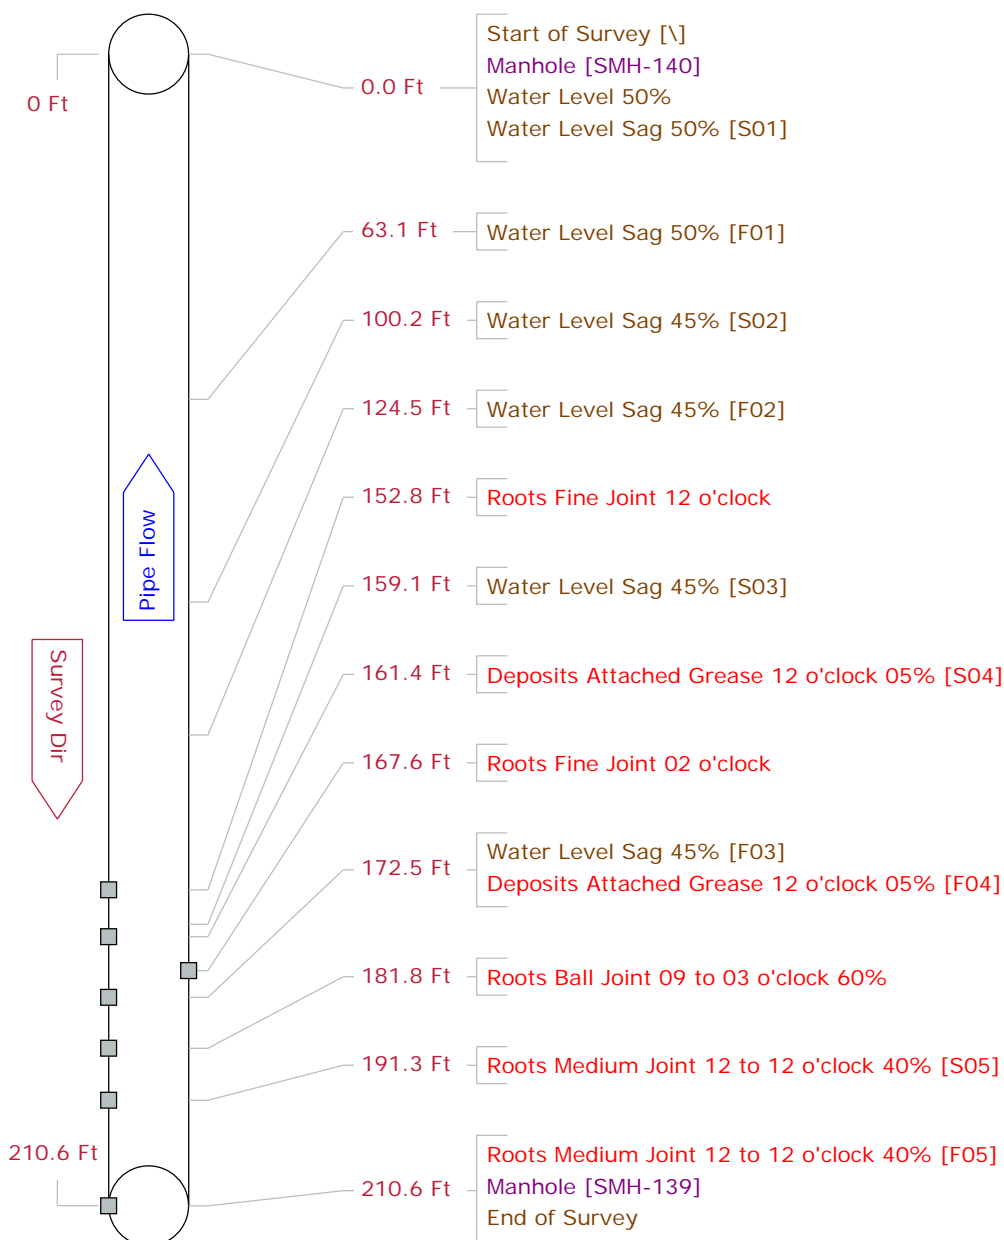
# Pipe Graphic Report of PLR SMH-139 S for WOODARD & CURRAN

<b>Setup</b> 54	<b>Surveyor</b> WP	<b>Certificate #</b> T-001-002	<b>System Owner</b> ALBANY UNIVERSITY
<b>Drainage</b> CAMPUS GRC	<b>Survey Customer</b> WOODARD & CURRAN		
<b>P/O #</b>	<b>Date</b> 2007/07/31	<b>Time</b> 13:17	<b>Street</b> SUNY OF ALBANY
<b>Locality</b> CAMPUS GROUNDS	<b>Further location details</b>		
<b>Start</b> SMH-140	<b>Rim to invert</b>	<b>Grade to invert</b>	<b>Rim to grade</b> <b>Ft</b>
<b>Finish</b> SMH-139	<b>Rim to invert</b>	<b>Grade to invert</b>	<b>Rim to grade</b> <b>Ft</b>
<b>Use</b> Sanitary	<b>Direction</b> Upstream	<b>Flow control</b> Not Controlled	<b>Tape/Media #</b> WP-02
<b>Shape</b> Circular	<b>Height</b> 10	<b>Width</b> ins	<b>Preclean</b> J <b>Year Cleaned</b>
<b>Material</b> Vitrified Clay Pipe	<b>Joint length</b> <b>Ft</b>	<b>Total length</b> 210.6 <b>Ft</b>	<b>Length Surveyed</b> 210.60
<b>Lining</b>	<b>Year laid</b>	<b>Year rehabilitated</b>	<b>Weather</b> Dry

<b>Purpose</b> Infiltration/Inflow Investigation	<b>Cat</b>		
<b>Additional info</b> CAN NOT LOCATE SMH-139		<b>Structural</b>	<b>O&amp;M</b> <b>Constructional</b>
<b>Location</b> Light Highway		<b>Miscellaneous</b>	<b>Hydraulic</b>

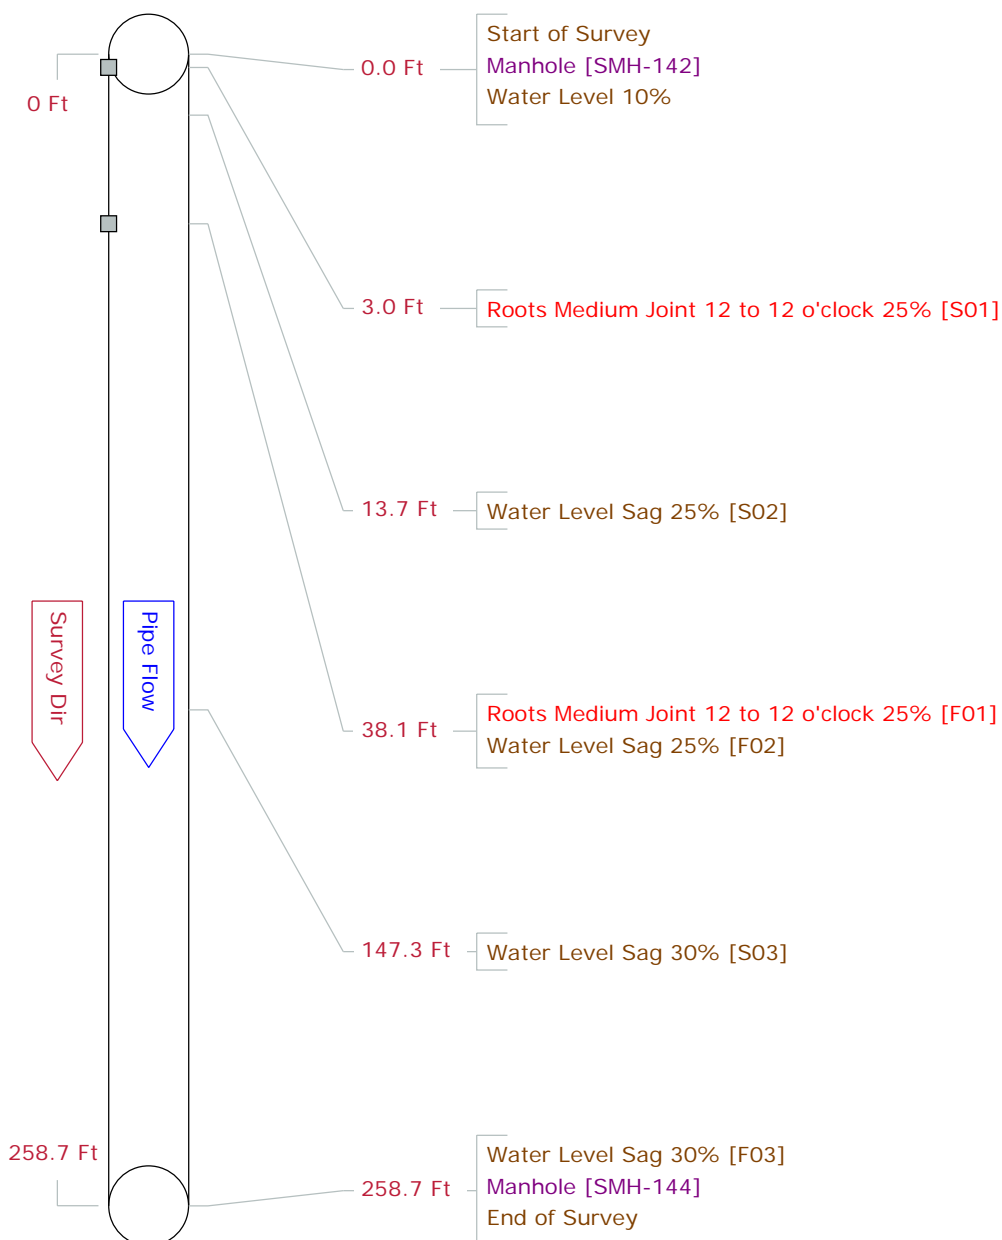
# Pipe Graphic Report of PLR SMH-142 S for WOODARD & CURRAN

<b>Setup</b> 55	<b>Surveyor</b> WP	<b>Certificate #</b> T-001-002	<b>System Owner</b> ALBANY UNIVERSITY
<b>Drainage</b> CAMPUS GRC	<b>Survey Customer</b> WOODARD & CURRAN		
<b>P/O #</b>	<b>Date</b> 2007/07/31	<b>Time</b> 13:55	<b>Street</b> SUNY OF ALBANY
<b>Locality</b> CAMPUS GROUNDS	<b>Further location details</b>		
<b>Start</b> SMH-142	<b>Rim to invert</b>	<b>Grade to invert</b>	<b>Rim to grade</b> <b>Ft</b>
<b>Finish</b> SMH-144	<b>Rim to invert</b>	<b>Grade to invert</b>	<b>Rim to grade</b> <b>Ft</b>
<b>Use</b> Sanitary	<b>Direction</b> Downstream	<b>Flow control</b> Not Controlled	<b>Tape/Media #</b> WP-02
<b>Shape</b> Circular	<b>Height</b> 10	<b>Width</b> ins	<b>Preclean</b> J <b>Year Cleaned</b>
<b>Material</b> Vitrified Clay Pipe	<b>Joint length</b> <b>Ft</b>	<b>Total length</b> 258.7 <b>Ft</b>	<b>Length Surveyed</b> 258.70
<b>Lining</b>	<b>Year laid</b>	<b>Year rehabilitated</b>	<b>Weather</b> Dry

<b>Purpose</b> Infiltration/Inflow Investigation	<b>Cat</b>		
<b>Additional info</b>		<b>Structural</b>	<b>O&amp;M</b>
<b>Location</b> Light Highway		<b>Miscellaneous</b>	<b>Hydraulic</b>
		<b>Constructional</b>

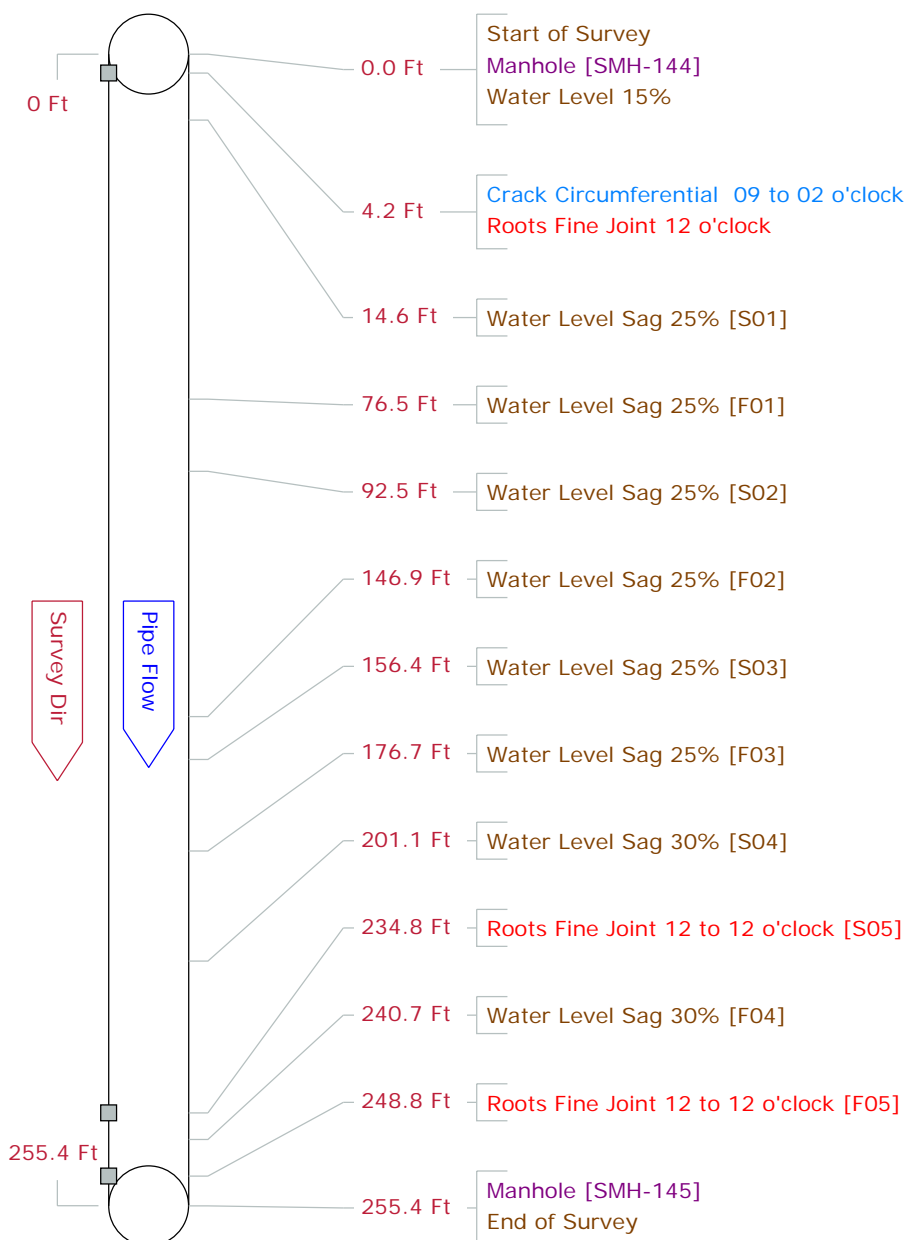
# Pipe Graphic Report of PLR SMH-144 S for WOODARD & CURRAN

<b>Setup</b> 56	<b>Surveyor</b> WP	<b>Certificate #</b> T-001-002	<b>System Owner</b> ALBANY UNIVERSITY
<b>Drainage</b> CAMPUS GRC	<b>Survey Customer</b> WOODARD & CURRAN		
<b>P/O #</b>	<b>Date</b> 2007/07/31	<b>Time</b> 14:07	<b>Street</b> SUNY OF ALBANY
<b>Locality</b> CAMPUS GROUNDS	<b>Further location details</b>		
<b>Start</b> SMH-144	<b>Rim to invert</b>	<b>Grade to invert</b>	<b>Rim to grade</b> <b>Ft</b>
<b>Finish</b> SMH-145	<b>Rim to invert</b>	<b>Grade to invert</b>	<b>Rim to grade</b> <b>Ft</b>
<b>Use</b> Sanitary	<b>Direction</b> Downstream	<b>Flow control</b> Not Controlled	<b>Tape/Media #</b> WP-02
<b>Shape</b> Circular	<b>Height</b> 10	<b>Width</b> ins	<b>Preclean</b> J <b>Year Cleaned</b>
<b>Material</b> Vitrified Clay Pipe	<b>Joint length</b> <b>Ft</b>	<b>Total length</b> 255.4 <b>Ft</b>	<b>Length Surveyed</b> 255.40
<b>Lining</b>	<b>Year laid</b>	<b>Year rehabilitated</b>	<b>Weather</b> Dry

<b>Purpose</b> Infiltration/Inflow Investigation	<b>Cat</b>		
<b>Additional info</b>		<b>Structural</b>	<b>O&amp;M</b> <b>Constructional</b>
<b>Location</b> Light Highway		<b>Miscellaneous</b>	<b>Hydraulic</b>

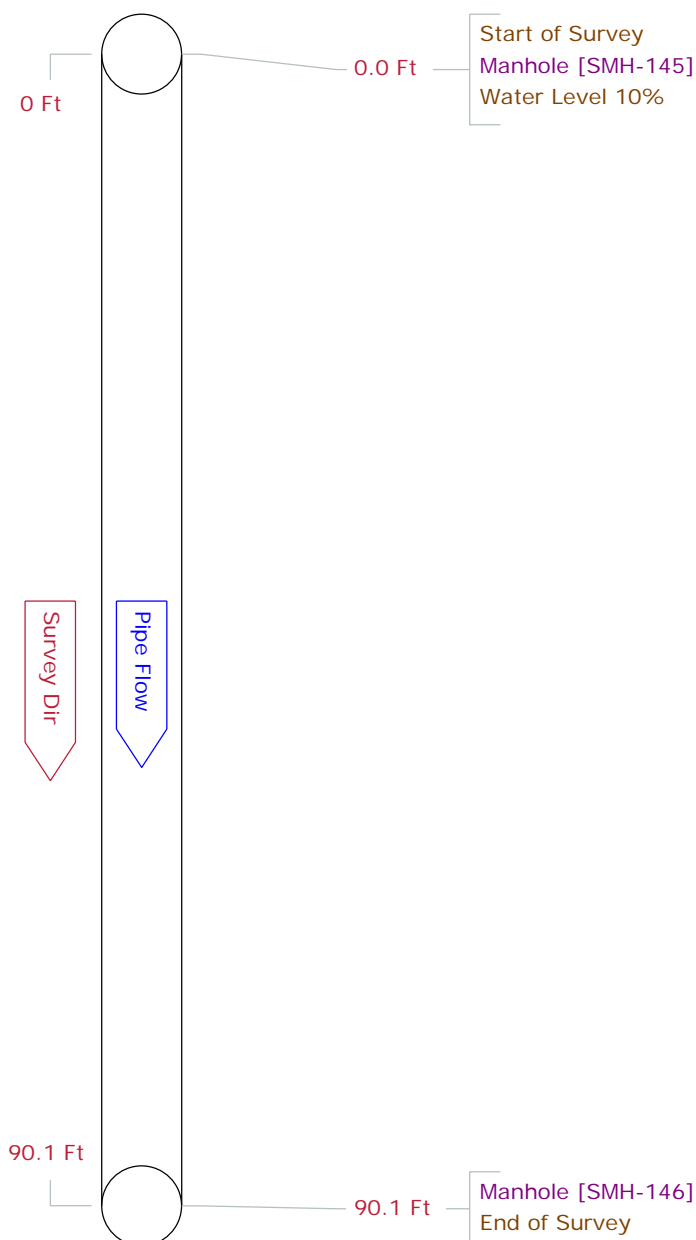
# Pipe Graphic Report of PLR SMH-145 S for WOODARD & CURRAN

<b>Setup</b> 57	<b>Surveyor</b> WP	<b>Certificate #</b> T-001-002	<b>System Owner</b> ALBANY UNIVERSITY
<b>Drainage</b> CAMPUS GRC	<b>Survey Customer</b> WOODARD & CURRAN		
<b>P/O #</b>	<b>Date</b> 2007/07/31	<b>Time</b> 14:35	<b>Street</b> SUNY OF ALBANY
<b>Locality</b> CAMPUS GROUNDS	<b>Further location details</b>		
<b>Start</b> SMH-145	<b>Rim to invert</b>	<b>Grade to invert</b>	<b>Rim to grade</b> <b>Ft</b>
<b>Finish</b> SMH-146	<b>Rim to invert</b>	<b>Grade to invert</b>	<b>Rim to grade</b> <b>Ft</b>
<b>Use</b> Sanitary	<b>Direction</b> Downstream	<b>Flow control</b> Not Controlled	<b>Tape/Media #</b> WP-02
<b>Shape</b> Circular	<b>Height</b> 12	<b>Width</b> ins	<b>Preclean</b> J <b>Year Cleaned</b>
<b>Material</b> Cast Iron	<b>Joint length</b> <b>Ft</b>	<b>Total length</b> 90.1 <b>Ft</b>	<b>Length Surveyed</b> 90.10
<b>Lining</b>	<b>Year laid</b>	<b>Year rehabilitated</b>	<b>Weather</b> Dry

<b>Purpose</b> Infiltration/Inflow Investigation	<b>Cat</b>		
<b>Additional info</b>		<b>Structural</b>	<b>O&amp;M</b> <b>Constructional</b>
<b>Location</b> Light Highway		<b>Miscellaneous</b>	<b>Hydraulic</b>

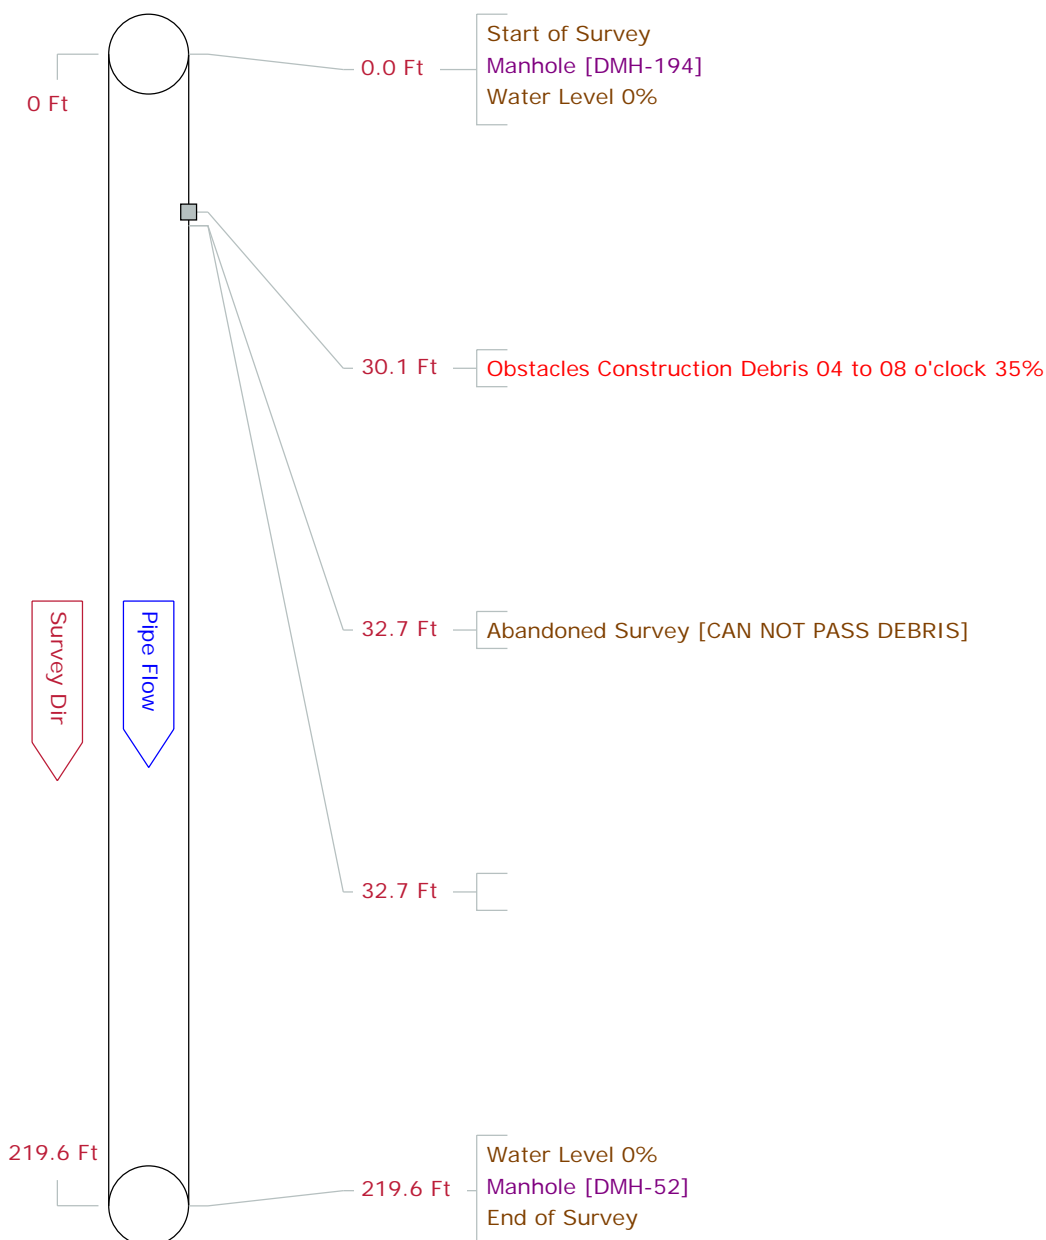
# Pipe Graphic Report of PLR DMH-194 X for WOODARD & CURRAN

<b>Setup</b>	10/9	<b>Surveyor</b>	WP	<b>Certificate #</b>	T-001-002	<b>System Owner</b>	SUNY OF ALBANY
<b>Drainage</b>	STORM DRAIN	<b>Survey Customer</b>	WOODARD & CURRAN				
<b>P/O #</b>		<b>Date</b>	2007/08/01	<b>Time</b>	11:14	<b>Street</b>	SUNY OF ALBANY
<b>Locality</b>	VARIOUS LOCATIONS	<b>Further location details</b>					
<b>Start</b>	DMH-52	<b>Rim to invert</b>		<b>Grade to invert</b>		<b>Rim to grade</b>	<b>Ft</b>
<b>Finish</b>	DMH-194	<b>Rim to invert</b>		<b>Grade to invert</b>		<b>Rim to grade</b>	<b>Ft</b>
<b>Use</b>	Stormwater	<b>Direction</b>	Upstream	<b>Flow control</b>	Not Controlled	<b>Tape/Media #</b>	WP-03
<b>Shape</b>	Circular	<b>Height</b>	21	<b>Width</b>	ins	<b>Preclean</b>	N
<b>Material</b>	Reinforced Concrete Pipe	<b>Joint length</b>	Ft	<b>Total length</b>	219.6	<b>Ft</b>	<b>Length Surveyed</b> 186.90
<b>Lining</b>		<b>Year laid</b>		<b>Year rehabilitated</b>		<b>Weather</b>	Dry
