# Condition Assessment Report

**Stormwater, Sanitary  
Sewer, Water and  
Irrigation Systems**

**University at Albany  
(Uptown Campus)**

**SUCF Project No. 01834**

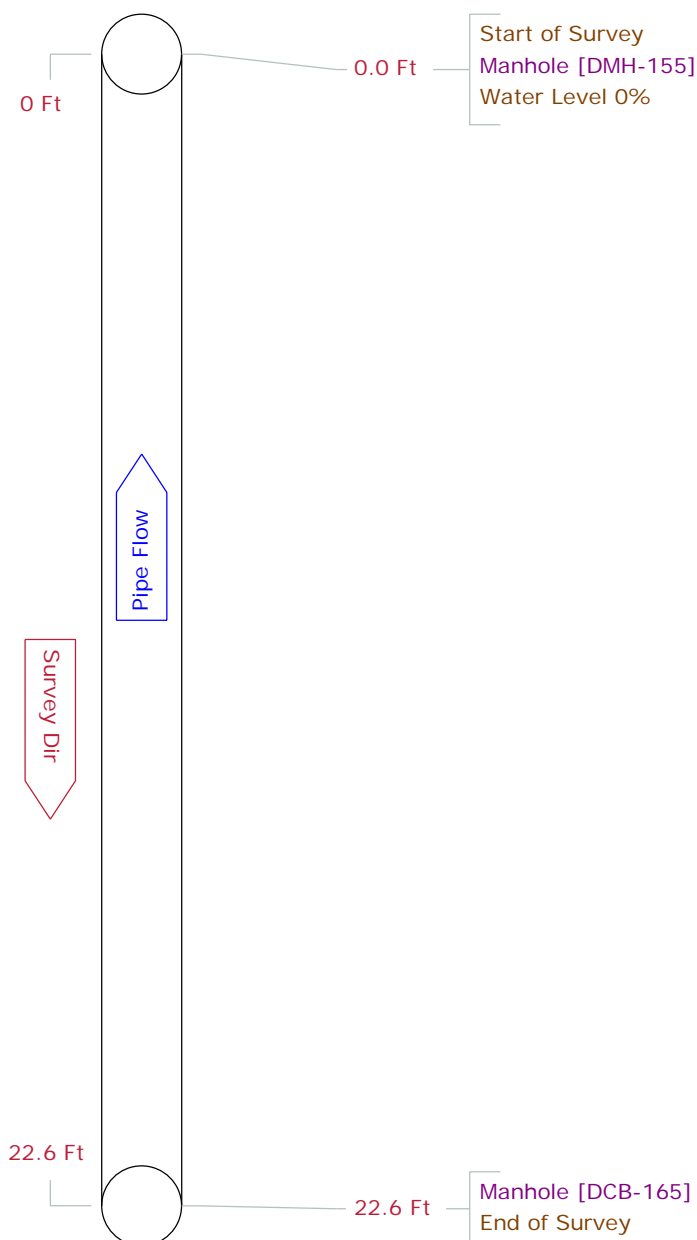
<b>Setup</b> 13	<b>Surveyor</b> WP	<b>Certificate #</b> T-001-002	<b>System Owner</b> SUNY OF ALBANY
<b>Drainage</b> STORM DRAIN	<b>Survey Customer</b> WOODARD & CURRAN		
<b>P/O #</b>	<b>Date</b> 2007/08/06	<b>Time</b> 9:54	<b>Street</b> SUNY OF ALBANY
<b>Locality</b> VARIOUS LOCATIONS	<b>Further location details</b>		
<b>Start</b> DMH-155	<b>Rim to invert</b>	<b>Grade to invert</b>	<b>Rim to grade</b> <b>Ft</b>
<b>Finish</b> DCB-165	<b>Rim to invert</b>	<b>Grade to invert</b>	<b>Rim to grade</b> <b>Ft</b>
<b>Use</b> Stormwater	<b>Direction</b> Upstream	<b>Flow control</b> Not Controlled	<b>Tape/Media #</b> WP-03
<b>Shape</b> Circular	<b>Height</b> 15	<b>Width</b> ins	<b>Preclean</b> N <b>Year Cleaned</b>
<b>Material</b> Reinforced Concrete Pipe	<b>Joint length</b> <b>Ft</b>	<b>Total length</b> 22.6 <b>Ft</b>	<b>Length Surveyed</b> 22.60
<b>Lining</b>	<b>Year laid</b>	<b>Year rehabilitated</b>	<b>Weather</b> Dry

<b>Purpose</b> Infiltration/Inflow Investigation	<b>Cat</b>		
<b>Additional info</b>		<b>Structural</b>	<b>O&amp;M</b> <b>Constructional</b>
<b>Location</b> Parking Lot		<b>Miscellaneous</b>	<b>Hydraulic</b>

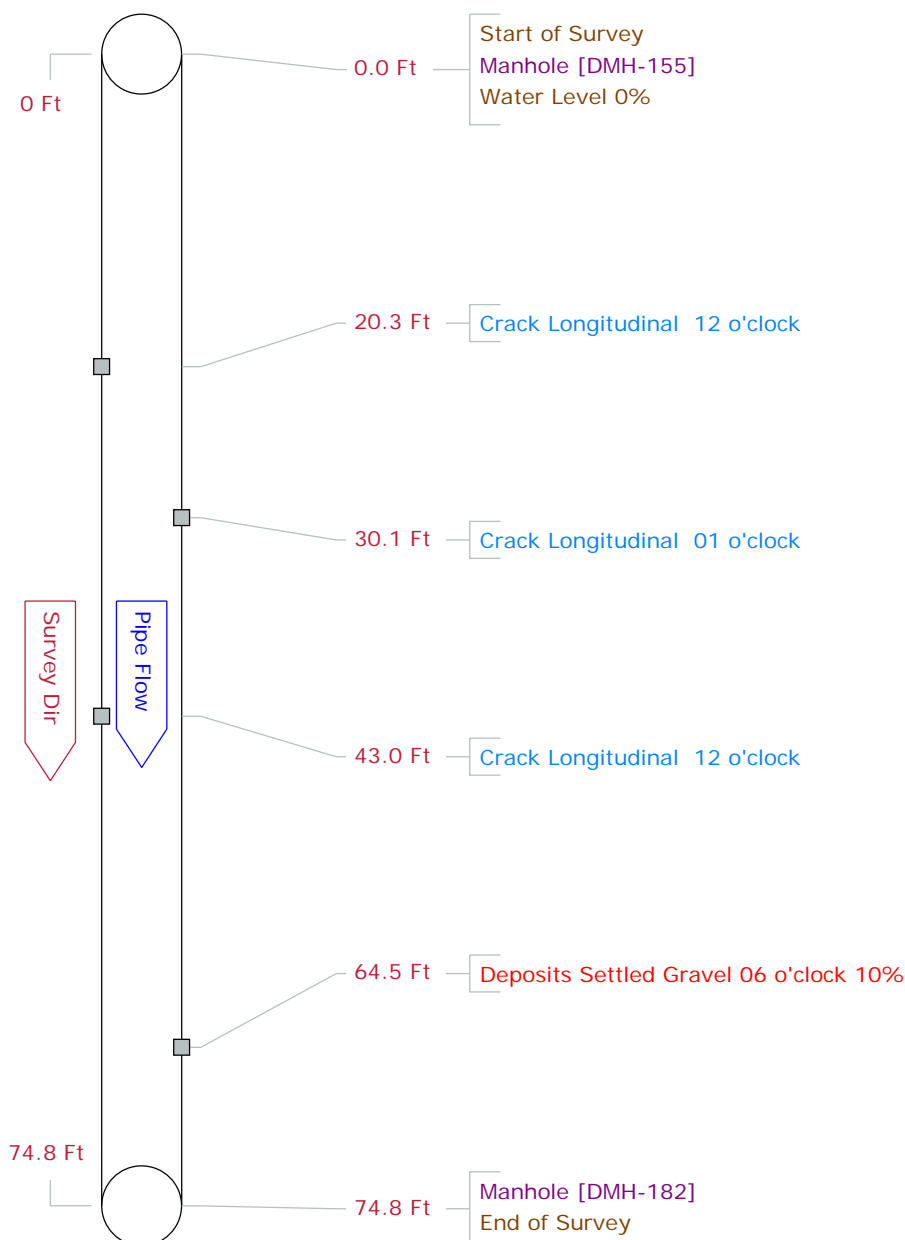
# Pipe Graphic Report of PLR DMH-155 X for WOODARD & CURRAN

<b>Setup</b> 14	<b>Surveyor</b> WP	<b>Certificate #</b> T-001-002	<b>System Owner</b> SUNY OF ALBANY
<b>Drainage</b> STORM DRAIN	<b>Survey Customer</b> WOODARD & CURRAN		
<b>P/O #</b>	<b>Date</b> 2007/08/06	<b>Time</b> 9:58	<b>Street</b> SUNY OF ALBANY
<b>Locality</b> VARIOUS LOCATIONS	<b>Further location details</b>		
<b>Start</b> DMH-155	<b>Rim to invert</b>	<b>Grade to invert</b>	<b>Rim to grade</b> <b>Ft</b>
<b>Finish</b> DMH-182	<b>Rim to invert</b>	<b>Grade to invert</b>	<b>Rim to grade</b> <b>Ft</b>
<b>Use</b> Stormwater	<b>Direction</b> Downstream	<b>Flow control</b> Not Controlled	<b>Tape/Media #</b> WP-03
<b>Shape</b> Circular	<b>Height</b> 15	<b>Width</b> ins	<b>Preclean</b> N <b>Year Cleaned</b>
<b>Material</b> Reinforced Concrete Pipe	<b>Joint length</b> <b>Ft</b>	<b>Total length</b> 74.8 <b>Ft</b>	<b>Length Surveyed</b> 74.80
<b>Lining</b>	<b>Year laid</b>	<b>Year rehabilitated</b>	<b>Weather</b> Dry

<b>Purpose</b> Infiltration/Inflow Investigation	<b>Cat</b>		
<b>Additional info</b>		<b>Structural</b>	<b>O&amp;M</b> <b>Constructional</b>
<b>Location</b> Parking Lot		<b>Miscellaneous</b>	<b>Hydraulic</b>

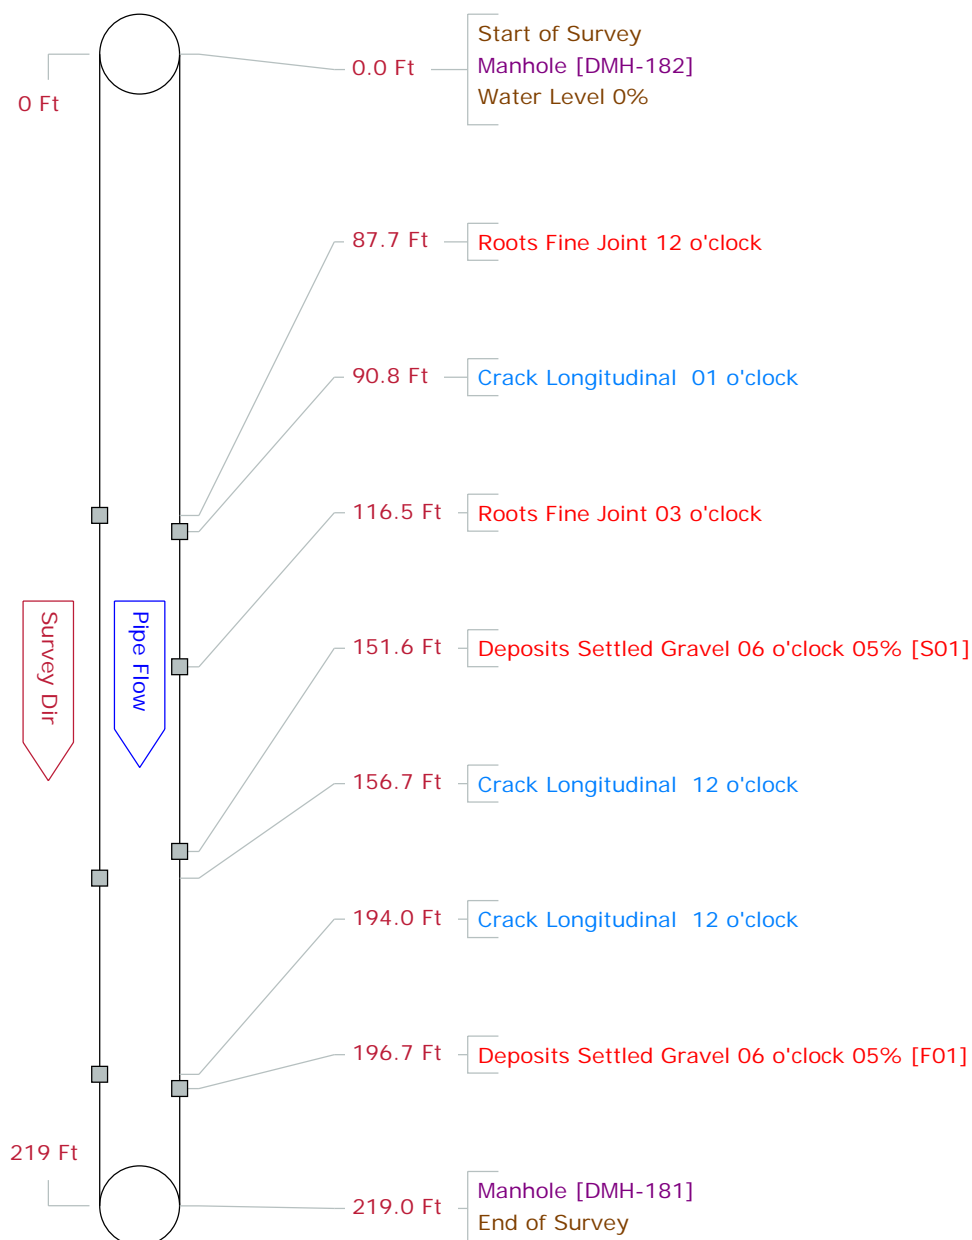
# Pipe Graphic Report of PLR DMH-182 X for WOODARD & CURRAN

<b>Setup</b> 15	<b>Surveyor</b> WP	<b>Certificate #</b> T-001-002	<b>System Owner</b> SUNY OF ALBANY
<b>Drainage</b> STORM DRAIN	<b>Survey Customer</b> WOODARD & CURRAN		
<b>P/O #</b>	<b>Date</b> 2007/08/06	<b>Time</b> 10:16	<b>Street</b> SUNY OF ALBANY
<b>Locality</b> VARIOUS LOCATIONS	<b>Further location details</b>		
<b>Start</b> DMH-182	<b>Rim to invert</b>	<b>Grade to invert</b>	<b>Rim to grade</b> <b>Ft</b>
<b>Finish</b> DMH-181	<b>Rim to invert</b>	<b>Grade to invert</b>	<b>Rim to grade</b> <b>Ft</b>
<b>Use</b> Stormwater	<b>Direction</b> Downstream	<b>Flow control</b> Not Controlled	<b>Tape/Media #</b> WP-03
<b>Shape</b> Circular	<b>Height</b> 18	<b>Width</b> ins	<b>Preclean</b> N <b>Year Cleaned</b>
<b>Material</b> Reinforced Concrete Pipe	<b>Joint length</b> <b>Ft</b>	<b>Total length</b> 219.0 <b>Ft</b>	<b>Length Surveyed</b> 219.00
<b>Lining</b>	<b>Year laid</b>	<b>Year rehabilitated</b>	<b>Weather</b> Dry

<b>Purpose</b> Infiltration/Inflow Investigation	<b>Cat</b>		
<b>Additional info</b>		<b>Structural</b>	<b>O&amp;M</b> <b>Constructional</b>
<b>Location</b> Parking Lot		<b>Miscellaneous</b>	<b>Hydraulic</b>

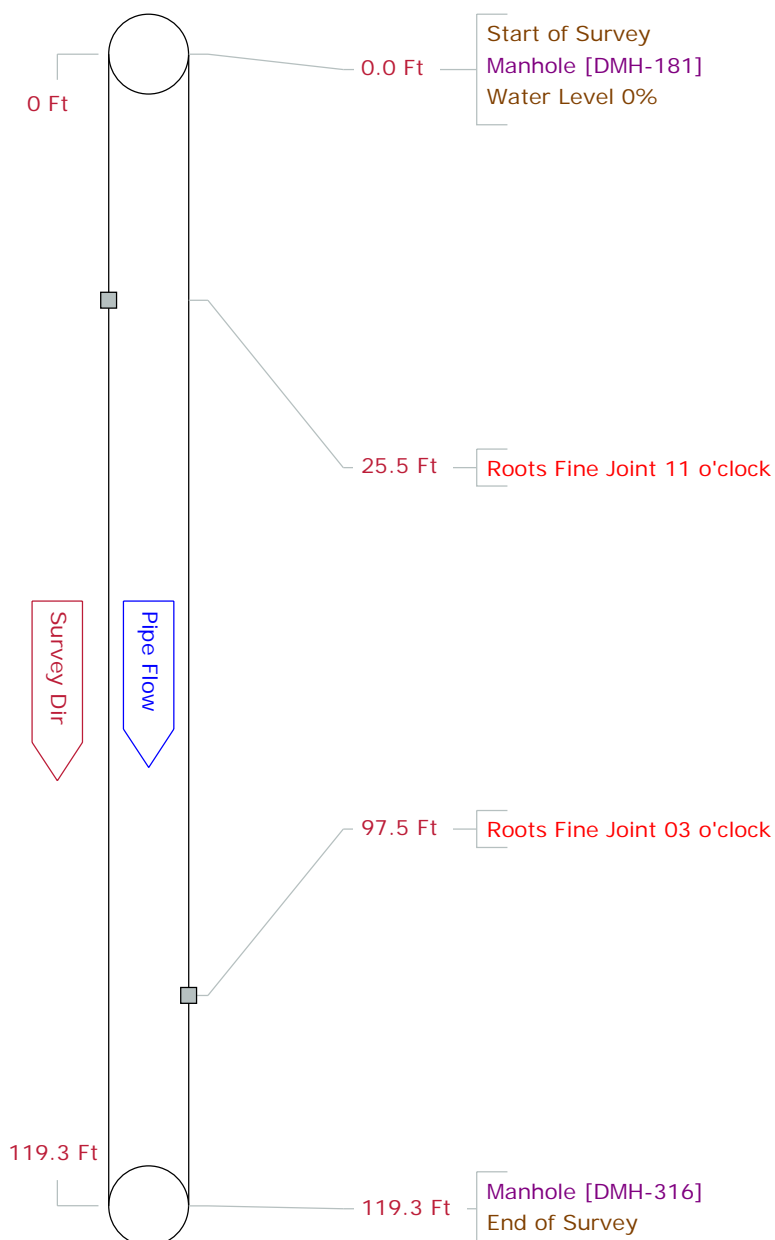
# Pipe Graphic Report of PLR DMH-181 X for WOODARD & CURRAN

<b>Setup</b> 16	<b>Surveyor</b> WP	<b>Certificate #</b> T-001-002	<b>System Owner</b> SUNY OF ALBANY
<b>Drainage</b> STORM DRAIN	<b>Survey Customer</b> WOODARD & CURRAN		
<b>P/O #</b>	<b>Date</b> 2007/08/06	<b>Time</b> 12:54	<b>Street</b> SUNY OF ALBANY
<b>Locality</b> VARIOUS LOCATIONS	<b>Further location details</b>		
<b>Start</b> DMH-181	<b>Rim to invert</b>	<b>Grade to invert</b>	<b>Rim to grade</b> <b>Ft</b>
<b>Finish</b> DMH-316	<b>Rim to invert</b>	<b>Grade to invert</b>	<b>Rim to grade</b> <b>Ft</b>
<b>Use</b> Stormwater	<b>Direction</b> Downstream	<b>Flow control</b> Not Controlled	<b>Tape/Media #</b> WP-03
<b>Shape</b> Circular	<b>Height</b> 18	<b>Width</b> ins	<b>Preclean</b> N <b>Year Cleaned</b>
<b>Material</b> Reinforced Concrete Pipe	<b>Joint length</b> <b>Ft</b>	<b>Total length</b> 119.3 <b>Ft</b>	<b>Length Surveyed</b> 119.30
<b>Lining</b>	<b>Year laid</b>	<b>Year rehabilitated</b>	<b>Weather</b> Dry

<b>Purpose</b> Infiltration/Inflow Investigation	<b>Cat</b>		
<b>Additional info</b>		<b>Structural</b>	<b>O&amp;M</b> <b>Constructional</b>
<b>Location</b> Parking Lot		<b>Miscellaneous</b>	<b>Hydraulic</b>

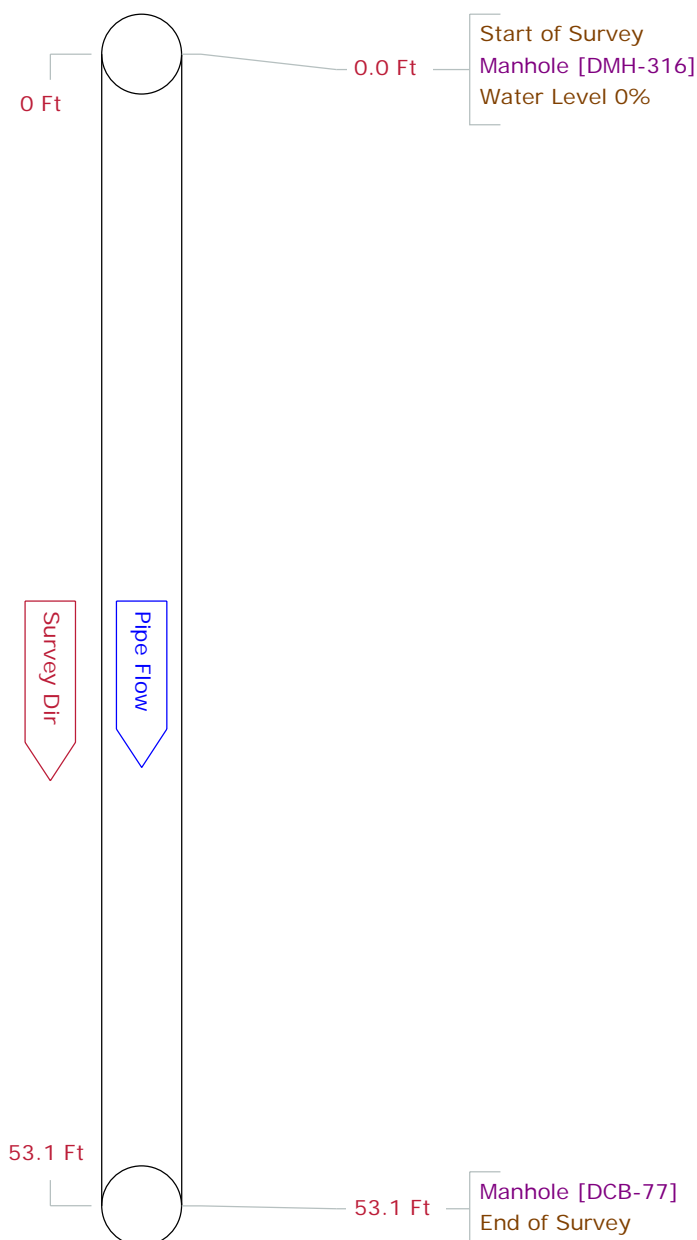
# Pipe Graphic Report of PLR DMH-316 X for WOODARD & CURRAN

<b>Setup</b> 17	<b>Surveyor</b> WP	<b>Certificate #</b> T-001-002	<b>System Owner</b> SUNY OF ALBANY
<b>Drainage</b> STORM DRAIN	<b>Survey Customer</b> WOODARD & CURRAN		
<b>P/O #</b>	<b>Date</b> 2007/08/06	<b>Time</b> 13:00	<b>Street</b> SUNY OF ALBANY
<b>Locality</b> VARIOUS LOCATIONS	<b>Further location details</b>		
<b>Start</b> DMH-316	<b>Rim to invert</b>	<b>Grade to invert</b>	<b>Rim to grade</b> <b>Ft</b>
<b>Finish</b> DCB-77	<b>Rim to invert</b>	<b>Grade to invert</b>	<b>Rim to grade</b> <b>Ft</b>
<b>Use</b> Stormwater	<b>Direction</b> Downstream	<b>Flow control</b> Not Controlled	<b>Tape/Media #</b> WP-03
<b>Shape</b> Circular	<b>Height</b> 18	<b>Width</b> ins	<b>Preclean</b> N <b>Year Cleaned</b>
<b>Material</b> Reinforced Concrete Pipe	<b>Joint length</b> <b>Ft</b>	<b>Total length</b> 53.1 <b>Ft</b>	<b>Length Surveyed</b> 53.10
<b>Lining</b>	<b>Year laid</b>	<b>Year rehabilitated</b>	<b>Weather</b> Dry

<b>Purpose</b> Infiltration/Inflow Investigation	<b>Cat</b>		
<b>Additional info</b>		<b>Structural</b>	<b>O&amp;M</b> <b>Constructional</b>
<b>Location</b> Parking Lot		<b>Miscellaneous</b>	<b>Hydraulic</b>

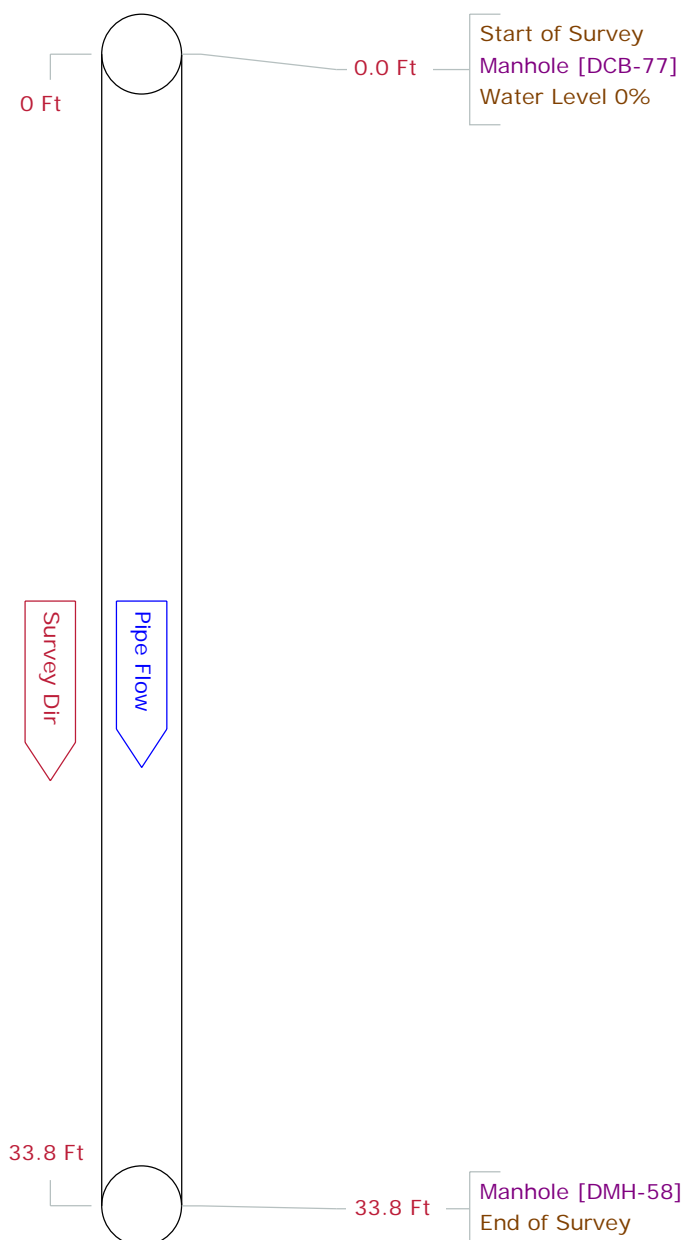
# Pipe Graphic Report of PLR DCB-77 X for WOODARD & CURRAN

<b>Setup</b> 18	<b>Surveyor</b> WP	<b>Certificate #</b> T-001-002	<b>System Owner</b> SUNY OF ALBANY
<b>Drainage</b> STORM DRAIN	<b>Survey Customer</b> WOODARD & CURRAN		
<b>P/O #</b>	<b>Date</b> 2007/08/06	<b>Time</b> 13:03	<b>Street</b> SUNY OF ALBANY
<b>Locality</b> VARIOUS LOCATIONS	<b>Further location details</b>		
<b>Start</b> DCB-77	<b>Rim to invert</b>	<b>Grade to invert</b>	<b>Rim to grade</b> <b>Ft</b>
<b>Finish</b> DMH-58	<b>Rim to invert</b>	<b>Grade to invert</b>	<b>Rim to grade</b> <b>Ft</b>
<b>Use</b> Stormwater	<b>Direction</b> Downstream	<b>Flow control</b> Not Controlled	<b>Tape/Media #</b> WP-03
<b>Shape</b> Circular	<b>Height</b> 21	<b>Width</b> ins	<b>Preclean</b> N <b>Year Cleaned</b>
<b>Material</b> Reinforced Concrete Pipe	<b>Joint length</b> <b>Ft</b>	<b>Total length</b> 33.8	<b>Ft</b> <b>Length Surveyed</b> 33.80
<b>Lining</b>	<b>Year laid</b>	<b>Year rehabilitated</b>	<b>Weather</b> Dry

<b>Purpose</b> Infiltration/Inflow Investigation	<b>Cat</b>		
<b>Additional info</b>		<b>Structural</b>	<b>O&amp;M</b> <b>Constructional</b>
<b>Location</b> Parking Lot		<b>Miscellaneous</b>	<b>Hydraulic</b>

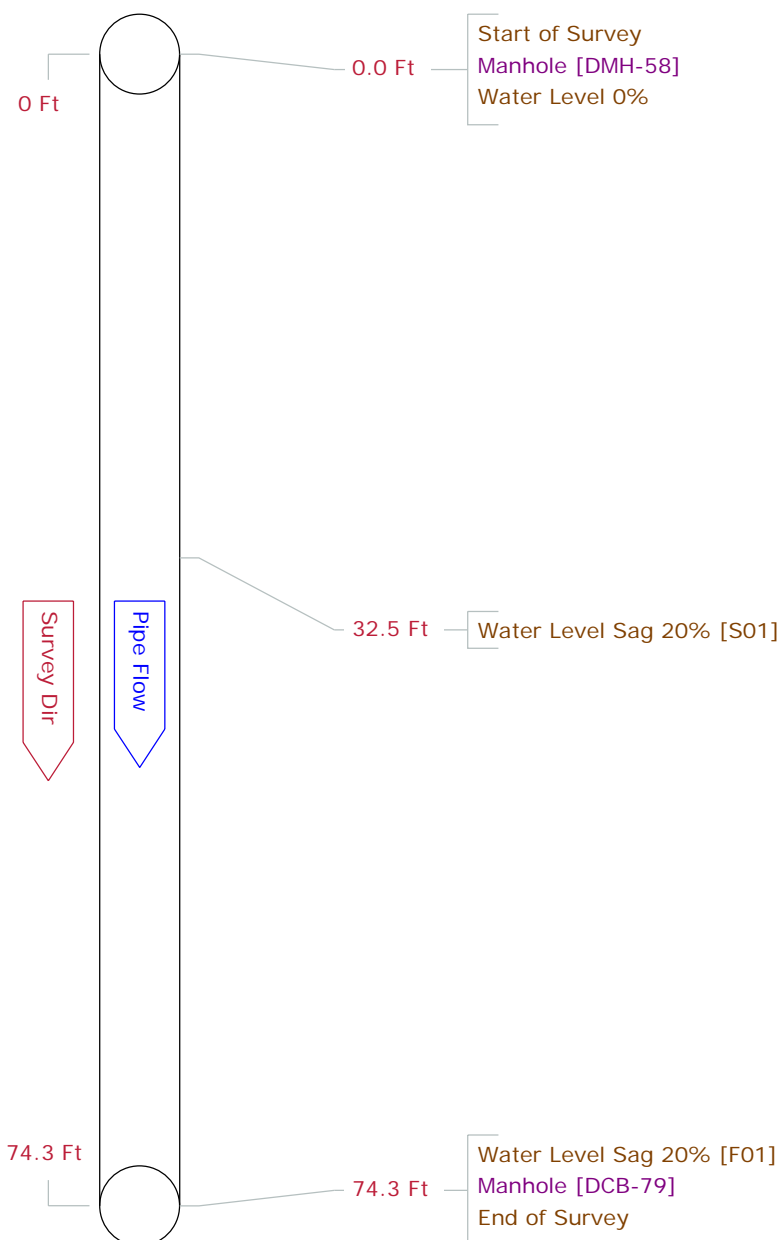
# Pipe Graphic Report of PLR DMH-58 X for WOODARD & CURRAN

<b>Setup</b> 19	<b>Surveyor</b> WP	<b>Certificate #</b> T-001-002	<b>System Owner</b> SUNY OF ALBANY
<b>Drainage</b> STORM DRAIN	<b>Survey Customer</b> WOODARD & CURRAN		
<b>P/O #</b>	<b>Date</b> 2007/08/06	<b>Time</b> 13:06	<b>Street</b> SUNY OF ALBANY
<b>Locality</b> VARIOUS LOCATIONS	<b>Further location details</b>		
<b>Start</b> DMH-58	<b>Rim to invert</b>	<b>Grade to invert</b>	<b>Rim to grade</b> <b>Ft</b>
<b>Finish</b> DCB-79	<b>Rim to invert</b>	<b>Grade to invert</b>	<b>Rim to grade</b> <b>Ft</b>
<b>Use</b> Stormwater	<b>Direction</b> Downstream	<b>Flow control</b> Not Controlled	<b>Tape/Media #</b> WP-03
<b>Shape</b> Circular	<b>Height</b> 21	<b>Width</b> ins	<b>Preclean</b> N <b>Year Cleaned</b>
<b>Material</b> Reinforced Concrete Pipe	<b>Joint length</b> <b>Ft</b>	<b>Total length</b> 74.3	<b>Ft</b> <b>Length Surveyed</b> 74.30
<b>Lining</b>	<b>Year laid</b>	<b>Year rehabilitated</b>	<b>Weather</b> Dry

<b>Purpose</b> Infiltration/Inflow Investigation	<b>Cat</b>		
<b>Additional info</b>		<b>Structural</b>	<b>O&amp;M</b> <b>Constructional</b>
<b>Location</b> Parking Lot		<b>Miscellaneous</b>	<b>Hydraulic</b>

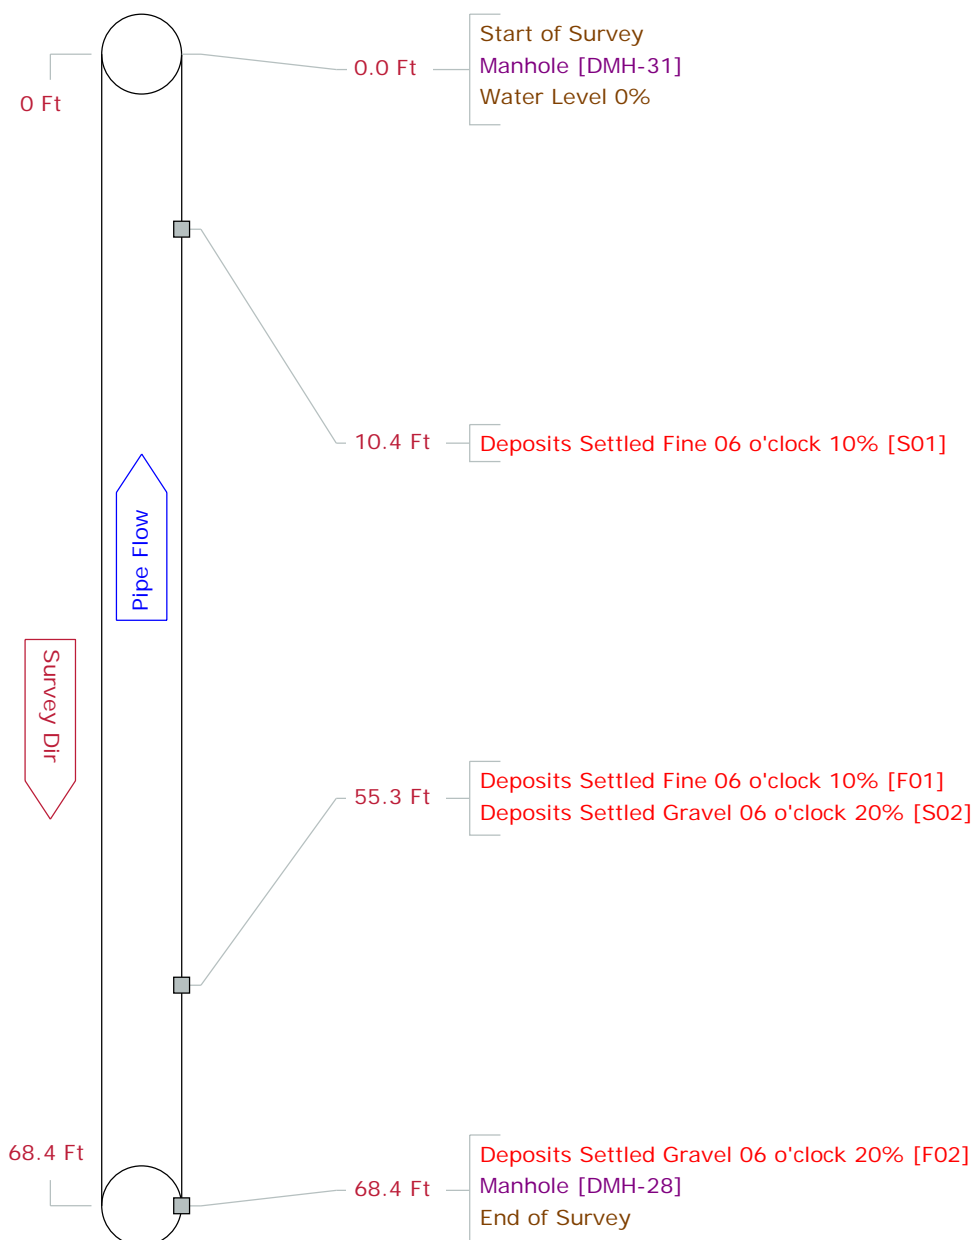
# Pipe Graphic Report of PLR DMH-28 X for WOODARD & CURRAN

<b>Setup</b> 20	<b>Surveyor</b> WP	<b>Certificate #</b> T-001-002	<b>System Owner</b> SUNY OF ALBANY
<b>Drainage</b> STORM DRAIN	<b>Survey Customer</b> WOODARD & CURRAN		
<b>P/O #</b>	<b>Date</b> 2007/08/06	<b>Time</b> 13:46	<b>Street</b> SUNY OF ALBANY
<b>Locality</b> VARIOUS LOCATIONS	<b>Further location details</b>		
<b>Start</b> DMH-31	<b>Rim to invert</b>	<b>Grade to invert</b>	<b>Rim to grade</b> <b>Ft</b>
<b>Finish</b> DMH-28	<b>Rim to invert</b>	<b>Grade to invert</b>	<b>Rim to grade</b> <b>Ft</b>
<b>Use</b> Stormwater	<b>Direction</b> Upstream	<b>Flow control</b> Not Controlled	<b>Tape/Media #</b> WP-03
<b>Shape</b> Circular	<b>Height</b> 15	<b>Width</b> ins	<b>Preclean</b> N <b>Year Cleaned</b>
<b>Material</b> Reinforced Concrete Pipe	<b>Joint length</b> <b>Ft</b>	<b>Total length</b> 68.4 <b>Ft</b>	<b>Length Surveyed</b> 68.40
<b>Lining</b>	<b>Year laid</b>	<b>Year rehabilitated</b>	<b>Weather</b> Dry

<b>Purpose</b> Infiltration/Inflow Investigation	<b>Cat</b>		
<b>Additional info</b>		<b>Structural</b>	<b>O&amp;M</b> <b>Constructional</b>
<b>Location</b> Parking Lot		<b>Miscellaneous</b>	<b>Hydraulic</b>

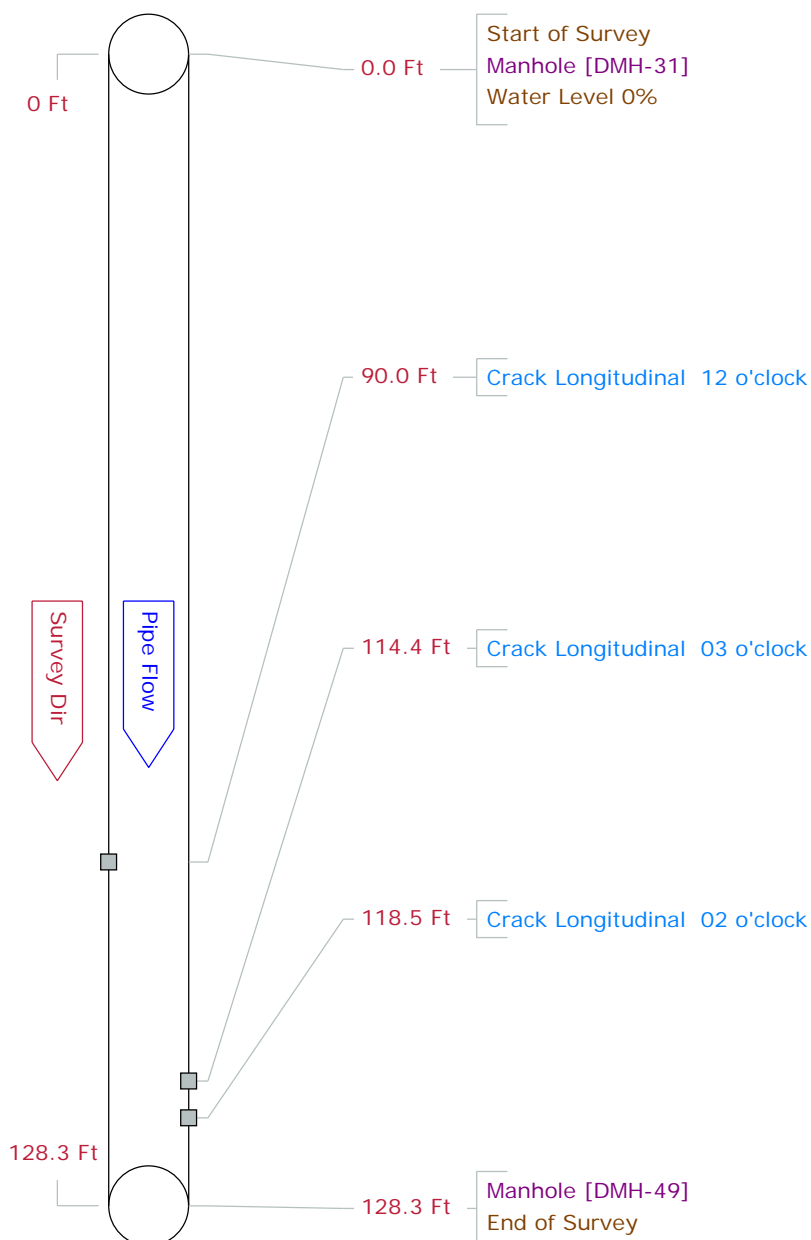
# Pipe Graphic Report of PLR DMH-31 X for WOODARD & CURRAN

<b>Setup</b> 21	<b>Surveyor</b> WP	<b>Certificate #</b> T-001-002	<b>System Owner</b> SUNY OF ALBANY
<b>Drainage</b> STORM DRAIN	<b>Survey Customer</b> WOODARD & CURRAN		
<b>P/O #</b>	<b>Date</b> 2007/08/06	<b>Time</b> 13:56	<b>Street</b> SUNY OF ALBANY
<b>Locality</b> VARIOUS LOCATIONS	<b>Further location details</b>		
<b>Start</b> DMH-31	<b>Rim to invert</b>	<b>Grade to invert</b>	<b>Rim to grade</b> <b>Ft</b>
<b>Finish</b> DMH-49A	<b>Rim to invert</b>	<b>Grade to invert</b>	<b>Rim to grade</b> <b>Ft</b>
<b>Use</b> Stormwater	<b>Direction</b> Downstream	<b>Flow control</b> Not Controlled	<b>Tape/Media #</b> WP-03
<b>Shape</b> Circular	<b>Height</b> 15	<b>Width</b> ins	<b>Preclean</b> N <b>Year Cleaned</b>
<b>Material</b> Reinforced Concrete Pipe	<b>Joint length</b> <b>Ft</b>	<b>Total length</b> 128.3 <b>Ft</b>	<b>Length Surveyed</b> 128.30
<b>Lining</b>	<b>Year laid</b>	<b>Year rehabilitated</b>	<b>Weather</b> Dry

<b>Purpose</b> Infiltration/Inflow Investigation	<b>Cat</b>		
<b>Additional info</b>		<b>Structural</b>	<b>O&amp;M</b> <b>Constructional</b>
<b>Location</b> Parking Lot		<b>Miscellaneous</b>	<b>Hydraulic</b>

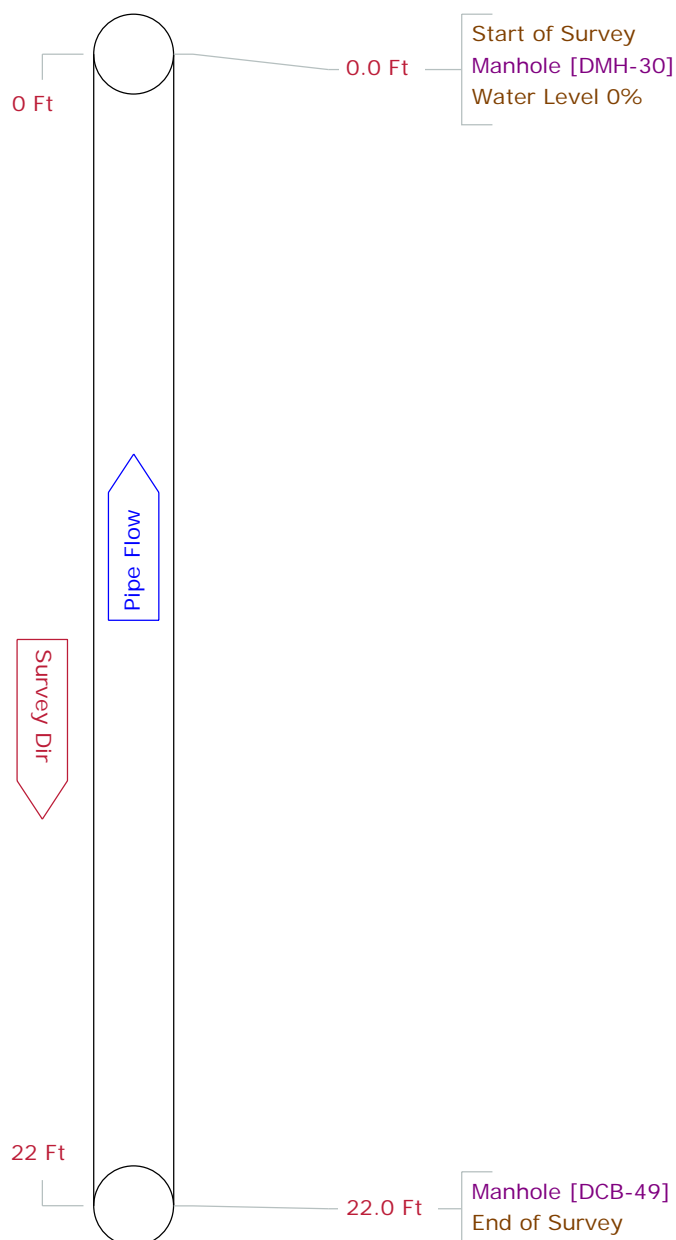
# Pipe Graphic Report of PLR DCB-50 X for WOODARD & CURRAN

<b>Setup</b> 22	<b>Surveyor</b> WP	<b>Certificate #</b> T-001-002	<b>System Owner</b> SUNY OF ALBANY
<b>Drainage</b> STORM DRAIN	<b>Survey Customer</b> WOODARD & CURRAN		
<b>P/O #</b>	<b>Date</b> 2007/08/06	<b>Time</b> 14:19	<b>Street</b> SUNY OF ALBANY
<b>Locality</b> VARIOUS LOCATIONS	<b>Further location details</b>		
<b>Start</b> DMH-30	<b>Rim to invert</b>	<b>Grade to invert</b>	<b>Rim to grade</b> <b>Ft</b>
<b>Finish</b> DCB-50	<b>Rim to invert</b>	<b>Grade to invert</b>	<b>Rim to grade</b> <b>Ft</b>
<b>Use</b> Stormwater	<b>Direction</b> Upstream	<b>Flow control</b> Not Controlled	<b>Tape/Media #</b> WP-03
<b>Shape</b> Circular	<b>Height</b> 15	<b>Width</b> ins	<b>Preclean</b> N <b>Year Cleaned</b>
<b>Material</b> Reinforced Concrete Pipe	<b>Joint length</b> <b>Ft</b>	<b>Total length</b> 22.0 <b>Ft</b>	<b>Length Surveyed</b> 22.00
<b>Lining</b>	<b>Year laid</b>	<b>Year rehabilitated</b>	<b>Weather</b> Dry

<b>Purpose</b> Infiltration/Inflow Investigation	<b>Cat</b>		
<b>Additional info</b>		<b>Structural</b>	<b>O&amp;M</b> <b>Constructional</b>
<b>Location</b> Parking Lot		<b>Miscellaneous</b>	<b>Hydraulic</b>

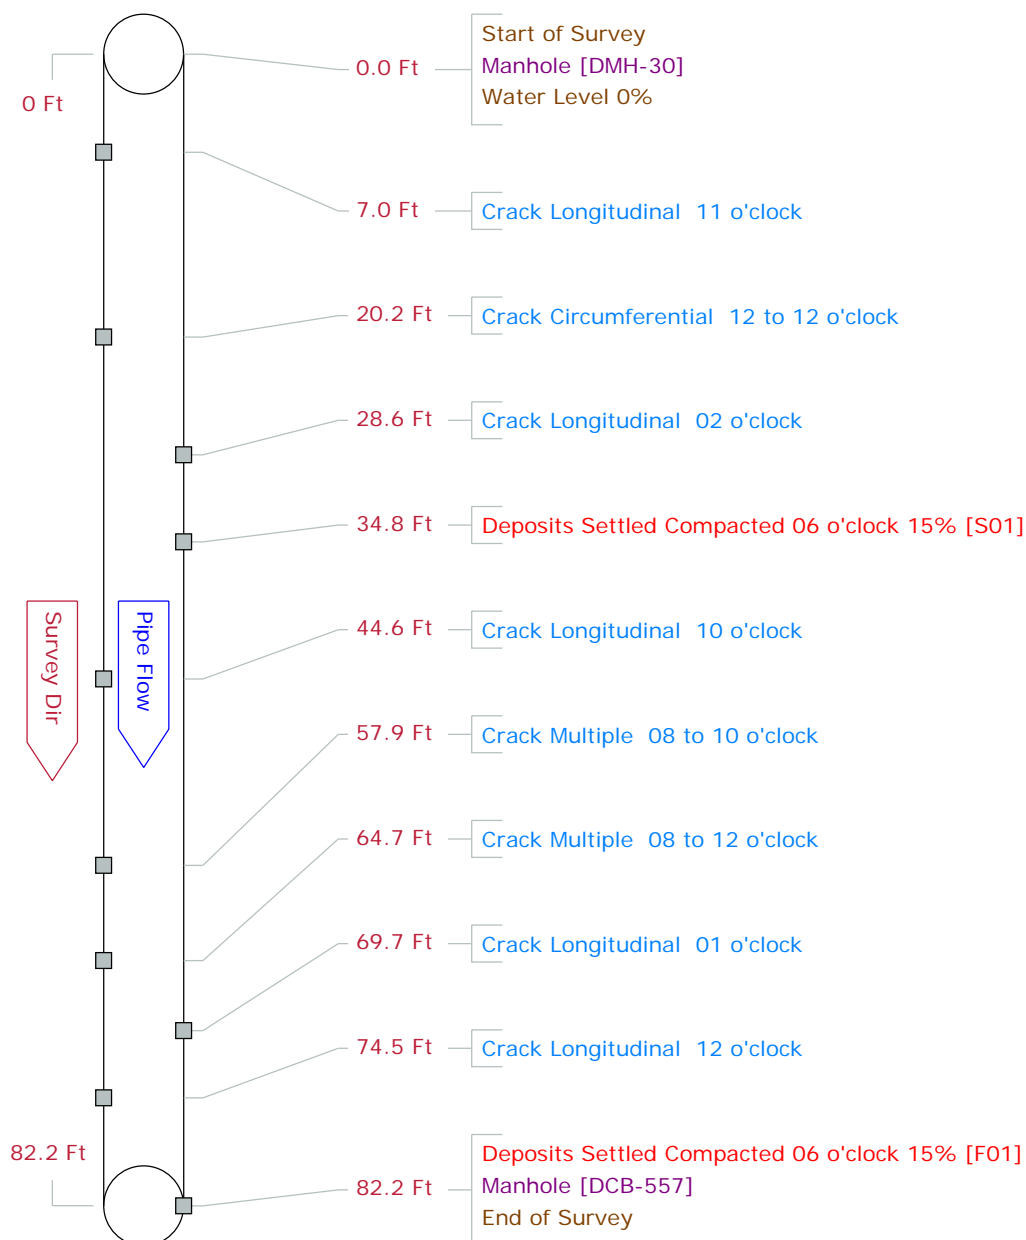
# Pipe Graphic Report of PLR DMH-30 X for WOODARD & CURRAN

<b>Setup</b> 23	<b>Surveyor</b> WP	<b>Certificate #</b> T-001-002	<b>System Owner</b> SUNY OF ALBANY
<b>Drainage</b> STORM DRAIN	<b>Survey Customer</b> WOODARD & CURRAN		
<b>P/O #</b>	<b>Date</b> 2007/08/06	<b>Time</b> 14:23	<b>Street</b> SUNY OF ALBANY
<b>Locality</b> VARIOUS LOCATIONS	<b>Further location details</b>		
<b>Start</b> DMH-30	<b>Rim to invert</b>	<b>Grade to invert</b>	<b>Rim to grade</b> <b>Ft</b>
<b>Finish</b> DCB-557	<b>Rim to invert</b>	<b>Grade to invert</b>	<b>Rim to grade</b> <b>Ft</b>
<b>Use</b> Stormwater	<b>Direction</b> Downstream	<b>Flow control</b> Not Controlled	<b>Tape/Media #</b> WP-03
<b>Shape</b> Circular	<b>Height</b> 15	<b>Width</b> ins	<b>Preclean</b> N
<b>Material</b> Reinforced Concrete Pipe	<b>Joint length</b> <b>Ft</b>	<b>Total length</b> 82.2 <b>Ft</b>	<b>Length Surveyed</b> 82.20
<b>Lining</b>	<b>Year laid</b>	<b>Year rehabilitated</b>	<b>Weather</b> Dry
<b>Purpose</b> Infiltration/Inflow Investigation	<b>Cat</b>

<b>Additional info</b>		<b>Structural</b>	<b>O&amp;M</b>
<b>Location</b> Parking Lot		<b>Miscellaneous</b>	<b>Hydraulic</b>

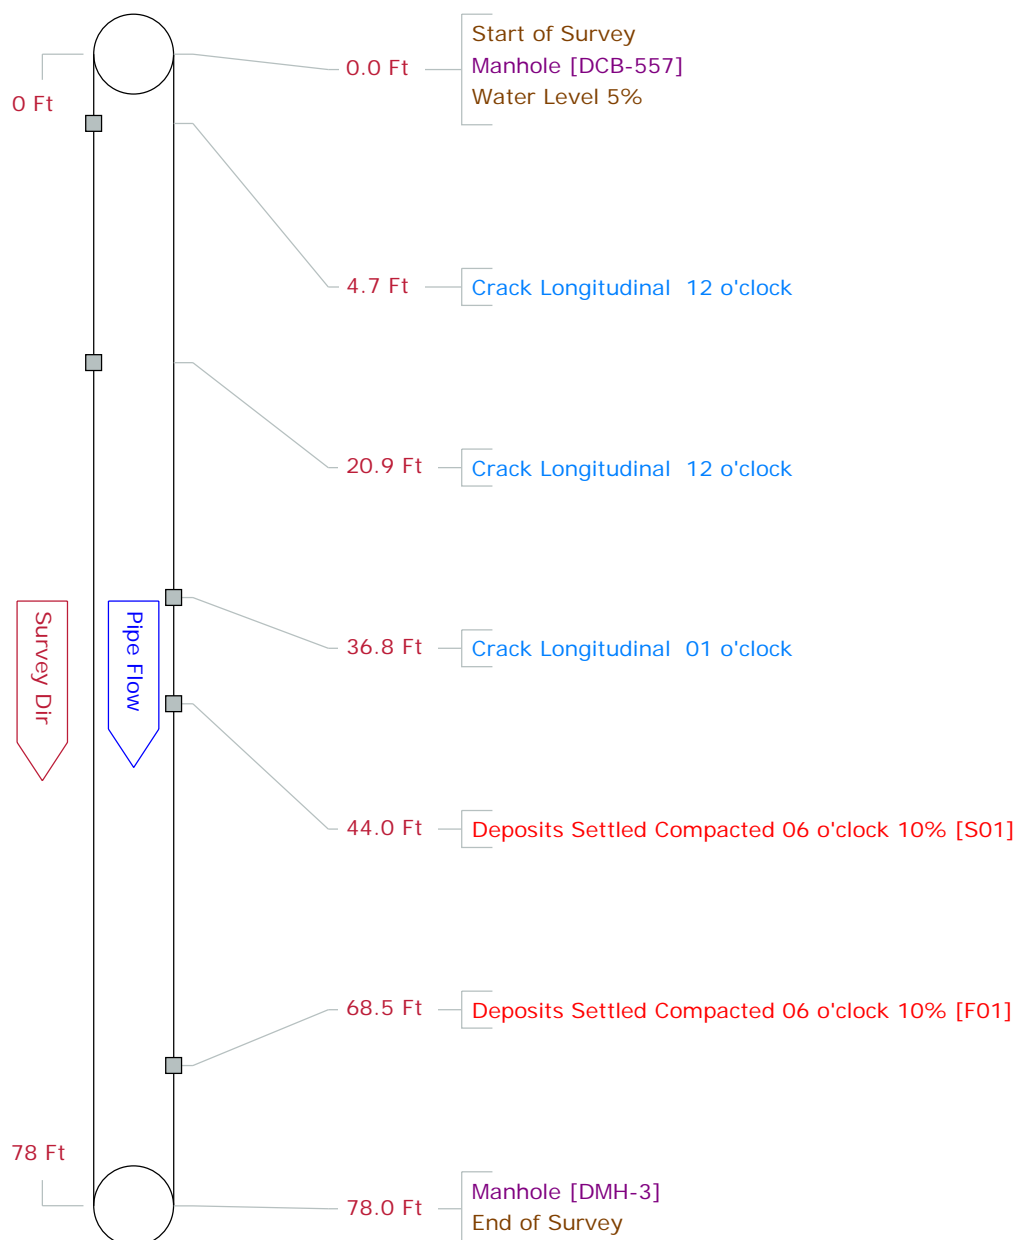
# Pipe Graphic Report of PLR DCB-557 X for WOODARD & CURRAN

<b>Setup</b> 24	<b>Surveyor</b> WP	<b>Certificate #</b> T-001-002	<b>System Owner</b> SUNY OF ALBANY
<b>Drainage</b> STORM DRAIN	<b>Survey Customer</b> WOODARD & CURRAN		
<b>P/O #</b>	<b>Date</b> 2007/08/06	<b>Time</b> 14:30	<b>Street</b> SUNY OF ALBANY
<b>Locality</b> VARIOUS LOCATIONS	<b>Further location details</b>		
<b>Start</b> DCB-557	<b>Rim to invert</b>	<b>Grade to invert</b>	<b>Rim to grade</b> <b>Ft</b>
<b>Finish</b> DMH-3	<b>Rim to invert</b>	<b>Grade to invert</b>	<b>Rim to grade</b> <b>Ft</b>
<b>Use</b> Stormwater	<b>Direction</b> Downstream	<b>Flow control</b> Not Controlled	<b>Tape/Media #</b> WP-03
<b>Shape</b> Circular	<b>Height</b> 18	<b>Width</b> ins	<b>Preclean</b> N <b>Year Cleaned</b>
<b>Material</b> Reinforced Concrete Pipe	<b>Joint length</b> <b>Ft</b>	<b>Total length</b> 78.0 <b>Ft</b>	<b>Length Surveyed</b> 78.00
<b>Lining</b>	<b>Year laid</b>	<b>Year rehabilitated</b>	<b>Weather</b> Dry

<b>Purpose</b> Infiltration/Inflow Investigation	<b>Cat</b>		
<b>Additional info</b>		<b>Structural</b>	<b>O&amp;M</b> <b>Constructional</b>
<b>Location</b> Parking Lot		<b>Miscellaneous</b>	<b>Hydraulic</b>

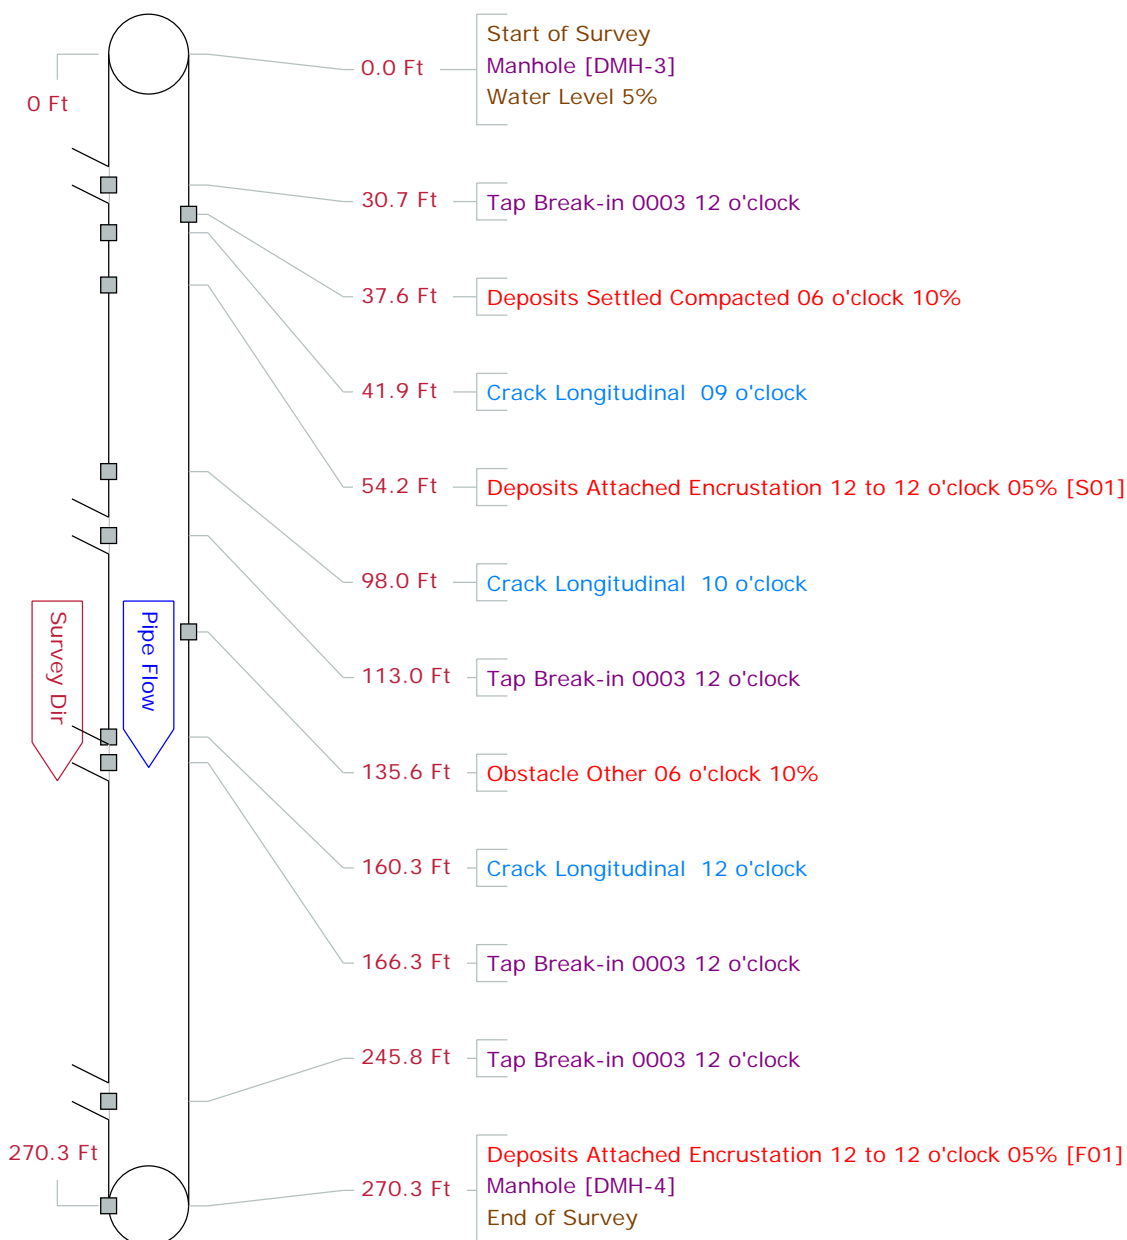
# Pipe Graphic Report of PLR DMH-3 X for WOODARD & CURRAN

<b>Setup</b> 25	<b>Surveyor</b> WP	<b>Certificate #</b> T-001-002	<b>System Owner</b> SUNY OF ALBANY
<b>Drainage</b> STORM DRAIN	<b>Survey Customer</b> WOODARD & CURRAN		
<b>P/O #</b>	<b>Date</b> 2007/08/06	<b>Time</b> 14:38	<b>Street</b> SUNY OF ALBANY
<b>Locality</b> VARIOUS LOCATIONS	<b>Further location details</b>		
<b>Start</b> DMH-3	<b>Rim to invert</b>	<b>Grade to invert</b>	<b>Rim to grade</b> <b>Ft</b>
<b>Finish</b> DMH-4	<b>Rim to invert</b>	<b>Grade to invert</b>	<b>Rim to grade</b> <b>Ft</b>
<b>Use</b> Stormwater	<b>Direction</b> Downstream	<b>Flow control</b> Not Controlled	<b>Tape/Media #</b> WP-03
<b>Shape</b> Circular	<b>Height</b> 18	<b>Width</b> ins	<b>Preclean</b> N <b>Year Cleaned</b>
<b>Material</b> Reinforced Concrete Pipe	<b>Joint length</b> <b>Ft</b>	<b>Total length</b> 270.3 <b>Ft</b>	<b>Length Surveyed</b> 270.30
<b>Lining</b>	<b>Year laid</b>	<b>Year rehabilitated</b>	<b>Weather</b> Dry

<b>Purpose</b> Infiltration/Inflow Investigation	<b>Cat</b>		
<b>Additional info</b>		<b>Structural</b>	<b>O&amp;M</b> <b>Constructional</b>
<b>Location</b> Parking Lot		<b>Miscellaneous</b>	<b>Hydraulic</b>

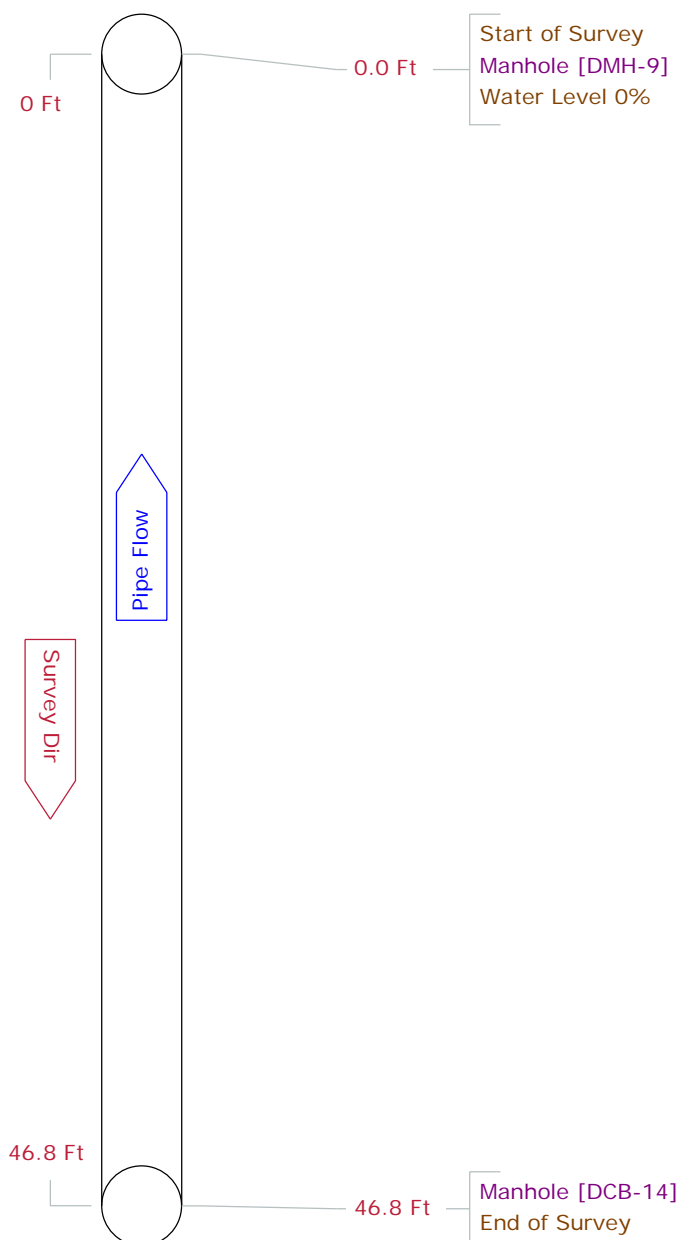
# Pipe Graphic Report of PLR DCB-14 X for WOODARD & CURRAN

<b>Setup</b> 26	<b>Surveyor</b> WP	<b>Certificate #</b> T-001-002	<b>System Owner</b> SUNY OF ALBANY
<b>Drainage</b> STORM DRAIN	<b>Survey Customer</b> WOODARD & CURRAN		
<b>P/O #</b>	<b>Date</b> 2007/08/06	<b>Time</b> 15:29	<b>Street</b> SUNY OF ALBANY
<b>Locality</b> VARIOUS LOCATIONS	<b>Further location details</b>		
<b>Start</b> DMH-9	<b>Rim to invert</b>	<b>Grade to invert</b>	<b>Rim to grade</b> <b>Ft</b>
<b>Finish</b> DCB-14	<b>Rim to invert</b>	<b>Grade to invert</b>	<b>Rim to grade</b> <b>Ft</b>
<b>Use</b> Stormwater	<b>Direction</b> Upstream	<b>Flow control</b> Not Controlled	<b>Tape/Media #</b> WP-03
<b>Shape</b> Circular	<b>Height</b> 15 <b>Width</b> ins	<b>Preclean</b> N	<b>Year Cleaned</b>
<b>Material</b> Reinforced Concrete Pipe	<b>Joint length</b> <b>Ft</b>	<b>Total length</b> 46.8 <b>Ft</b>	<b>Length Surveyed</b> 46.80
<b>Lining</b>	<b>Year laid</b>	<b>Year rehabilitated</b>	<b>Weather</b> Dry

<b>Purpose</b> Infiltration/Inflow Investigation	<b>Cat</b>		
<b>Additional info</b>		<b>Structural</b>	<b>O&amp;M</b> <b>Constructional</b>
<b>Location</b> Parking Lot		<b>Miscellaneous</b>	<b>Hydraulic</b>

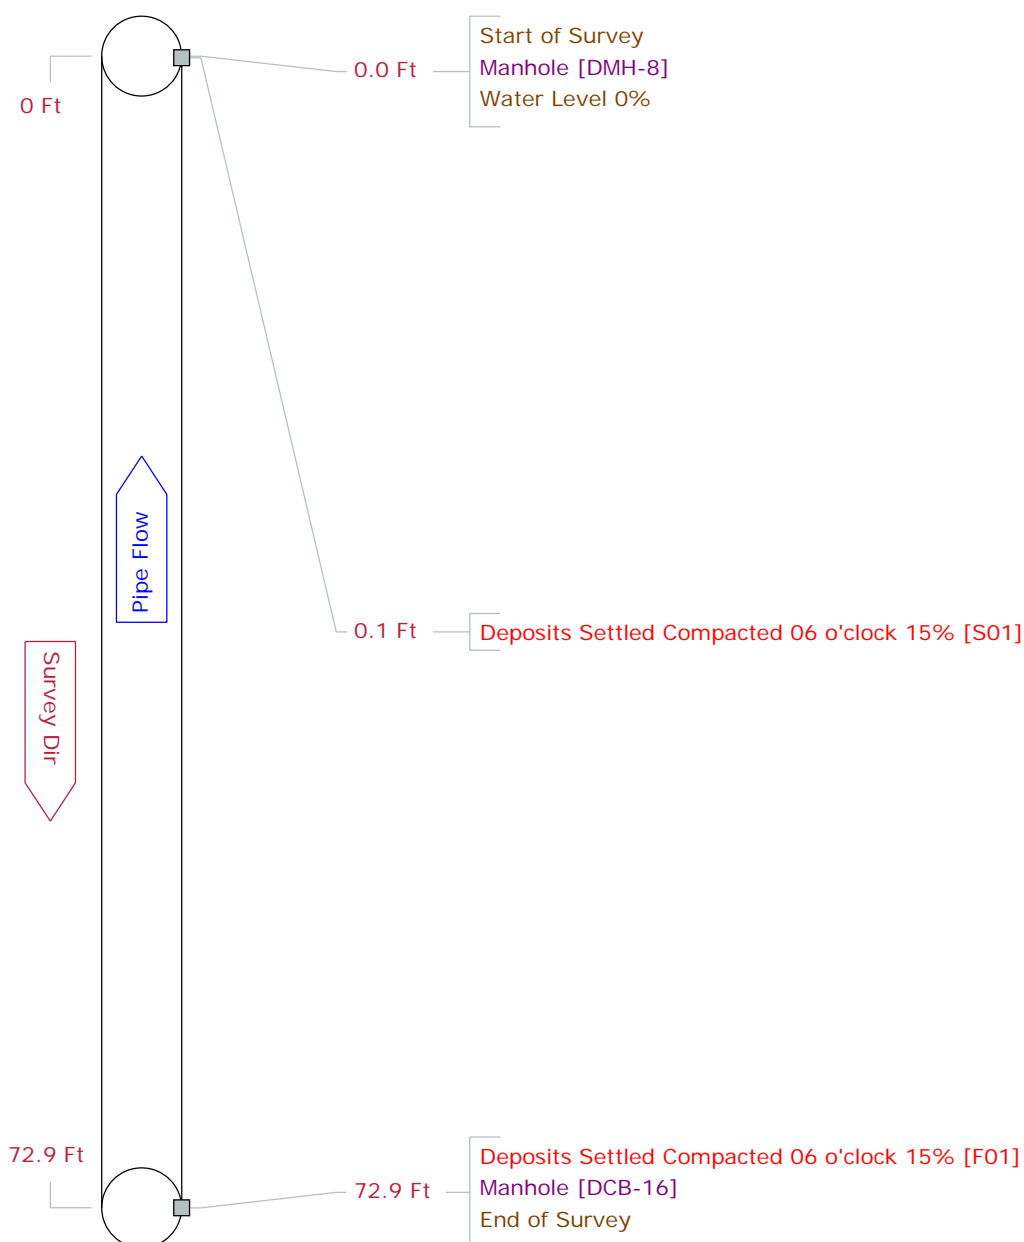
# Pipe Graphic Report of PLR DCB-16 X for WOODARD & CURRAN

<b>Setup</b> 28	<b>Surveyor</b> WP	<b>Certificate #</b> T-001-002	<b>System Owner</b> SUNY OF ALBANY
<b>Drainage</b> STORM DRAIN	<b>Survey Customer</b> WOODARD & CURRAN		
<b>P/O #</b>	<b>Date</b> 2007/08/07	<b>Time</b> 13:54	<b>Street</b> SUNY OF ALBANY
<b>Locality</b> VARIOUS LOCATIONS	<b>Further location details</b>		
<b>Start</b> DMH-8	<b>Rim to invert</b>	<b>Grade to invert</b>	<b>Rim to grade</b> <b>Ft</b>
<b>Finish</b> DCB-16	<b>Rim to invert</b>	<b>Grade to invert</b>	<b>Rim to grade</b> <b>Ft</b>
<b>Use</b> Stormwater	<b>Direction</b> Upstream	<b>Flow control</b> Not Controlled	<b>Tape/Media #</b> WP-03
<b>Shape</b> Circular	<b>Height</b> 15	<b>Width</b> ins	<b>Preclean</b> N <b>Year Cleaned</b>
<b>Material</b> Reinforced Concrete Pipe	<b>Joint length</b> <b>Ft</b>	<b>Total length</b> 72.9 <b>Ft</b>	<b>Length Surveyed</b> 72.90
<b>Lining</b>	<b>Year laid</b>	<b>Year rehabilitated</b>	<b>Weather</b> Dry

<b>Purpose</b> Infiltration/Inflow Investigation	<b>Cat</b>		
<b>Additional info</b>		<b>Structural</b>	<b>O&amp;M</b> <b>Constructional</b>
<b>Location</b> Parking Lot		<b>Miscellaneous</b>	<b>Hydraulic</b>

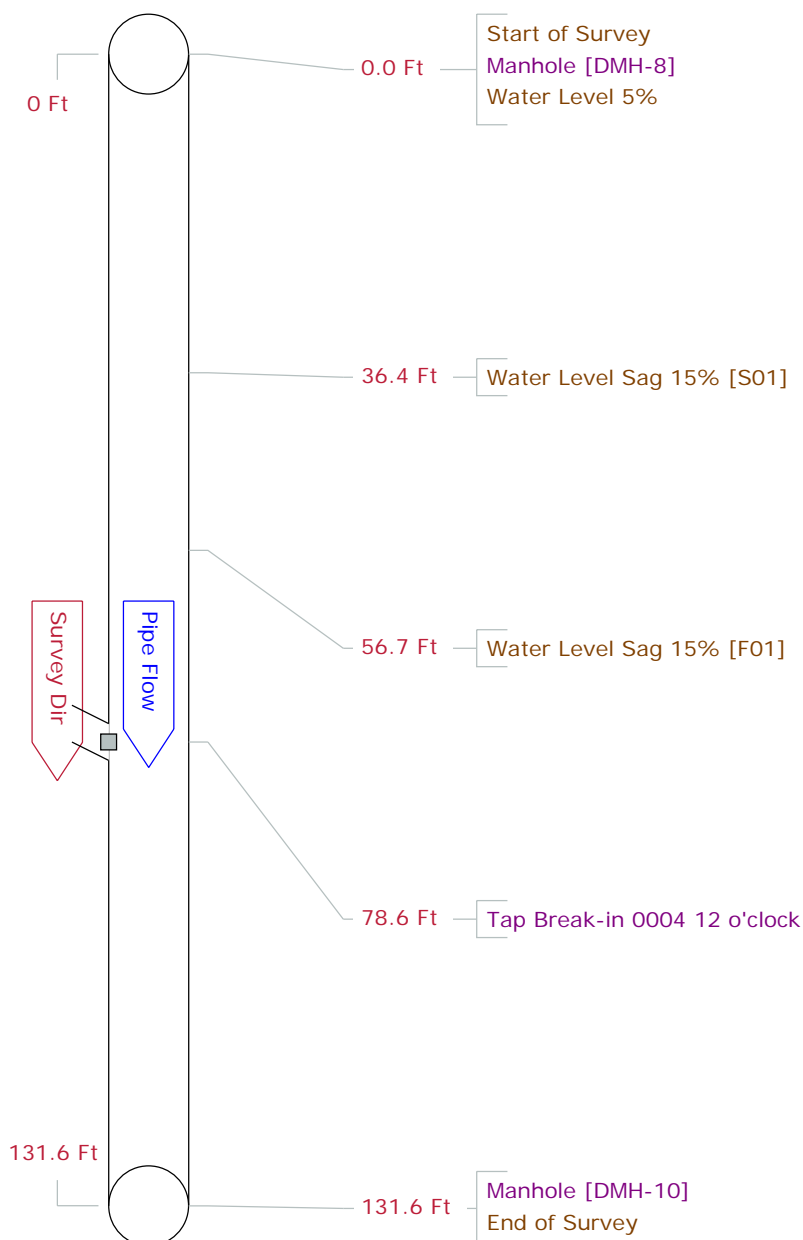
# Pipe Graphic Report of PLR DMH-8 X for WOODARD & CURRAN

<b>Setup</b> 31	<b>Surveyor</b> WP	<b>Certificate #</b> T-001-002	<b>System Owner</b> SUNY OF ALBANY
<b>Drainage</b> STORM DRAIN	<b>Survey Customer</b> WOODARD & CURRAN		
<b>P/O #</b>	<b>Date</b> 2007/08/07	<b>Time</b> 14:33	<b>Street</b> SUNY OF ALBANY
<b>Locality</b> VARIOUS LOCATIONS	<b>Further location details</b>		
<b>Start</b> DMH-8	<b>Rim to invert</b>	<b>Grade to invert</b>	<b>Rim to grade</b> <b>Ft</b>
<b>Finish</b> DMH-10	<b>Rim to invert</b>	<b>Grade to invert</b>	<b>Rim to grade</b> <b>Ft</b>
<b>Use</b> Stormwater	<b>Direction</b> Downstream	<b>Flow control</b> Not Controlled	<b>Tape/Media #</b> WP-03
<b>Shape</b> Circular	<b>Height</b> 21	<b>Width</b> ins	<b>Preclean</b> N <b>Year Cleaned</b>
<b>Material</b> Reinforced Concrete Pipe	<b>Joint length</b> <b>Ft</b>	<b>Total length</b> 131.6 <b>Ft</b>	<b>Length Surveyed</b> 131.60
<b>Lining</b>	<b>Year laid</b>	<b>Year rehabilitated</b>	<b>Weather</b> Dry

<b>Purpose</b> Infiltration/Inflow Investigation	<b>Cat</b>		
<b>Additional info</b>		<b>Structural</b>	<b>O&amp;M</b> <b>Constructional</b>
<b>Location</b> Parking Lot		<b>Miscellaneous</b>	<b>Hydraulic</b>
