# Condition Assessment Report

**Stormwater, Sanitary  
Sewer, Water and  
Irrigation Systems**

**University at Albany  
(Uptown Campus)**

**SUCF Project No. 01834**

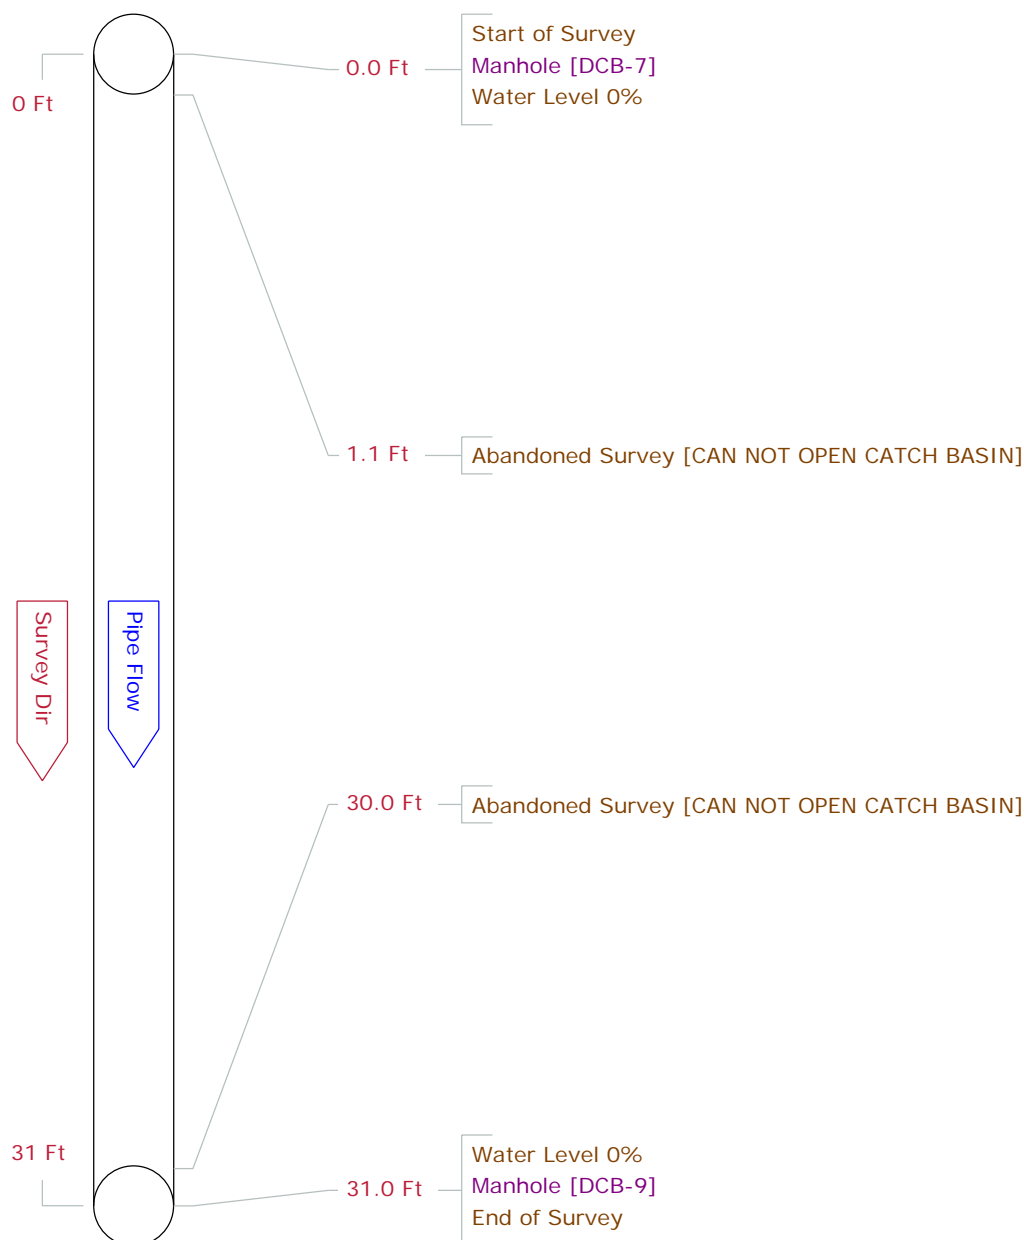
# Pipe Graphic Report of PLR DCB-7 X for WOODARD & CURRAN

<b>Setup</b> 45/44	<b>Surveyor</b> WP	<b>Certificate #</b> T-001-002	<b>System Owner</b> SUNY OF ALBANY
<b>Drainage</b> STORM DRAIN	<b>Survey Customer</b> WOODARD & CURRAN		
<b>P/O #</b>	<b>Date</b> 2007/08/14	<b>Time</b> 9:12	<b>Street</b> SUNY OF ALBANY
<b>Locality</b> VARIOUS LOCATIONS	<b>Further location details</b>		
<b>Start</b> DCB-9	<b>Rim to invert</b>	<b>Grade to invert</b>	<b>Rim to grade</b> <b>Ft</b>
<b>Finish</b> DCB-7	<b>Rim to invert</b>	<b>Grade to invert</b>	<b>Rim to grade</b> <b>Ft</b>
<b>Use</b> Stormwater	<b>Direction</b> Upstream	<b>Flow control</b> Not Controlled	<b>Tape/Media #</b> WP-03
<b>Shape</b> Circular	<b>Height</b> 15	<b>Width</b> ins	<b>Preclean</b> N <b>Year Cleaned</b>
<b>Material</b> Reinforced Concrete Pipe	<b>Joint length</b> <b>Ft</b>	<b>Total length</b> 31.0 <b>Ft</b>	<b>Length Surveyed</b> 01.00
<b>Lining</b>	<b>Year laid</b>	<b>Year rehabilitated</b>	<b>Weather</b> Dry

<b>Purpose</b> Infiltration/Inflow Investigation	<b>Cat</b>		
<b>Additional info</b> Reverse set up on sheet:44		<b>Structural</b>	<b>O&amp;M</b> <b>Constructional</b>
<b>Location</b> Parking Lot		<b>Miscellaneous</b>	<b>Hydraulic</b>

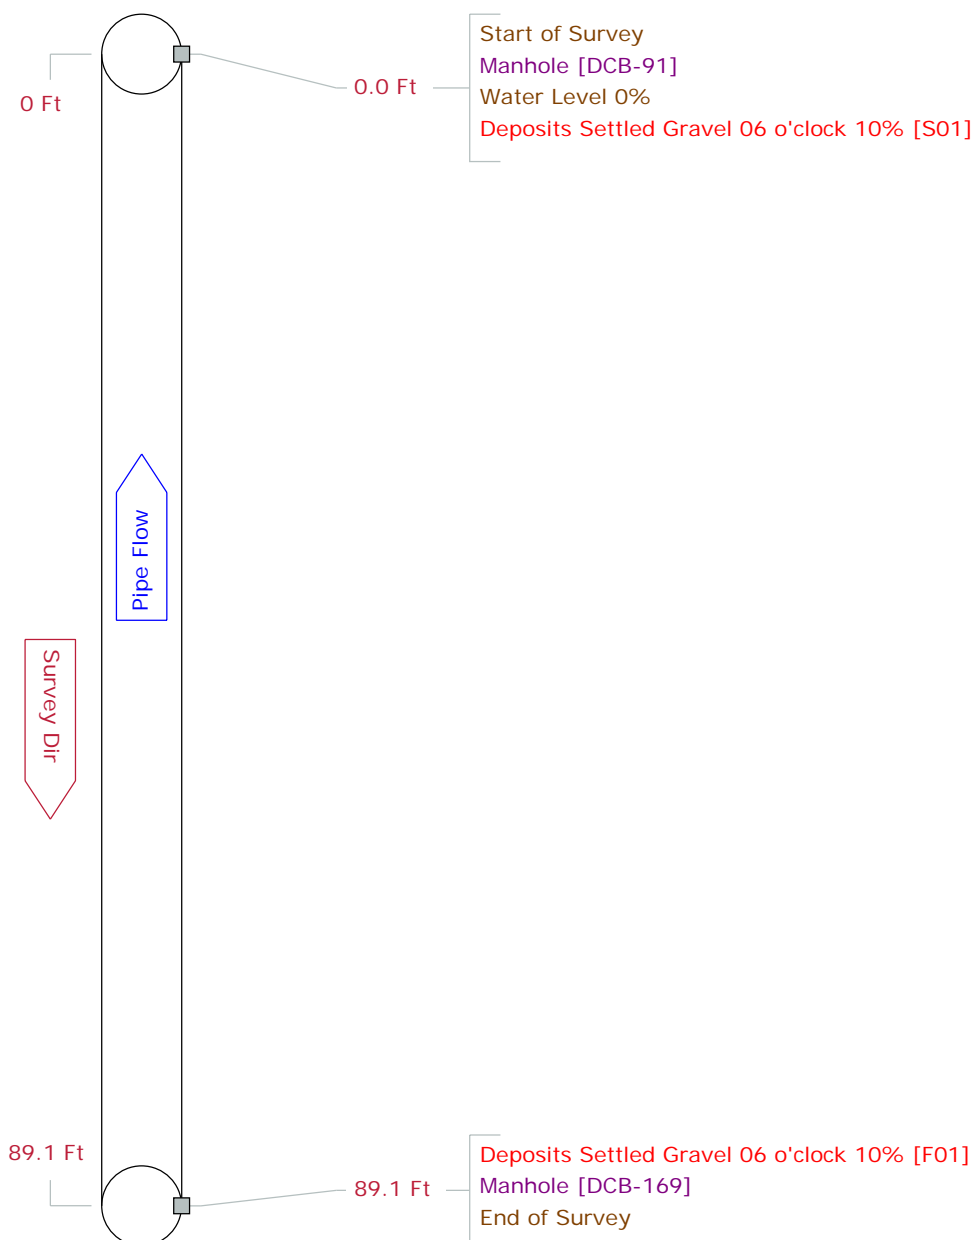
# Pipe Graphic Report of PLR DCB-169 W for WOODARD & CURRAN

<b>Setup</b> 55	<b>Surveyor</b> WP	<b>Certificate #</b> T-001-002	<b>System Owner</b> SUNY OF ALBANY
<b>Drainage</b> STORM DRAIN	<b>Survey Customer</b> WOODARD & CURRAN		
<b>P/O #</b>	<b>Date</b> 2007/08/14	<b>Time</b> 11:06	<b>Street</b> SUNY OF ALBANY
<b>Locality</b> VARIOUS LOCATIONS	<b>Further location details</b>		
<b>Start</b> DCB-91	<b>Rim to invert</b>	<b>Grade to invert</b>	<b>Rim to grade</b> <b>Ft</b>
<b>Finish</b> DCB-164	<b>Rim to invert</b>	<b>Grade to invert</b>	<b>Rim to grade</b> <b>Ft</b>
<b>Use</b> Stormwater	<b>Direction</b> Upstream	<b>Flow control</b> Not Controlled	<b>Tape/Media #</b> WP-03
<b>Shape</b> Circular	<b>Height</b> 15	<b>Width</b> ins	<b>Preclean</b> N <b>Year Cleaned</b>
<b>Material</b> Reinforced Concrete Pipe	<b>Joint length</b> <b>Ft</b>	<b>Total length</b> 89.1 <b>Ft</b>	<b>Length Surveyed</b> 89.10
<b>Lining</b>	<b>Year laid</b>	<b>Year rehabilitated</b>	<b>Weather</b> Dry

<b>Purpose</b> Infiltration/Inflow Investigation	<b>Cat</b>		
<b>Additional info</b>		<b>Structural</b>	<b>O&amp;M</b> <b>Constructional</b>
<b>Location</b> Parking Lot		<b>Miscellaneous</b>	<b>Hydraulic</b>

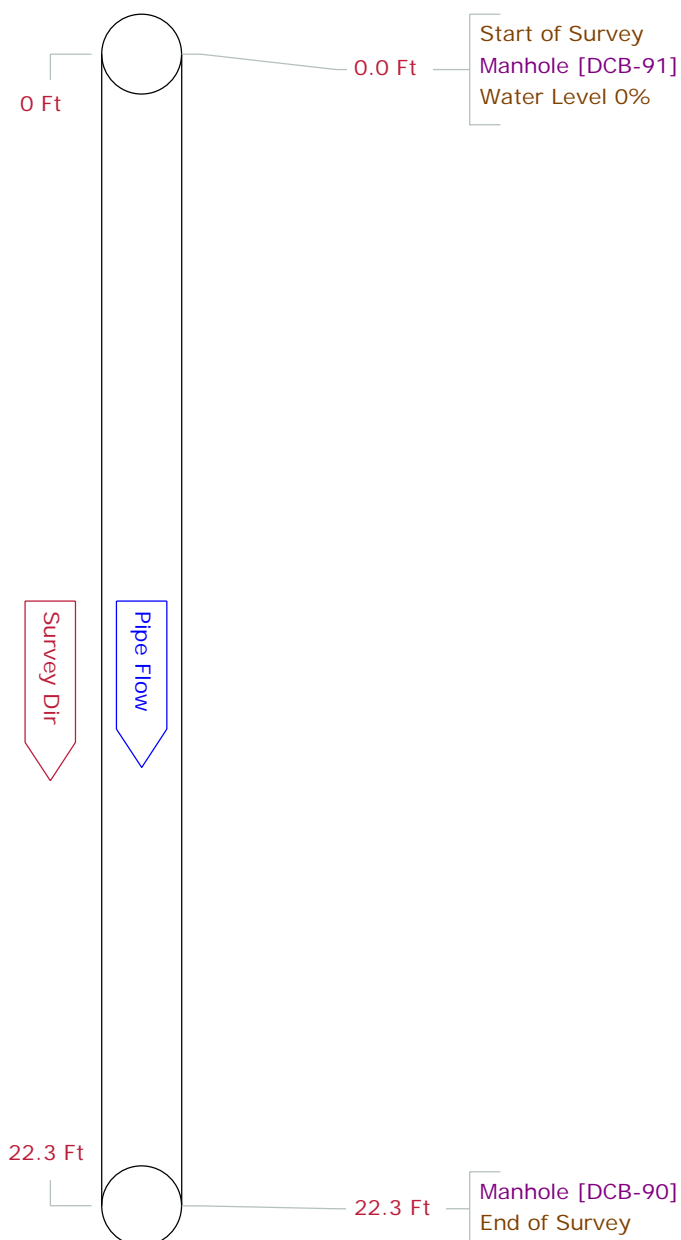
# Pipe Graphic Report of PLR DCB-91 W for WOODARD & CURRAN

<b>Setup</b> 56	<b>Surveyor</b> WP	<b>Certificate #</b> T-001-002	<b>System Owner</b> SUNY OF ALBANY
<b>Drainage</b> STORM DRAIN	<b>Survey Customer</b> WOODARD & CURRAN		
<b>P/O #</b>	<b>Date</b> 2007/08/14	<b>Time</b> 11:17	<b>Street</b> SUNY OF ALBANY
<b>Locality</b> VARIOUS LOCATIONS	<b>Further location details</b>		
<b>Start</b> DCB-91	<b>Rim to invert</b>	<b>Grade to invert</b>	<b>Rim to grade</b> <b>Ft</b>
<b>Finish</b> DCB-90	<b>Rim to invert</b>	<b>Grade to invert</b>	<b>Rim to grade</b> <b>Ft</b>
<b>Use</b> Stormwater	<b>Direction</b> Downstream	<b>Flow control</b> Not Controlled	<b>Tape/Media #</b> WP-03
<b>Shape</b> Circular	<b>Height</b> 15	<b>Width</b> ins	<b>Preclean</b> N <b>Year Cleaned</b>
<b>Material</b> Reinforced Concrete Pipe	<b>Joint length</b> <b>Ft</b>	<b>Total length</b> 22.3 <b>Ft</b>	<b>Length Surveyed</b> 22.30
<b>Lining</b>	<b>Year laid</b>	<b>Year rehabilitated</b>	<b>Weather</b> Dry

<b>Purpose</b> Infiltration/Inflow Investigation	<b>Cat</b>		
<b>Additional info</b>		<b>Structural</b>	<b>O&amp;M</b> <b>Constructional</b>
<b>Location</b> Parking Lot		<b>Miscellaneous</b>	<b>Hydraulic</b>

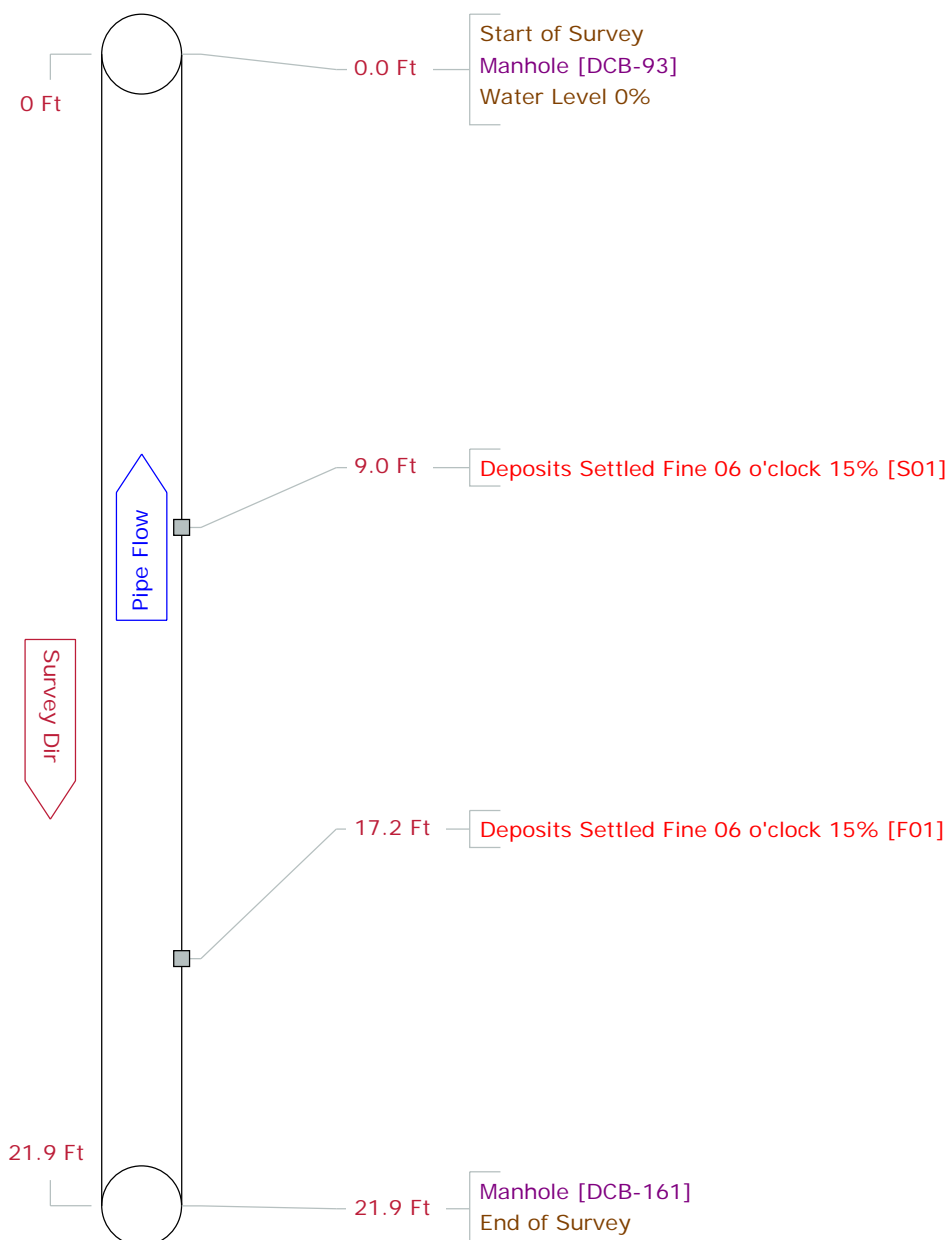
# Pipe Graphic Report of PLR DCB-161 W for WOODARD & CURRAN

<b>Setup</b> 57	<b>Surveyor</b> WP	<b>Certificate #</b> T-001-002	<b>System Owner</b> SUNY OF ALBANY
<b>Drainage</b> STORM DRAIN	<b>Survey Customer</b> WOODARD & CURRAN		
<b>P/O #</b>	<b>Date</b> 2007/08/14	<b>Time</b> 11:25	<b>Street</b> SUNY OF ALBANY
<b>Locality</b> VARIOUS LOCATIONS	<b>Further location details</b>		
<b>Start</b> DCB-93	<b>Rim to invert</b>	<b>Grade to invert</b>	<b>Rim to grade</b> <b>Ft</b>
<b>Finish</b> DCB-161	<b>Rim to invert</b>	<b>Grade to invert</b>	<b>Rim to grade</b> <b>Ft</b>
<b>Use</b> Stormwater	<b>Direction</b> Upstream	<b>Flow control</b> Not Controlled	<b>Tape/Media #</b> WP-03
<b>Shape</b> Circular	<b>Height</b> 15	<b>Width</b> ins	<b>Preclean</b> N <b>Year Cleaned</b>
<b>Material</b> Reinforced Concrete Pipe	<b>Joint length</b> <b>Ft</b>	<b>Total length</b> 21.9 <b>Ft</b>	<b>Length Surveyed</b> 21.90
<b>Lining</b>	<b>Year laid</b>	<b>Year rehabilitated</b>	<b>Weather</b> Dry

<b>Purpose</b> Infiltration/Inflow Investigation	<b>Cat</b>		
<b>Additional info</b>		<b>Structural</b>	<b>O&amp;M</b> <b>Constructional</b>
<b>Location</b> Parking Lot		<b>Miscellaneous</b>	<b>Hydraulic</b>

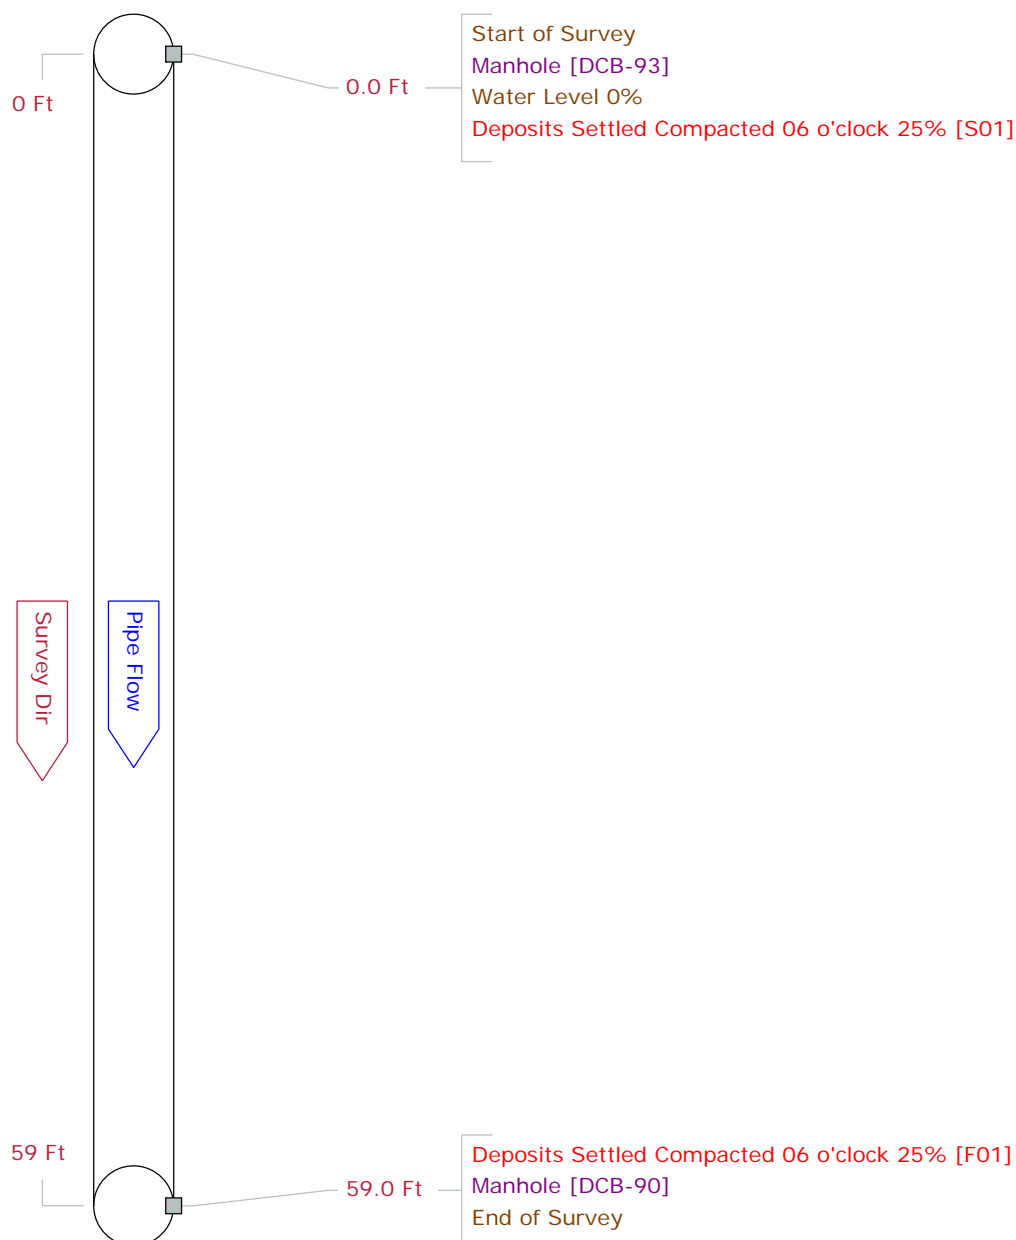
# Pipe Graphic Report of PLR DCB-93 W for WOODARD & CURRAN

<b>Setup</b> 58	<b>Surveyor</b> WP	<b>Certificate #</b> T-001-002	<b>System Owner</b> SUNY OF ALBANY
<b>Drainage</b> STORM DRAIN	<b>Survey Customer</b> WOODARD & CURRAN		
<b>P/O #</b>	<b>Date</b> 2007/08/14	<b>Time</b> 11:29	<b>Street</b> SUNY OF ALBANY
<b>Locality</b> VARIOUS LOCATIONS	<b>Further location details</b>		
<b>Start</b> DCB-93	<b>Rim to invert</b>	<b>Grade to invert</b>	<b>Rim to grade</b> <b>Ft</b>
<b>Finish</b> DCB-90	<b>Rim to invert</b>	<b>Grade to invert</b>	<b>Rim to grade</b> <b>Ft</b>
<b>Use</b> Stormwater	<b>Direction</b> Downstream	<b>Flow control</b> Not Controlled	<b>Tape/Media #</b> WP-03
<b>Shape</b> Circular	<b>Height</b> 15	<b>Width</b> ins	<b>Preclean</b> N <b>Year Cleaned</b>
<b>Material</b> Reinforced Concrete Pipe	<b>Joint length</b> <b>Ft</b>	<b>Total length</b> 59.0	<b>Ft</b> <b>Length Surveyed</b> 59.00
<b>Lining</b>	<b>Year laid</b>	<b>Year rehabilitated</b>	<b>Weather</b> Dry

<b>Purpose</b> Infiltration/Inflow Investigation	<b>Cat</b>		
<b>Additional info</b>		<b>Structural</b>	<b>O&amp;M</b> <b>Constructional</b>
<b>Location</b> Parking Lot		<b>Miscellaneous</b>	<b>Hydraulic</b>

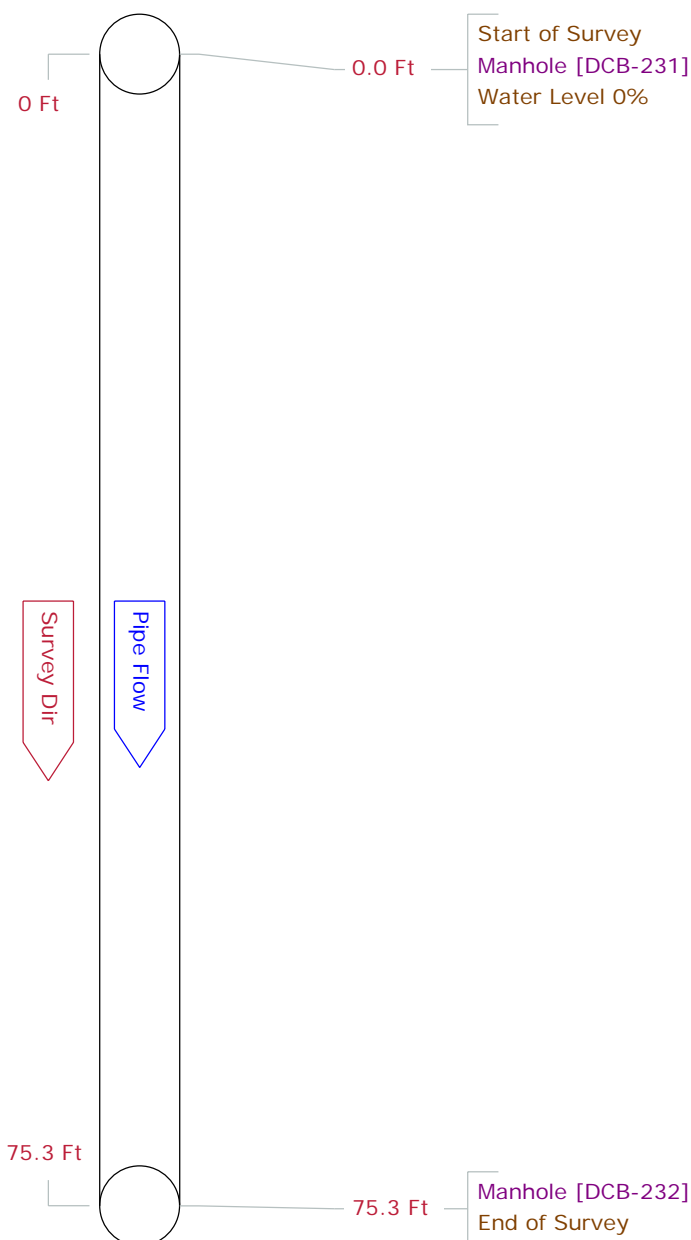
# Pipe Graphic Report of PLR DCB-231 W for WOODARD & CURRAN

<b>Setup</b> 61	<b>Surveyor</b> WP	<b>Certificate #</b> T-001-002	<b>System Owner</b> SUNY OF ALBANY
<b>Drainage</b> STORM DRAIN	<b>Survey Customer</b> WOODARD & CURRAN		
<b>P/O #</b>	<b>Date</b> 2007/08/14	<b>Time</b> 13:45	<b>Street</b> SUNY OF ALBANY
<b>Locality</b> VARIOUS LOCATIONS	<b>Further location details</b>		
<b>Start</b> DCB-231	<b>Rim to invert</b>	<b>Grade to invert</b>	<b>Rim to grade</b> <b>Ft</b>
<b>Finish</b> DCB-232	<b>Rim to invert</b>	<b>Grade to invert</b>	<b>Rim to grade</b> <b>Ft</b>
<b>Use</b> Stormwater	<b>Direction</b> Downstream	<b>Flow control</b> Not Controlled	<b>Tape/Media #</b> WP-03
<b>Shape</b> Circular	<b>Height</b> 15	<b>Width</b> ins	<b>Preclean</b> N <b>Year Cleaned</b>
<b>Material</b> Reinforced Concrete Pipe	<b>Joint length</b> <b>Ft</b>	<b>Total length</b> 75.3 <b>Ft</b>	<b>Length Surveyed</b> 75.30
<b>Lining</b>	<b>Year laid</b>	<b>Year rehabilitated</b>	<b>Weather</b> Dry

<b>Purpose</b> Infiltration/Inflow Investigation	<b>Cat</b>		
<b>Additional info</b>		<b>Structural</b>	<b>O&amp;M</b> <b>Constructional</b>
<b>Location</b> Parking Lot		<b>Miscellaneous</b>	<b>Hydraulic</b>

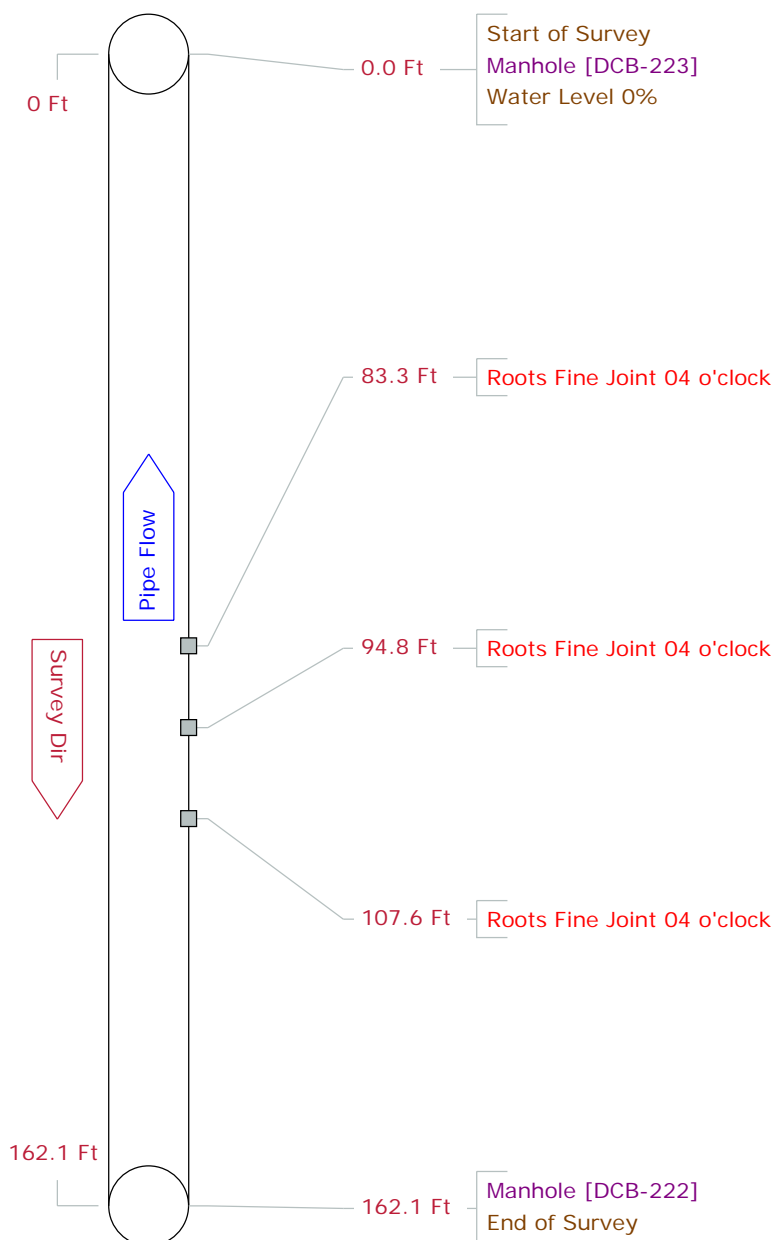
# Pipe Graphic Report of PLR DCB-222 W for WOODARD & CURRAN

<b>Setup</b> 62	<b>Surveyor</b> WP	<b>Certificate #</b> T-001-002	<b>System Owner</b> SUNY OF ALBANY
<b>Drainage</b> STORM DRAIN	<b>Survey Customer</b> WOODARD & CURRAN		
<b>P/O #</b>	<b>Date</b> 2007/08/14	<b>Time</b> 14:29	<b>Street</b> SUNY OF ALBANY
<b>Locality</b> VARIOUS LOCATIONS	<b>Further location details</b>		
<b>Start</b> DCB-223	<b>Rim to invert</b>	<b>Grade to invert</b>	<b>Rim to grade</b> <b>Ft</b>
<b>Finish</b> DCB-222	<b>Rim to invert</b>	<b>Grade to invert</b>	<b>Rim to grade</b> <b>Ft</b>
<b>Use</b> Stormwater	<b>Direction</b> Upstream	<b>Flow control</b> Not Controlled	<b>Tape/Media #</b> WP-03
<b>Shape</b> Circular	<b>Height</b> 15	<b>Width</b> ins	<b>Preclean</b> N <b>Year Cleaned</b>
<b>Material</b> Reinforced Concrete Pipe	<b>Joint length</b> <b>Ft</b>	<b>Total length</b> 162.1 <b>Ft</b>	<b>Length Surveyed</b> 162.10
<b>Lining</b>	<b>Year laid</b>	<b>Year rehabilitated</b>	<b>Weather</b> Dry

<b>Purpose</b> Infiltration/Inflow Investigation	<b>Cat</b>		
<b>Additional info</b>		<b>Structural</b>	<b>O&amp;M</b> <b>Constructional</b>
<b>Location</b> Parking Lot		<b>Miscellaneous</b>	<b>Hydraulic</b>

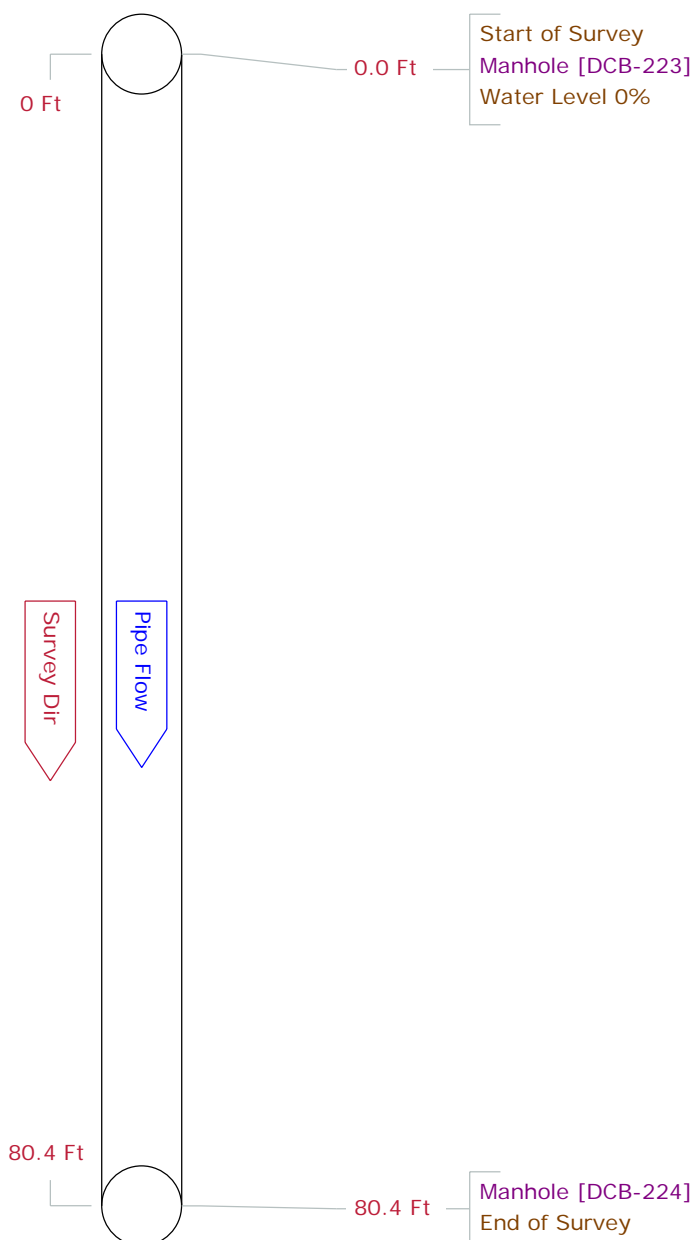
# Pipe Graphic Report of PLR DCB-223 W for WOODARD & CURRAN

<b>Setup</b> 63	<b>Surveyor</b> WP	<b>Certificate #</b> T-001-002	<b>System Owner</b> SUNY OF ALBANY
<b>Drainage</b> STORM DRAIN	<b>Survey Customer</b> WOODARD & CURRAN		
<b>P/O #</b>	<b>Date</b> 2007/08/14	<b>Time</b> 14:38	<b>Street</b> SUNY OF ALBANY
<b>Locality</b> VARIOUS LOCATIONS	<b>Further location details</b>		
<b>Start</b> DCB-223	<b>Rim to invert</b>	<b>Grade to invert</b>	<b>Rim to grade</b> <b>Ft</b>
<b>Finish</b> DCB-224	<b>Rim to invert</b>	<b>Grade to invert</b>	<b>Rim to grade</b> <b>Ft</b>
<b>Use</b> Stormwater	<b>Direction</b> Downstream	<b>Flow control</b> Not Controlled	<b>Tape/Media #</b> WP-03
<b>Shape</b> Circular	<b>Height</b> 15	<b>Width</b> ins	<b>Preclean</b> N <b>Year Cleaned</b>
<b>Material</b> Reinforced Concrete Pipe	<b>Joint length</b> <b>Ft</b>	<b>Total length</b> 80.4 <b>Ft</b>	<b>Length Surveyed</b> 80.40
<b>Lining</b>	<b>Year laid</b>	<b>Year rehabilitated</b>	<b>Weather</b> Dry

<b>Purpose</b> Infiltration/Inflow Investigation	<b>Cat</b>		
<b>Additional info</b>		<b>Structural</b>	<b>O&amp;M</b> <b>Constructional</b>
<b>Location</b> Parking Lot		<b>Miscellaneous</b>	<b>Hydraulic</b>

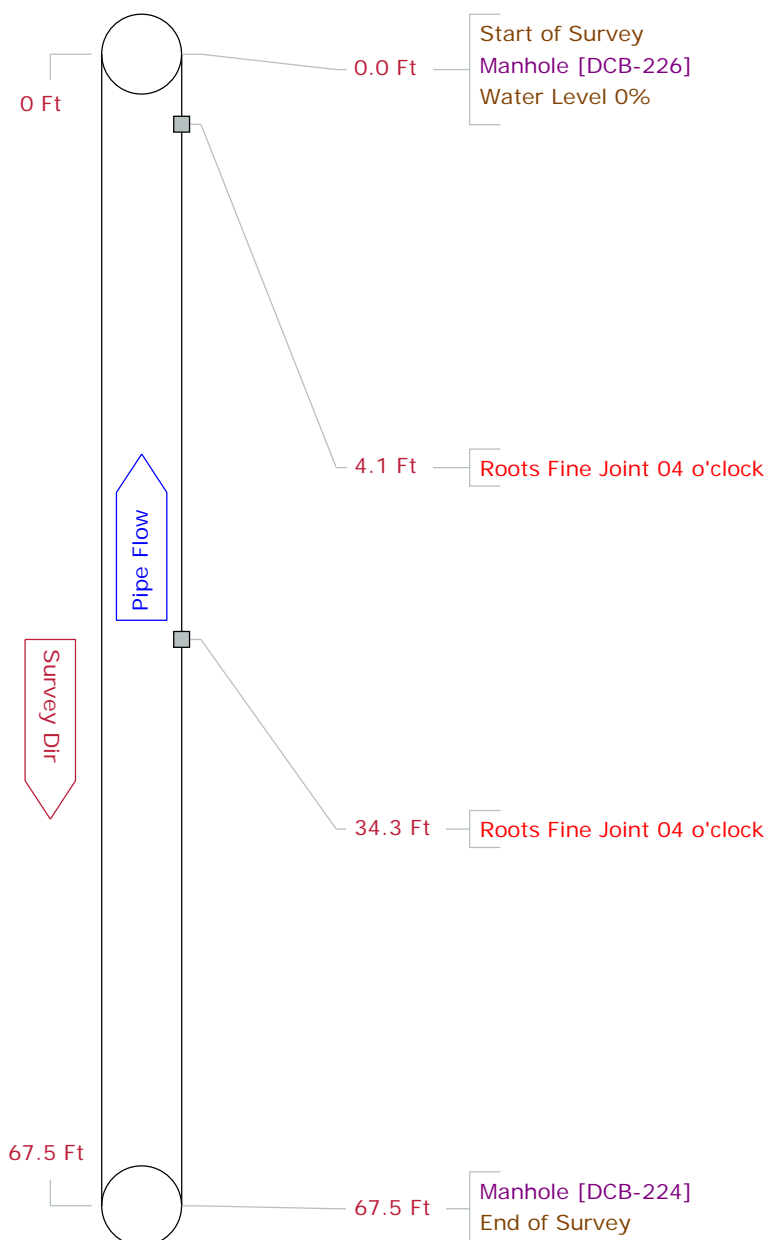
# Pipe Graphic Report of PLR DCB-224 W for WOODARD & CURRAN

<b>Setup</b> 64	<b>Surveyor</b> WP	<b>Certificate #</b> T-001-002	<b>System Owner</b> SUNY OF ALBANY
<b>Drainage</b> STORM DRAIN	<b>Survey Customer</b> WOODARD & CURRAN		
<b>P/O #</b>	<b>Date</b> 2007/08/14	<b>Time</b> 15:06	<b>Street</b> SUNY OF ALBANY
<b>Locality</b> VARIOUS LOCATIONS	<b>Further location details</b>		
<b>Start</b> DCB-226	<b>Rim to invert</b>	<b>Grade to invert</b>	<b>Rim to grade</b> <b>Ft</b>
<b>Finish</b> DCB-224	<b>Rim to invert</b>	<b>Grade to invert</b>	<b>Rim to grade</b> <b>Ft</b>
<b>Use</b> Stormwater	<b>Direction</b> Upstream	<b>Flow control</b> Not Controlled	<b>Tape/Media #</b> WP-03
<b>Shape</b> Circular	<b>Height</b> 15	<b>Width</b> ins	<b>Preclean</b> N <b>Year Cleaned</b>
<b>Material</b> Reinforced Concrete Pipe	<b>Joint length</b> <b>Ft</b>	<b>Total length</b> 67.5 <b>Ft</b>	<b>Length Surveyed</b> 67.50
<b>Lining</b>	<b>Year laid</b>	<b>Year rehabilitated</b>	<b>Weather</b> Dry

<b>Purpose</b> Infiltration/Inflow Investigation	<b>Cat</b>		
<b>Additional info</b>		<b>Structural</b>	<b>O&amp;M</b> <b>Constructional</b>
<b>Location</b> Parking Lot		<b>Miscellaneous</b>	<b>Hydraulic</b>

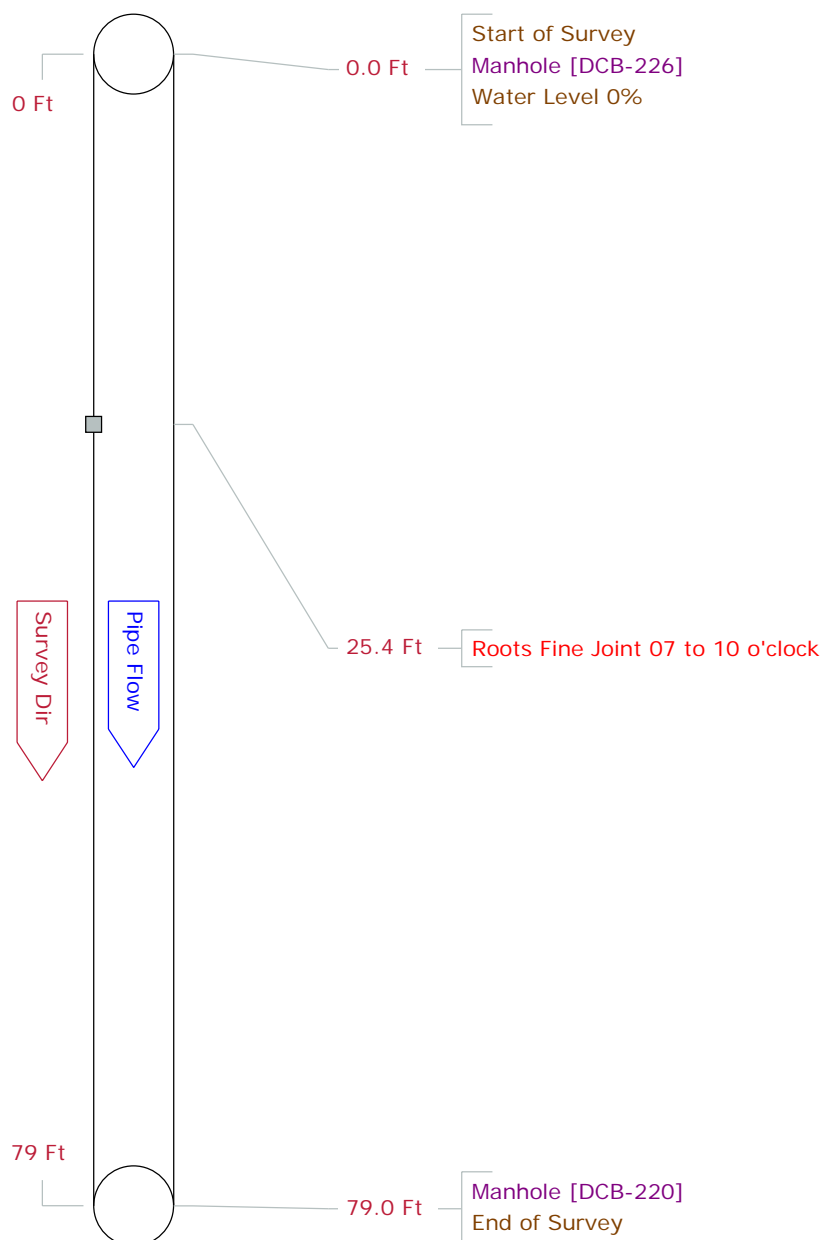
# Pipe Graphic Report of PLR DCB-226 X for WOODARD & CURRAN

<b>Setup</b> 65	<b>Surveyor</b> WP	<b>Certificate #</b> T-001-002	<b>System Owner</b> SUNY OF ALBANY
<b>Drainage</b> STORM DRAIN	<b>Survey Customer</b> WOODARD & CURRAN		
<b>P/O #</b>	<b>Date</b> 2007/08/14	<b>Time</b> 15:13	<b>Street</b> SUNY OF ALBANY
<b>Locality</b> VARIOUS LOCATIONS	<b>Further location details</b>		
<b>Start</b> DCB-226	<b>Rim to invert</b>	<b>Grade to invert</b>	<b>Rim to grade</b> <b>Ft</b>
<b>Finish</b> DCB-220	<b>Rim to invert</b>	<b>Grade to invert</b>	<b>Rim to grade</b> <b>Ft</b>
<b>Use</b> Stormwater	<b>Direction</b> Downstream	<b>Flow control</b> Not Controlled	<b>Tape/Media #</b> WP-03
<b>Shape</b> Circular	<b>Height</b> 15	<b>Width</b> ins	<b>Preclean</b> N <b>Year Cleaned</b>
<b>Material</b> Reinforced Concrete Pipe	<b>Joint length</b> <b>Ft</b>	<b>Total length</b> 79.0 <b>Ft</b>	<b>Length Surveyed</b> 79.00
<b>Lining</b>	<b>Year laid</b>	<b>Year rehabilitated</b>	<b>Weather</b> Dry

<b>Purpose</b> Infiltration/Inflow Investigation	<b>Cat</b>		
<b>Additional info</b>		<b>Structural</b>	<b>O&amp;M</b> <b>Constructional</b>
<b>Location</b> Parking Lot		<b>Miscellaneous</b>	<b>Hydraulic</b>

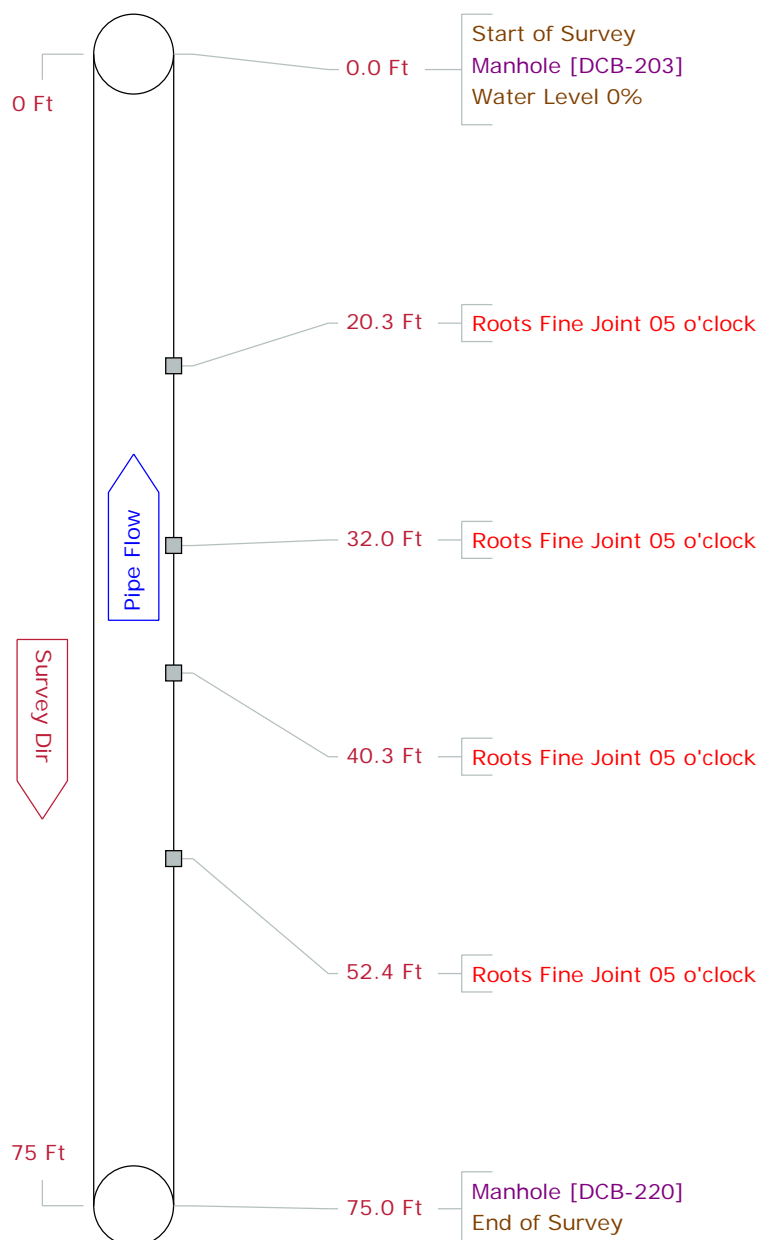
# Pipe Graphic Report of PLR DCB-220 X for WOODARD & CURRAN

<b>Setup</b> 66	<b>Surveyor</b> WP	<b>Certificate #</b> T-001-002	<b>System Owner</b> SUNY OF ALBANY
<b>Drainage</b> STORM DRAIN	<b>Survey Customer</b> WOODARD & CURRAN		
<b>P/O #</b>	<b>Date</b> 2007/08/14	<b>Time</b> 15:28	<b>Street</b> SUNY OF ALBANY
<b>Locality</b> VARIOUS LOCATIONS	<b>Further location details</b>		
<b>Start</b> DCB-203	<b>Rim to invert</b>	<b>Grade to invert</b>	<b>Rim to grade</b> <b>Ft</b>
<b>Finish</b> DCB-220	<b>Rim to invert</b>	<b>Grade to invert</b>	<b>Rim to grade</b> <b>Ft</b>
<b>Use</b> Stormwater	<b>Direction</b> Upstream	<b>Flow control</b> Not Controlled	<b>Tape/Media #</b> WP-03
<b>Shape</b> Circular	<b>Height</b> 15	<b>Width</b> ins	<b>Preclean</b> N <b>Year Cleaned</b>
<b>Material</b> Reinforced Concrete Pipe	<b>Joint length</b> <b>Ft</b>	<b>Total length</b> 75.0 <b>Ft</b>	<b>Length Surveyed</b> 75.00
<b>Lining</b>	<b>Year laid</b>	<b>Year rehabilitated</b>	<b>Weather</b> Dry

<b>Purpose</b> Infiltration/Inflow Investigation	<b>Cat</b>		
<b>Additional info</b>		<b>Structural</b>	<b>O&amp;M</b> <b>Constructional</b>
<b>Location</b> Parking Lot		<b>Miscellaneous</b>	<b>Hydraulic</b>

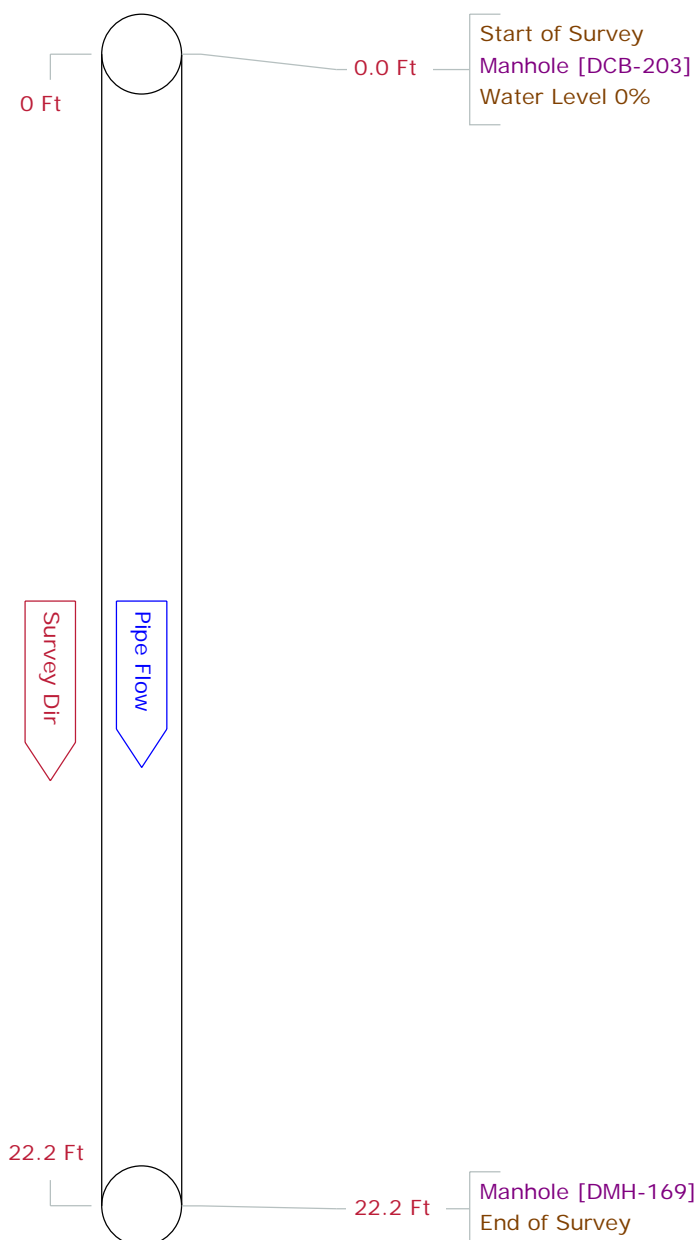
# Pipe Graphic Report of PLR DCB-203 X for WOODARD & CURRAN

<b>Setup</b> 67	<b>Surveyor</b> WP	<b>Certificate #</b> T-001-002	<b>System Owner</b> SUNY OF ALBANY
<b>Drainage</b> STORM DRAIN	<b>Survey Customer</b> WOODARD & CURRAN		
<b>P/O #</b>	<b>Date</b> 2007/08/14	<b>Time</b> 15:38	<b>Street</b> SUNY OF ALBANY
<b>Locality</b> VARIOUS LOCATIONS	<b>Further location details</b>		
<b>Start</b> DCB-203	<b>Rim to invert</b>	<b>Grade to invert</b>	<b>Rim to grade</b> <b>Ft</b>
<b>Finish</b> DMH-169	<b>Rim to invert</b>	<b>Grade to invert</b>	<b>Rim to grade</b> <b>Ft</b>
<b>Use</b> Stormwater	<b>Direction</b> Downstream	<b>Flow control</b> Not Controlled	<b>Tape/Media #</b> WP-03
<b>Shape</b> Circular	<b>Height</b> 15	<b>Width</b> ins	<b>Preclean</b> N <b>Year Cleaned</b>
<b>Material</b> Reinforced Concrete Pipe	<b>Joint length</b> <b>Ft</b>	<b>Total length</b> 22.2 <b>Ft</b>	<b>Length Surveyed</b> 22.20
<b>Lining</b>	<b>Year laid</b>	<b>Year rehabilitated</b>	<b>Weather</b> Dry

<b>Purpose</b> Infiltration/Inflow Investigation	<b>Cat</b>		
<b>Additional info</b>		<b>Structural</b>	<b>O&amp;M</b> <b>Constructional</b>
<b>Location</b> Parking Lot		<b>Miscellaneous</b>	<b>Hydraulic</b>

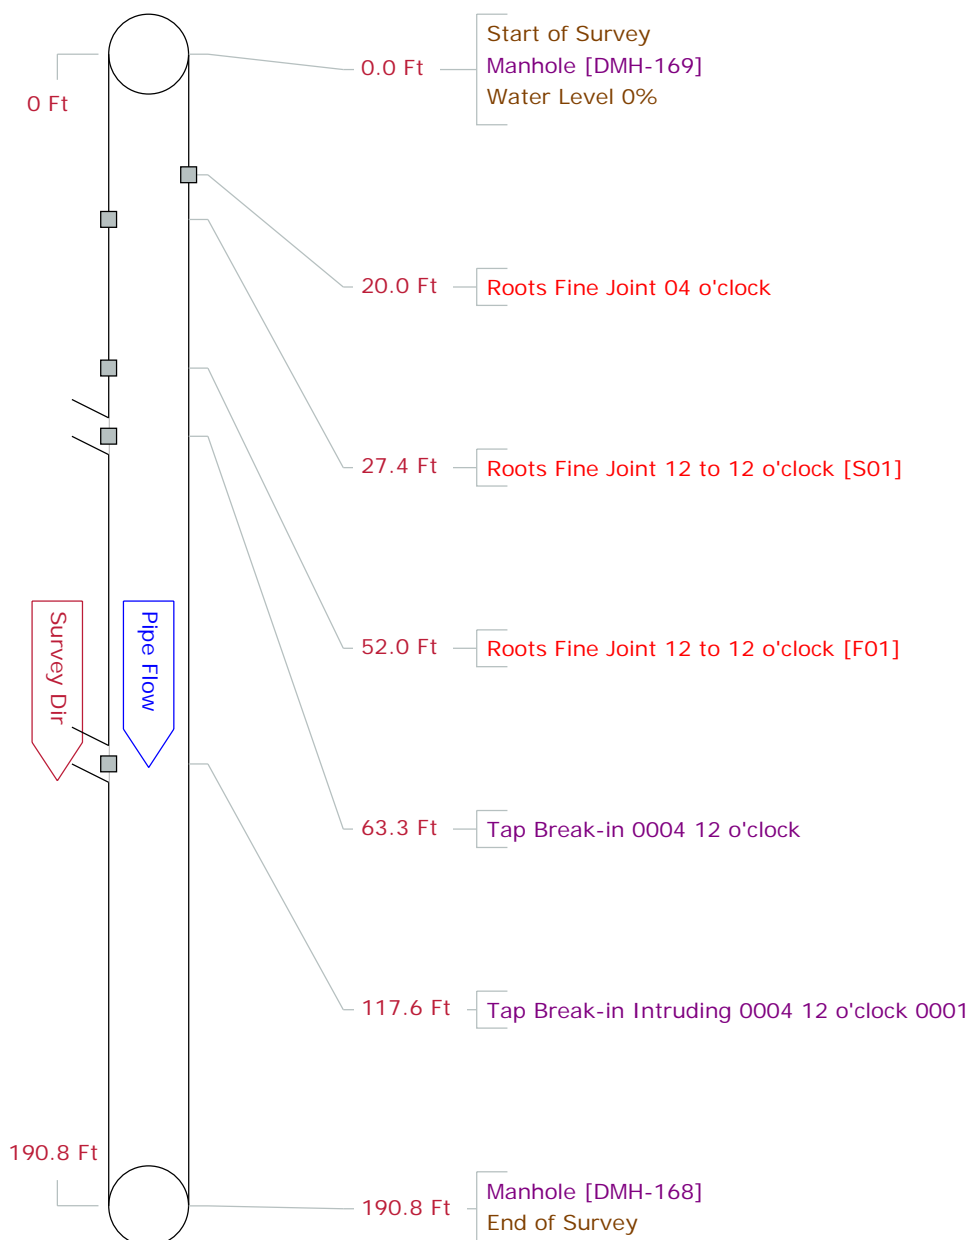
# Pipe Graphic Report of PLR DMH-169 X for WOODARD & CURRAN

<b>Setup</b> 68	<b>Surveyor</b> WP	<b>Certificate #</b> T-001-002	<b>System Owner</b> SUNY OF ALBANY
<b>Drainage</b> STORM DRAIN	<b>Survey Customer</b> WOODARD & CURRAN		
<b>P/O #</b>	<b>Date</b> 2007/08/14	<b>Time</b> 15:43	<b>Street</b> SUNY OF ALBANY
<b>Locality</b> VARIOUS LOCATIONS	<b>Further location details</b>		
<b>Start</b> DMH-169	<b>Rim to invert</b>	<b>Grade to invert</b>	<b>Rim to grade</b> <b>Ft</b>
<b>Finish</b> DMH-168	<b>Rim to invert</b>	<b>Grade to invert</b>	<b>Rim to grade</b> <b>Ft</b>
<b>Use</b> Stormwater	<b>Direction</b> Downstream	<b>Flow control</b> Not Controlled	<b>Tape/Media #</b> WP-03
<b>Shape</b> Circular	<b>Height</b> 15	<b>Width</b> ins	<b>Preclean</b> N <b>Year Cleaned</b>
<b>Material</b> Reinforced Concrete Pipe	<b>Joint length</b> <b>Ft</b>	<b>Total length</b> 190.8 <b>Ft</b>	<b>Length Surveyed</b> 190.80
<b>Lining</b>	<b>Year laid</b>	<b>Year rehabilitated</b>	<b>Weather</b> Dry

<b>Purpose</b> Infiltration/Inflow Investigation	<b>Cat</b>		
<b>Additional info</b>		<b>Structural</b>	<b>O&amp;M</b> <b>Constructional</b>
<b>Location</b> Parking Lot		<b>Miscellaneous</b>	<b>Hydraulic</b>

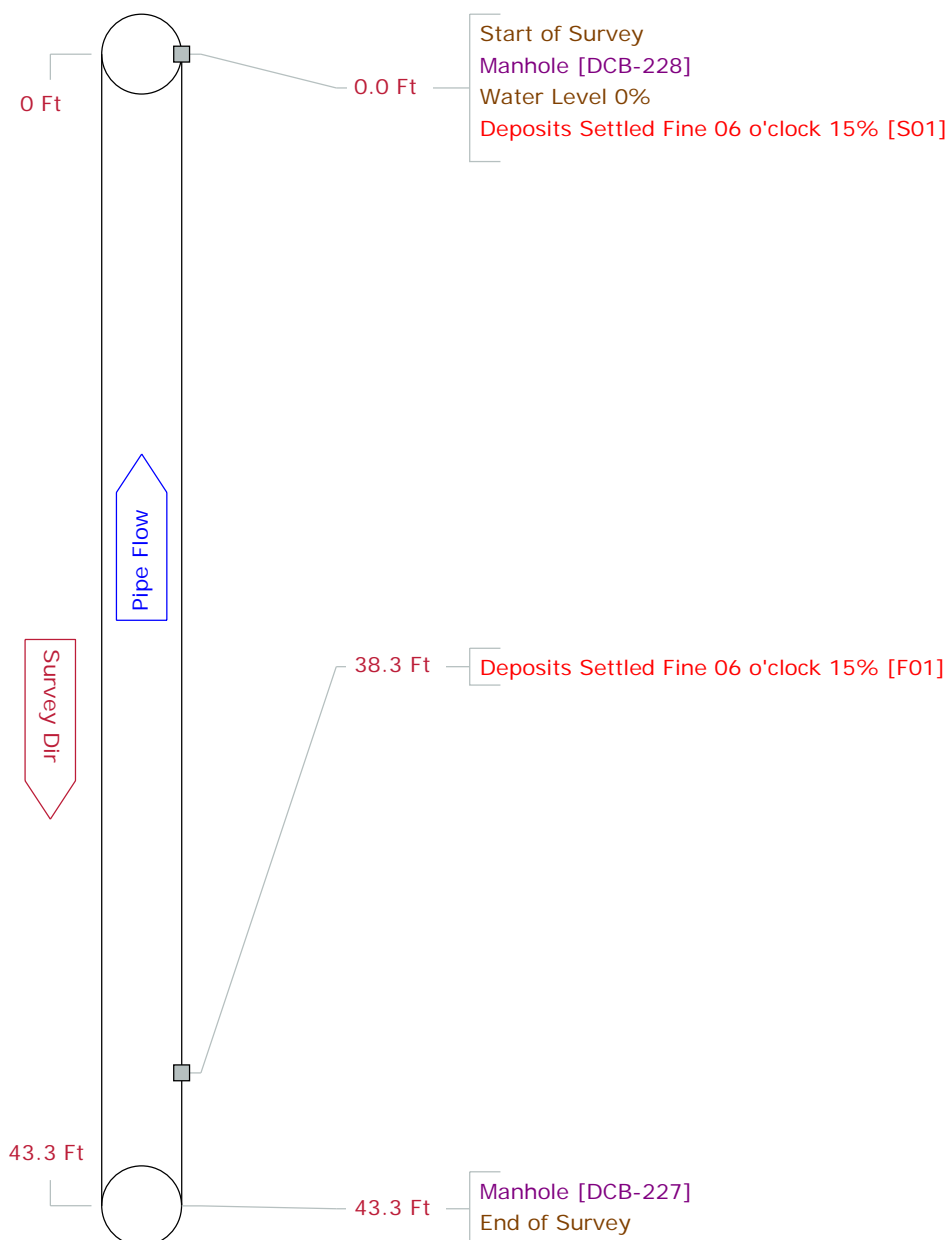
# Pipe Graphic Report of PLR DCB-227 X for WOODARD & CURRAN

<b>Setup</b> 69	<b>Surveyor</b> WP	<b>Certificate #</b> T-001-002	<b>System Owner</b> SUNY OF ALBANY
<b>Drainage</b> STORM DRAIN	<b>Survey Customer</b> WOODARD & CURRAN		
<b>P/O #</b>	<b>Date</b> 2007/08/14	<b>Time</b> 16:19	<b>Street</b> SUNY OF ALBANY
<b>Locality</b> VARIOUS LOCATIONS	<b>Further location details</b>		
<b>Start</b> DCB-228	<b>Rim to invert</b>	<b>Grade to invert</b>	<b>Rim to grade</b> <b>Ft</b>
<b>Finish</b> DCB-227	<b>Rim to invert</b>	<b>Grade to invert</b>	<b>Rim to grade</b> <b>Ft</b>
<b>Use</b> Stormwater	<b>Direction</b> Upstream	<b>Flow control</b> Not Controlled	<b>Tape/Media #</b> WP-03
<b>Shape</b> Circular	<b>Height</b> 15	<b>Width</b> ins	<b>Preclean</b> N <b>Year Cleaned</b>
<b>Material</b> Reinforced Concrete Pipe	<b>Joint length</b> <b>Ft</b>	<b>Total length</b> 43.3	<b>Ft</b> <b>Length Surveyed</b> 43.30
<b>Lining</b>	<b>Year laid</b>	<b>Year rehabilitated</b>	<b>Weather</b> Dry

<b>Purpose</b> Infiltration/Inflow Investigation	<b>Cat</b>		
<b>Additional info</b>		<b>Structural</b>	<b>O&amp;M</b> <b>Constructional</b>
<b>Location</b> Parking Lot		<b>Miscellaneous</b>	<b>Hydraulic</b>

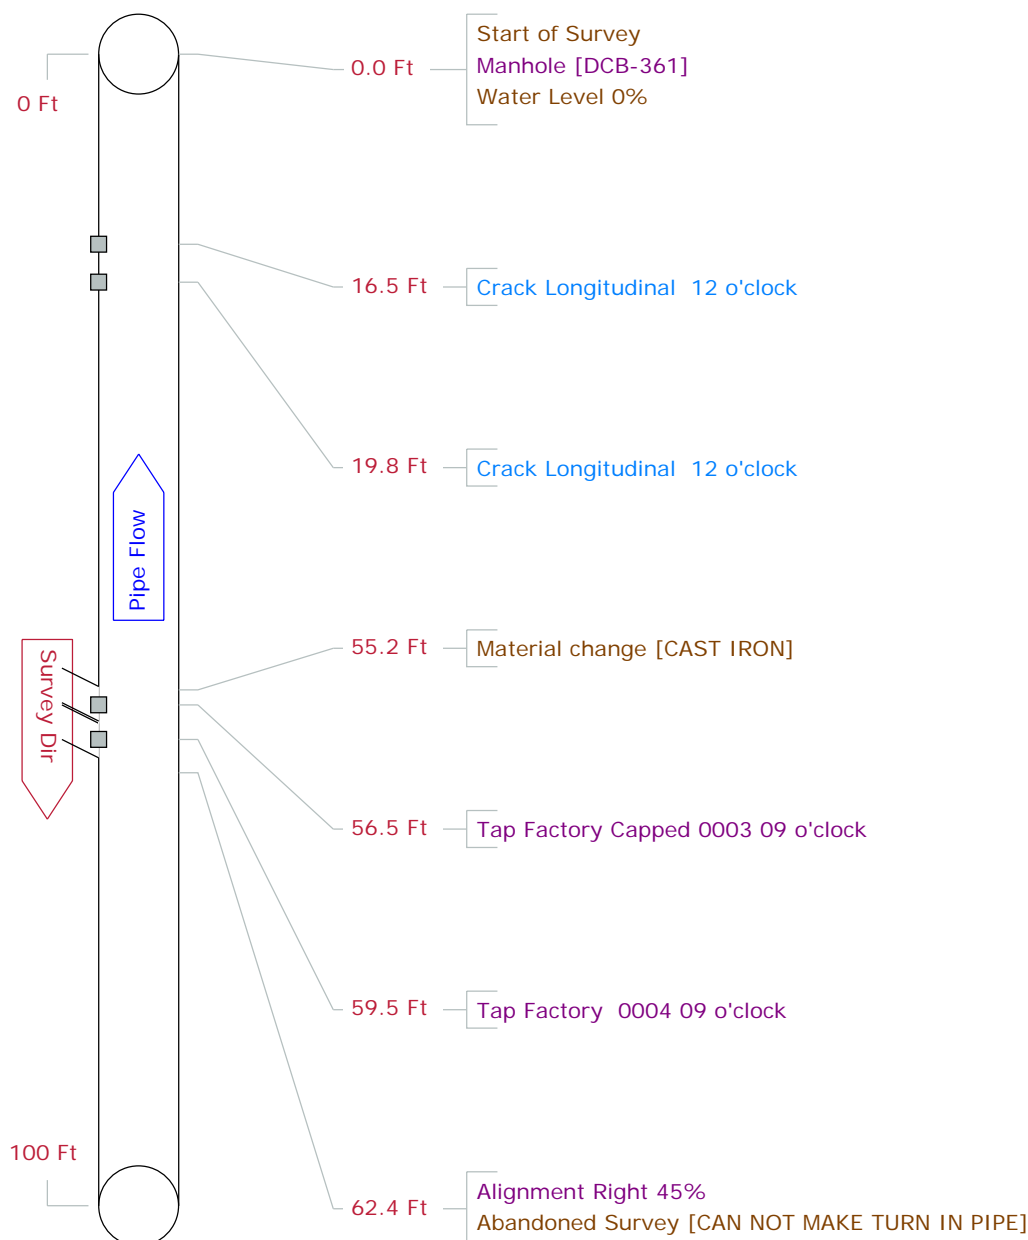
# Pipe Graphic Report of PLR DCB-374 X for WOODARD & CURRAN

<b>Setup</b> 90	<b>Surveyor</b> WP	<b>Certificate #</b> T-001-002	<b>System Owner</b> SUNY OF ALBANY
<b>Drainage</b> STORM DRAIN	<b>Survey Customer</b> WOODARD & CURRAN		
<b>P/O #</b>	<b>Date</b> 2007/08/20	<b>Time</b> 9:54	<b>Street</b> SUNY OF ALBANY
<b>Locality</b> VARIOUS LOCATIONS	<b>Further location details</b>		
<b>Start</b> DCB-361	<b>Rim to invert</b>	<b>Grade to invert</b>	<b>Rim to grade</b> <b>Ft</b>
<b>Finish</b> DCB-374	<b>Rim to invert</b>	<b>Grade to invert</b>	<b>Rim to grade</b> <b>Ft</b>
<b>Use</b> Stormwater	<b>Direction</b> Upstream	<b>Flow control</b> Not Controlled	<b>Tape/Media #</b> WP-03
<b>Shape</b> Circular	<b>Height</b> 8	<b>Width</b> ins	<b>Preclean</b> N <b>Year Cleaned</b>
<b>Material</b> Asbestos Cement	<b>Joint length</b> <b>Ft</b>	<b>Total length</b> 100.0 <b>Ft</b>	<b>Length Surveyed</b> 62.40
<b>Lining</b>	<b>Year laid</b>	<b>Year rehabilitated</b>	<b>Weather</b> Dry

<b>Purpose</b> Infiltration/Inflow Investigation	<b>Cat</b>		
<b>Additional info</b>		<b>Structural</b>	<b>O&amp;M</b> <b>Constructional</b>
<b>Location</b> Parking Lot		<b>Miscellaneous</b>	<b>Hydraulic</b>

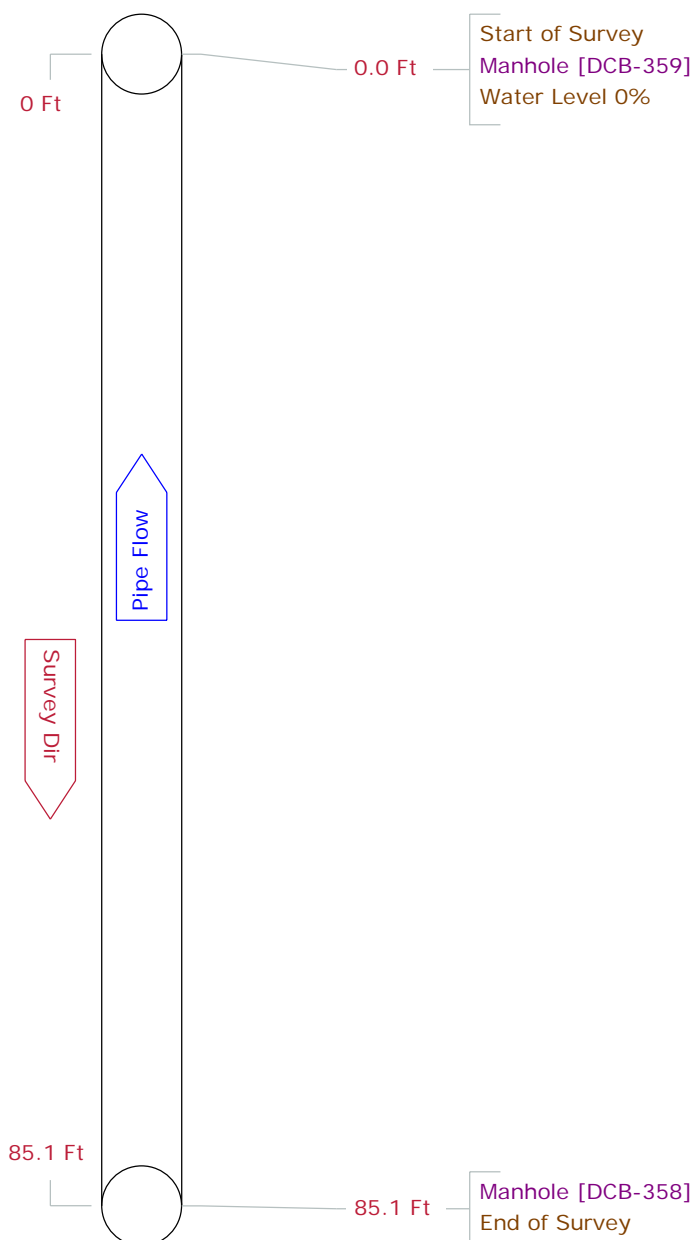
# Pipe Graphic Report of PLR DCB-358 X for WOODARD & CURRAN

<b>Setup</b> 91	<b>Surveyor</b> WP	<b>Certificate #</b> T-001-002	<b>System Owner</b> SUNY OF ALBANY
<b>Drainage</b> STORM DRAIN	<b>Survey Customer</b> WOODARD & CURRAN		
<b>P/O #</b>	<b>Date</b> 2007/08/20	<b>Time</b> 10:15	<b>Street</b> SUNY OF ALBANY
<b>Locality</b> VARIOUS LOCATIONS	<b>Further location details</b>		
<b>Start</b> DCB-359	<b>Rim to invert</b>	<b>Grade to invert</b>	<b>Rim to grade</b> <b>Ft</b>
<b>Finish</b> DCB-358	<b>Rim to invert</b>	<b>Grade to invert</b>	<b>Rim to grade</b> <b>Ft</b>
<b>Use</b> Stormwater	<b>Direction</b> Upstream	<b>Flow control</b> Not Controlled	<b>Tape/Media #</b> WP-03
<b>Shape</b> Circular	<b>Height</b> 15	<b>Width</b> ins	<b>Preclean</b> N <b>Year Cleaned</b>
<b>Material</b> Reinforced Concrete Pipe	<b>Joint length</b> <b>Ft</b>	<b>Total length</b> 85.1 <b>Ft</b>	<b>Length Surveyed</b> 85.10
<b>Lining</b>	<b>Year laid</b>	<b>Year rehabilitated</b>	<b>Weather</b> Dry

<b>Purpose</b> Infiltration/Inflow Investigation	<b>Cat</b>		
<b>Additional info</b>		<b>Structural</b>	<b>O&amp;M</b> <b>Constructional</b>
<b>Location</b> Parking Lot		<b>Miscellaneous</b>	<b>Hydraulic</b>
