# Condition Assessment Report

**Stormwater, Sanitary  
Sewer, Water and  
Irrigation Systems**

**University at Albany  
(Uptown Campus)**

**SUCF Project No. 01834**

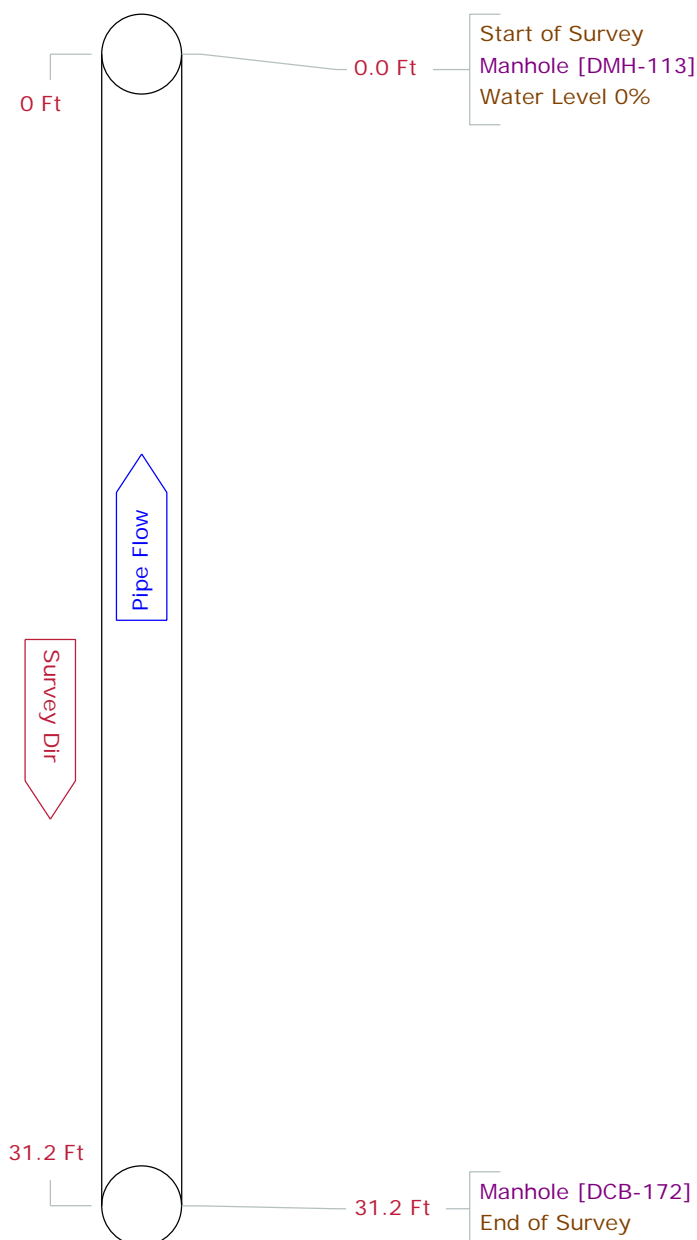
# Pipe Graphic Report of PLR DCB-172 X for WOODARD & CURRAN

<b>Setup</b> 94	<b>Surveyor</b> WP	<b>Certificate #</b> T-001-002	<b>System Owner</b> SUNY OF ALBANY
<b>Drainage</b> STORM DRAIN	<b>Survey Customer</b> WOODARD & CURRAN		
<b>P/O #</b>	<b>Date</b> 2007/08/20	<b>Time</b> 10:38	<b>Street</b> SUNY OF ALBANY
<b>Locality</b> VARIOUS LOCATIONS	<b>Further location details</b>		
<b>Start</b> DMH-113	<b>Rim to invert</b>	<b>Grade to invert</b>	<b>Rim to grade</b> <b>Ft</b>
<b>Finish</b> DCB-172	<b>Rim to invert</b>	<b>Grade to invert</b>	<b>Rim to grade</b> <b>Ft</b>
<b>Use</b> Stormwater	<b>Direction</b> Upstream	<b>Flow control</b> Not Controlled	<b>Tape/Media #</b> WP-03
<b>Shape</b> Circular	<b>Height</b> 15 <b>Width</b> ins	<b>Preclean</b> N	<b>Year Cleaned</b>
<b>Material</b> Reinforced Concrete Pipe	<b>Joint length</b> <b>Ft</b>	<b>Total length</b> 31.2 <b>Ft</b>	<b>Length Surveyed</b> 31.20
<b>Lining</b>	<b>Year laid</b>	<b>Year rehabilitated</b>	<b>Weather</b> Dry

<b>Purpose</b> Infiltration/Inflow Investigation	<b>Cat</b>		
<b>Additional info</b>		<b>Structural</b>	<b>O&amp;M</b> <b>Constructional</b>
<b>Location</b> Parking Lot		<b>Miscellaneous</b>	<b>Hydraulic</b>
